PENNSYLVANIA HISTORIC RESOURCE SURVEY FORM PHOTO/SITE PLAN SHEET

Address: 299 Morris Road

Surveyor Name/Title: Robert Wise Date: 6/16/2000
Project Name: Whitpain Township Historic Resource Survey
Organization: Robert Wise Consulting/Whitpain Township Telephone: (610) 722-5818
Street and No.: Station Square 1, Suite 104, 37 North Valley Road
City, State: Paoli, Pa Zip Code: 19301
Additional Survey Documentation: n/a
Associated Survey Codes: n/a

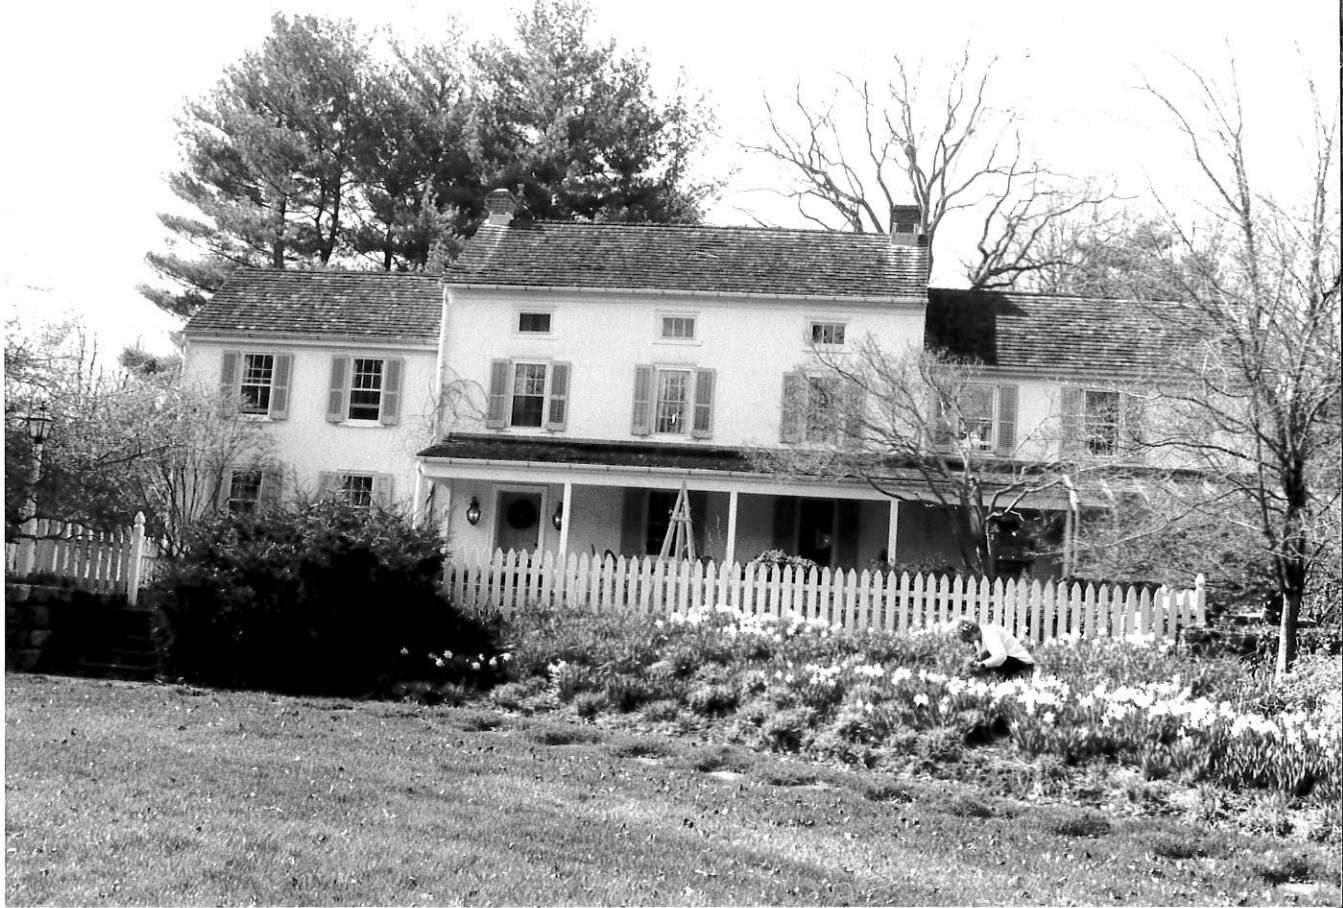
A fine Federal Colonial house in excellent condition, this house consists of a core with wings and a porch attached later. The core, built c. 1790, is a two and a half story, three bay, end gable house with interior end chimneys. It has a wooden shingle roof and stuccoed walls. Windows on the third floor are three paned awnings without shutters; on the first and second floors the windows are six over six double hung sash with shutters. The door is in the first bay rather than the center bay; otherwise the core is a symmetrical unit. The main wings are two story, two bay and are built on the same axis as the core. They have a similar window pattern on the façade and have four windows on the gable ends. There is also a circular window in the gable. There is also a rear addition. A long porch runs the length of the core and one addition; one end of the porch has been enclosed with glass to form a greenhouse.

Classification: While this house is in excellent condition, the many alterations make it a Class II resource.
