PENNSYLVANIA HISTORIC RESOURCE SURVEY FORM PHOTO/SITE PLAN SHEET

Address: 1533 Walton Road

Surveyor Name/Title: Robert Wise Date: 6/16/2000
Project Name: Whitpain Township Historic Resource Survey
Organization: Robert Wise Consulting/Whitpain Township Telephone: (610) 722-5818
Street and No.: Station Square 1, Suite 104, 37 North Valley Road
City, State: Paoli, Pa Zip Code: 19301
Additional Survey Documentation: n/a
Associated Survey Codes: n/a

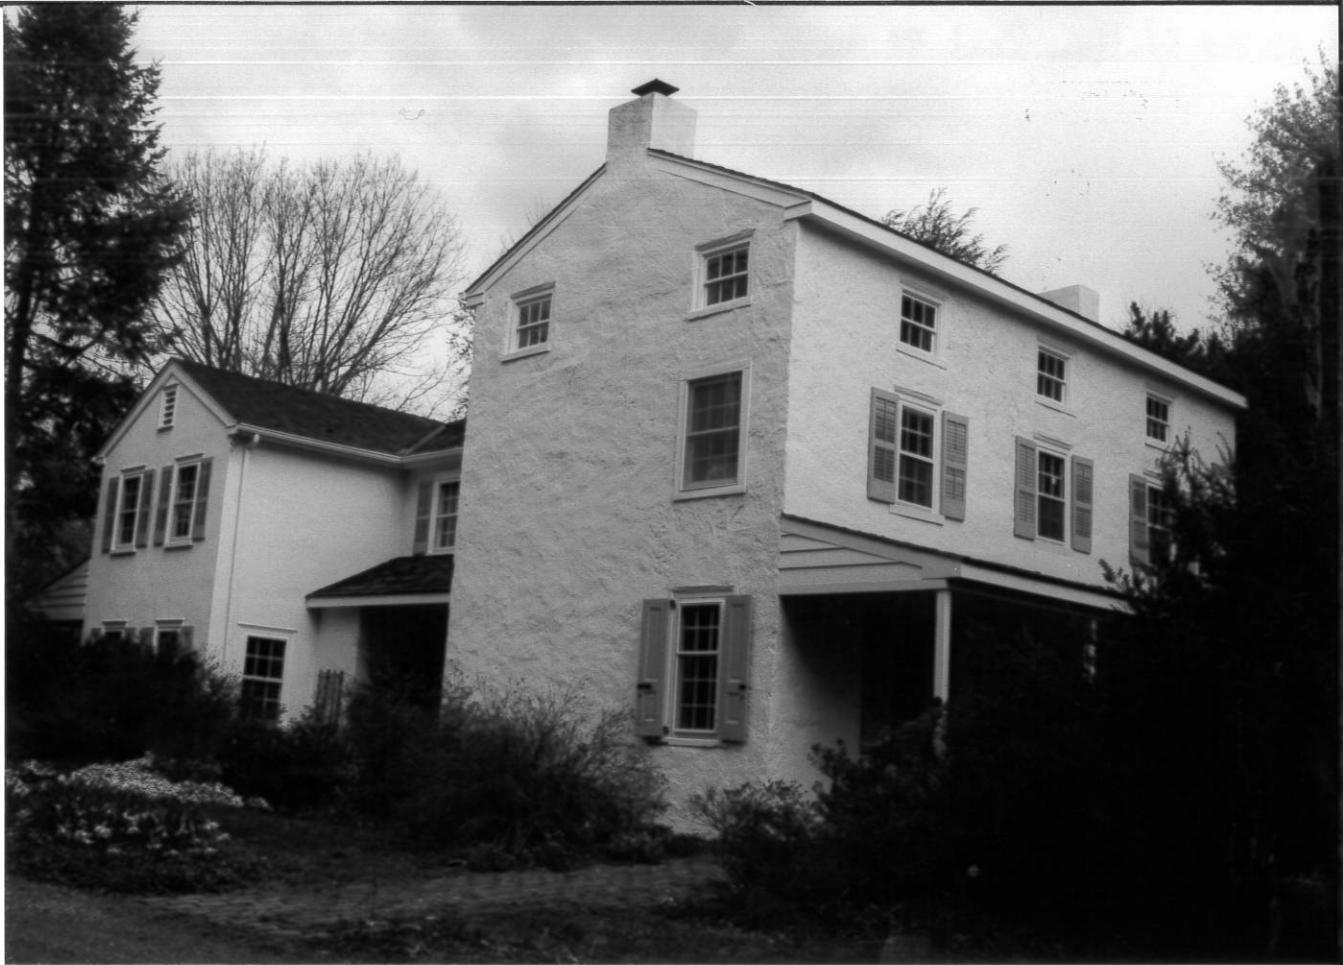
This secluded house is an example of Federal architecture. It consists of a large two and a half story, three bay core with additions to produce an H-plan building. The core is an end gable house with two interior end chimneys. The house is clad in stucco. The windows are floor specific: the first floor windows are six over nine double hung with shutters; the second floor windows are six over six double hung with shutters; the third floor windows are three over three double hung without shutters. A simple one story porch adorns the façade. The additions are also stucco-clad. They maintain the first and second story window treatment.

Classification: While this house is in excellent condition, the additions make it a Class II resource.
