PENNSYLVANIA HISTORIC RESOURCE SURVEY FORM PHOTO/SITE PLAN SHEET
Pennsylvania Historic and Museum Commission
Bureau of Historic Preservation
Box 1026, Harrisburg, PA 17108-1026

Address: 1951 Skippack Pike

PENNSYLVANIA HISTORIC RESOURCE SURVEY FORM - DATA SHEET

Surveyor Name/Title: Robert Wise Date: 6/16/2000
Project Name: Whitpain Township Historic Resource Survey
Organization: Robert Wise Consulting/Whitpain Township Telephone: (610) 722-5818
Street and No.: Station Square 1, Suite 104, 37 North Valley Road
City, State: Paoli, Pa Zip Code: 19301
Additional Survey Documentation: n/a
Associated Survey Codes: n/a

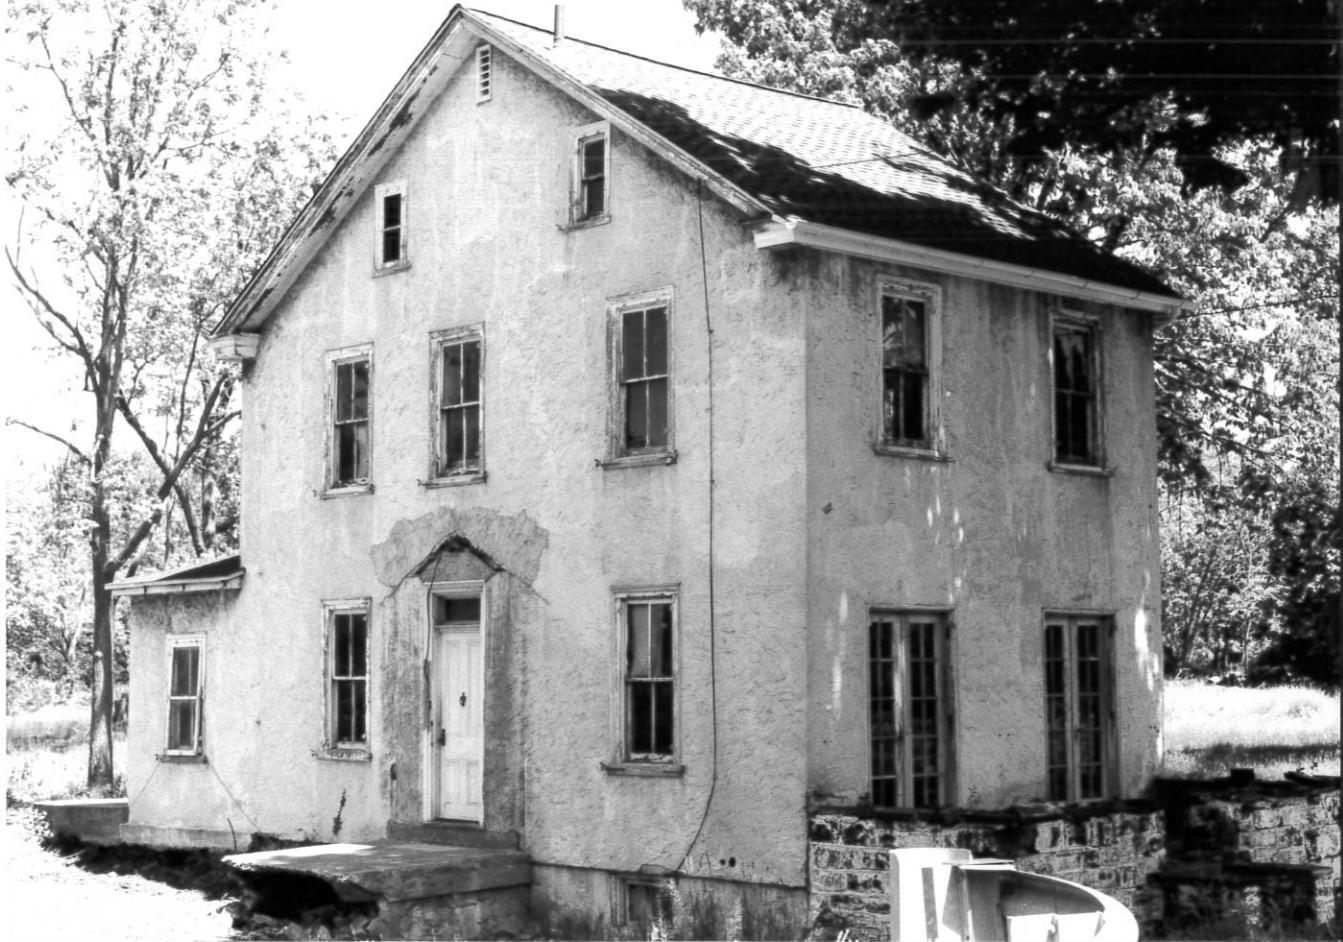
| Number | Description of View | Direction of Camera |
|---|---|---|
| 1 | House – façade | |

This house, reportedly built in 1890, may actually date to the post-Civil War era. The two story, stucco covered house has an front end-gabled, asphalt shingled roof, side entrance, and a pair of French doors facing Skippack Pike. The house consists of the core, a single story, rear addition, also stucco-covered, and walled front porch, consisting of coursed stonework. The façade facing the pike is symmetrical with two 2x2 double hung sash windows located above the two glass French doors. There is no ornamentation. The side entrance originally had a gabled hood. Today it consists of a solid paneled door with single pane transom. Windows on the first and second floors are 2x2 double hung sash. Those windows, like the two attic windows above, are asymmetrical. The house appears to be in poor condition.
