PENNSYLVANIA HISTORIC RESOURCE SURVEY FORM PHOTO/SITE PLAN SHEET

Address: 225 Mathers Drive

PENNSYLVANIA HISTORIC RESOURCE SURVEY FORM - DATA SHEET

Project Name: Whitpain Township Historic Resource Survey

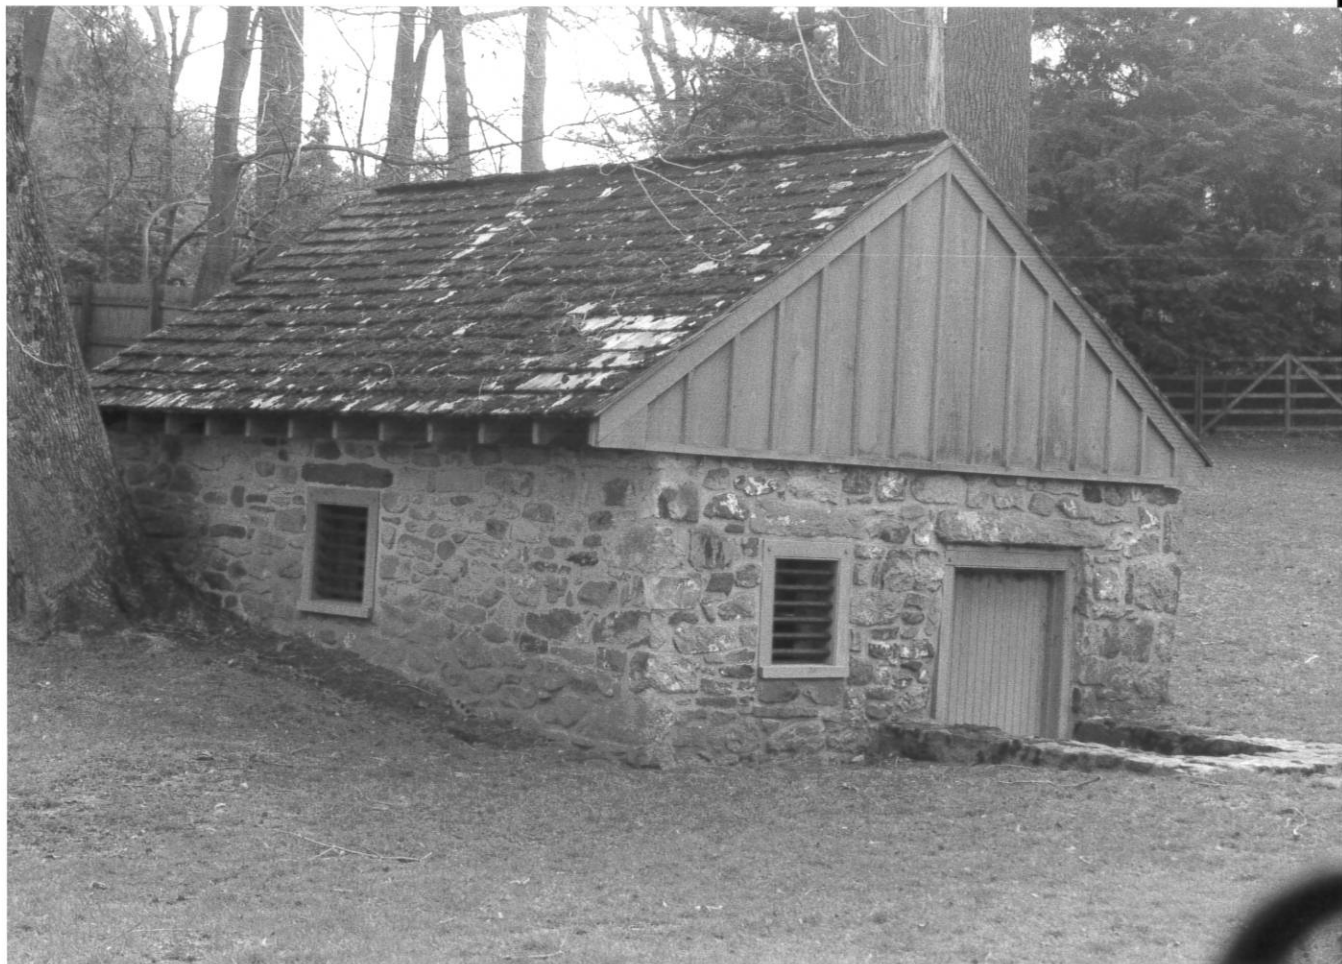
Springhouse: A springhouse is also associated with the house. This building is constructed of uncoursed stone and has exposed rafter tails.
