PENNSYLVANIA HISTORIC RESOURCE SURVEY FORM PHOTO/SITE PLAN SHEET

Address: 230 Mathers Road

Surveyor Name/Title: Robert Wise Date: 6/16/2000
Project Name: Whitpain Township Historic Resource Survey
Organization: Robert Wise Consulting/Whitpain Township Telephone: (610) 722-5818
Street and No.: Station Square 1, Suite 104, 37 North Valley Road
City, State: Paoli, Pa Zip Code: 19301
Additional Survey Documentation: n/a
Associated Survey Codes: n/a

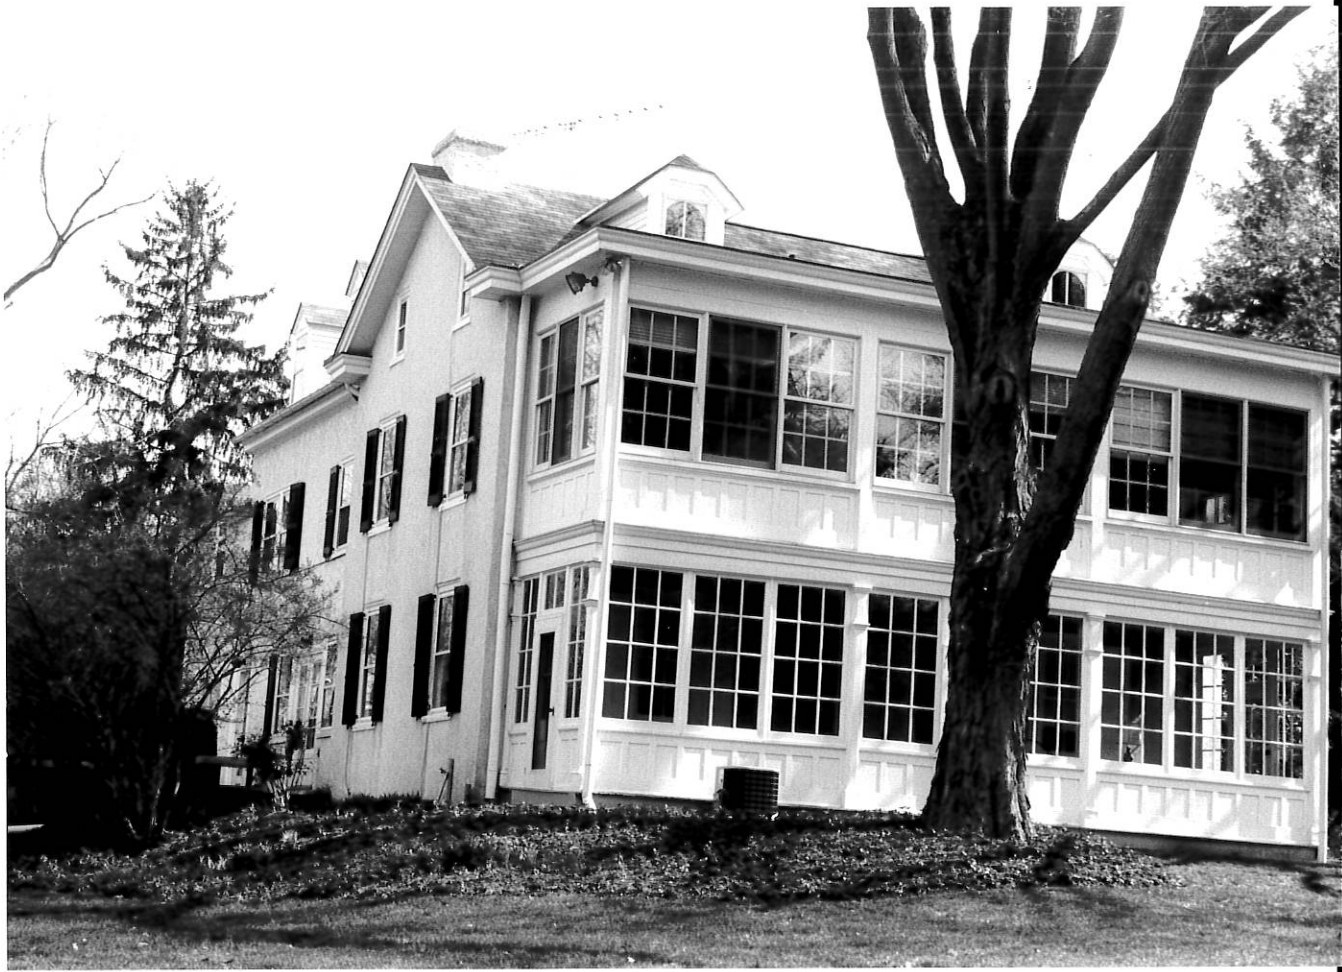
Number	Description of View	Direction of Camera
1	House – façade (left)	
2	House – façade (right)	
3		
4		
5		
6		
Photographer Name:	Robert Wise	Date: 1999

Owners of this house have made many changes throughout its history. It consists of a Federal style core built c. 1800 with a large enclosed porch on the front and significant additions on the rear. The core is a two and a half story, end-gabled house clad in stucco. It has interior end chimneys and two interesting dormers with hipped roofs. The windows in the dormers are two over two double hung without shutters; the windows on the house are two over two double hung sash with shutters. Built onto the façade is a two-story enclosed porch. It has two bands of windows; those on the upper floor are six over six double hung while those on the lower floor are twelve pane sashes which appear to be fixed. There are two pilasters on the façade which divide the window bands into thirds.

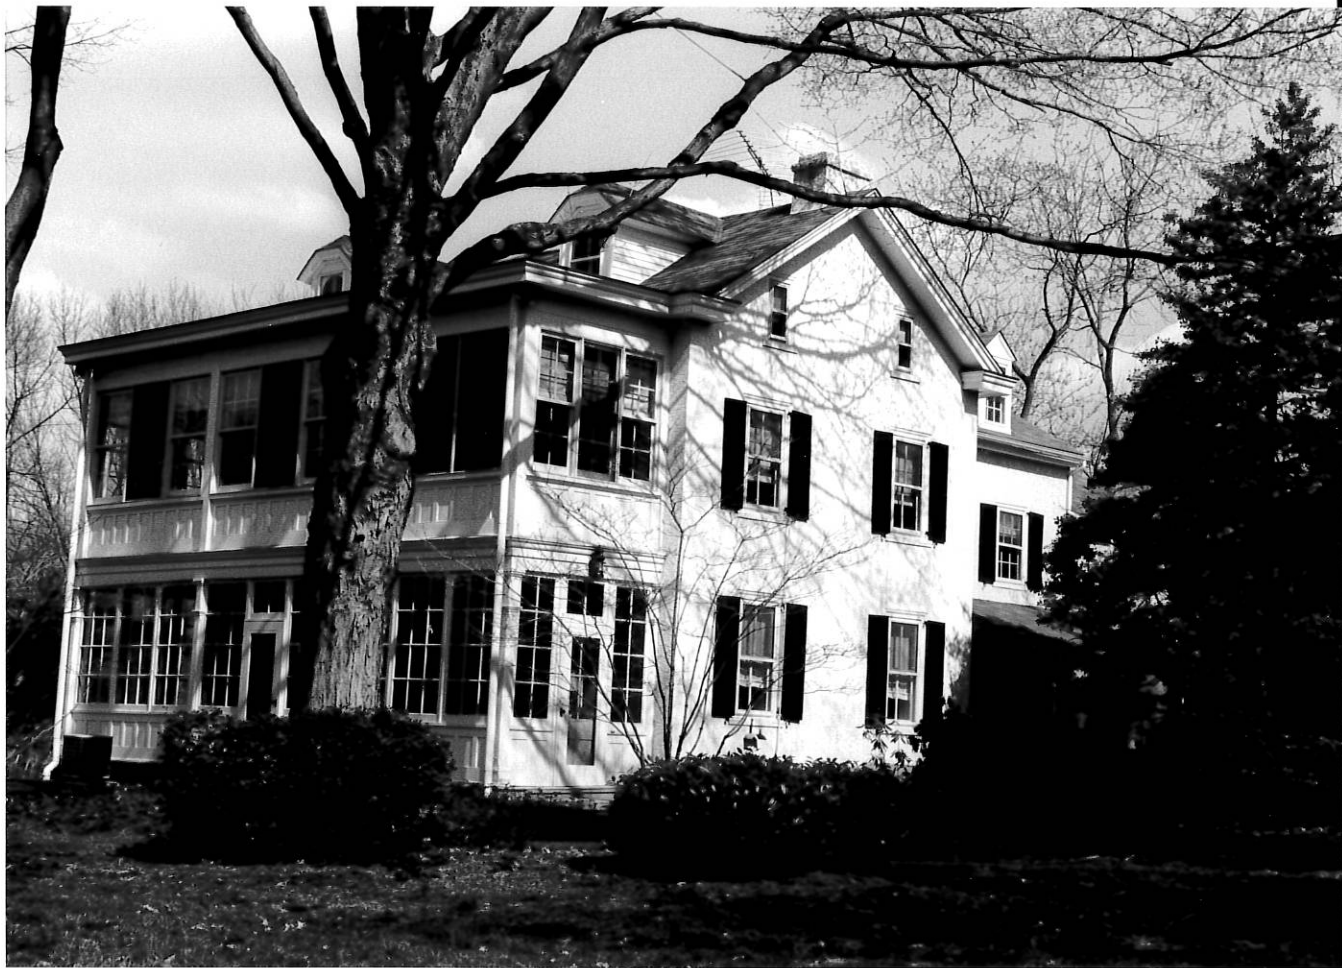
There is also an extensive rear addition on a perpendicular axis. Most of the rear addition is two story and covered with stucco. Dormers are gabled and have six over six double hung windows without shutters. The windows on the addition are also six over six double hung, but they have shutters.
