**PENNSYLVANIA HISTORIC RESOURCE SURVEY FORM PHOTO/SITE PLAN SHEET**

Municipality: Whitpain Township Address: 276 W. Mount Pleasant Avenue

Surveyor Name/Title: Robert Wise Date: 6/16/2000  
Project Name: Whitpain Township Historic Resource Survey  
Organization: Robert Wise Consulting/Whitpain Township Telephone: (610) 722-5818  
Street and No.: Station Square 1, Suite 104, 37 North Valley Road  
City, State: Paoli, Pa Zip Code: 19301  
Additional Survey Documentation: n/a  
Associated Survey Codes: n/a

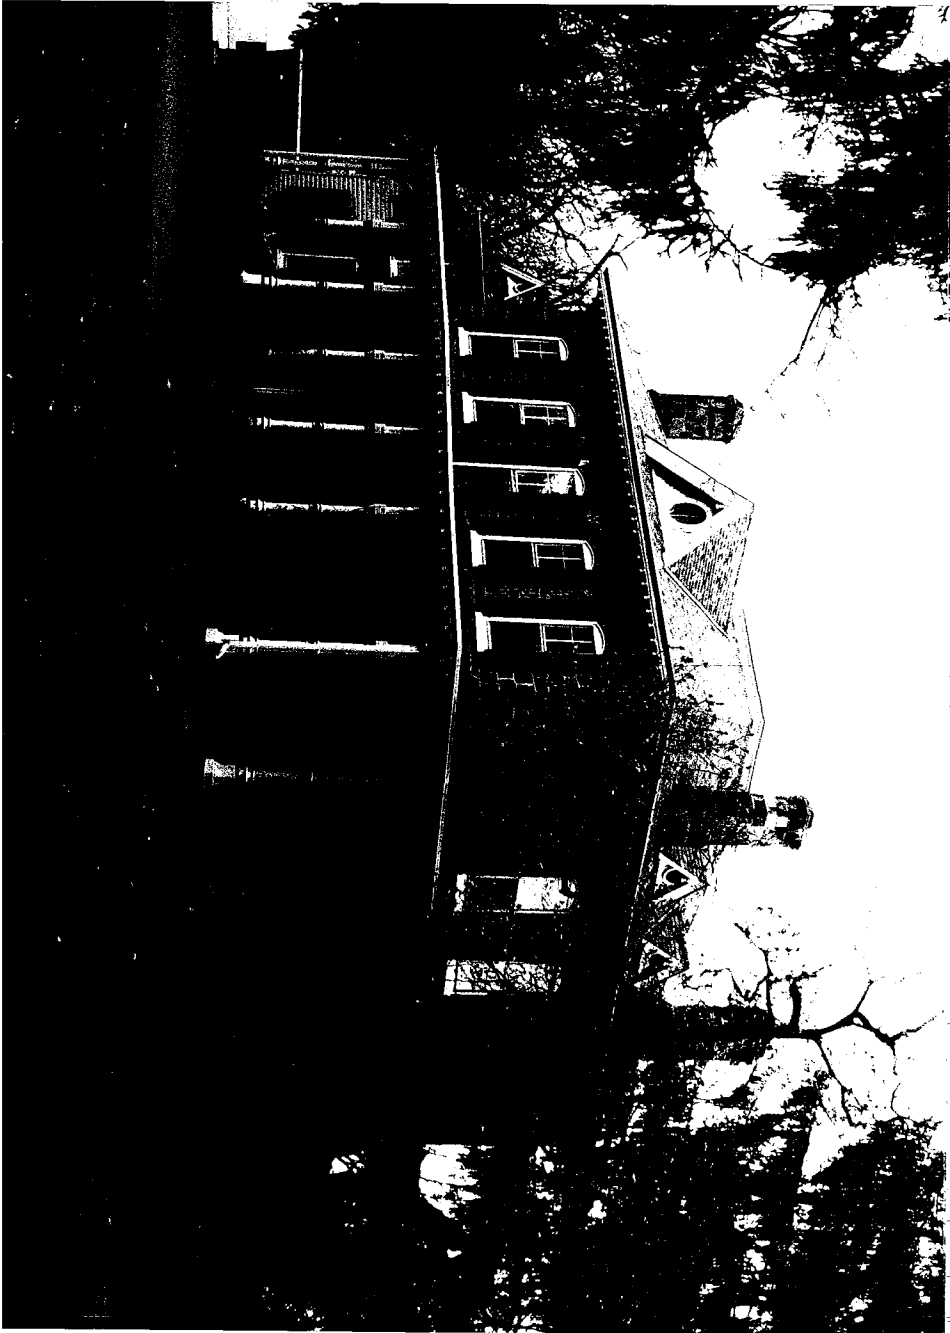
The core of the house consists of a two story, five bay 40' by 40' house built c. 1885 with a hipped roof. It is built of uncoursed stone and has four interior slope chimneys constructed of decorative stone. There is a large gabled eyebrow dormer in the center of the façade with a circular window. On the sides of the building are two smaller gabled eyebrow dormers with circular windows. The windows on the house are four over four double hung sash with shutters. Over each window is a stone arch, and the top rail of each shutter imitates the arch. A nice Italianate cornice frames the roof and is copied on the wrap-around porch. The porch consists of a one-story flat roof with a dentil molding resting upon spindle-like columns.

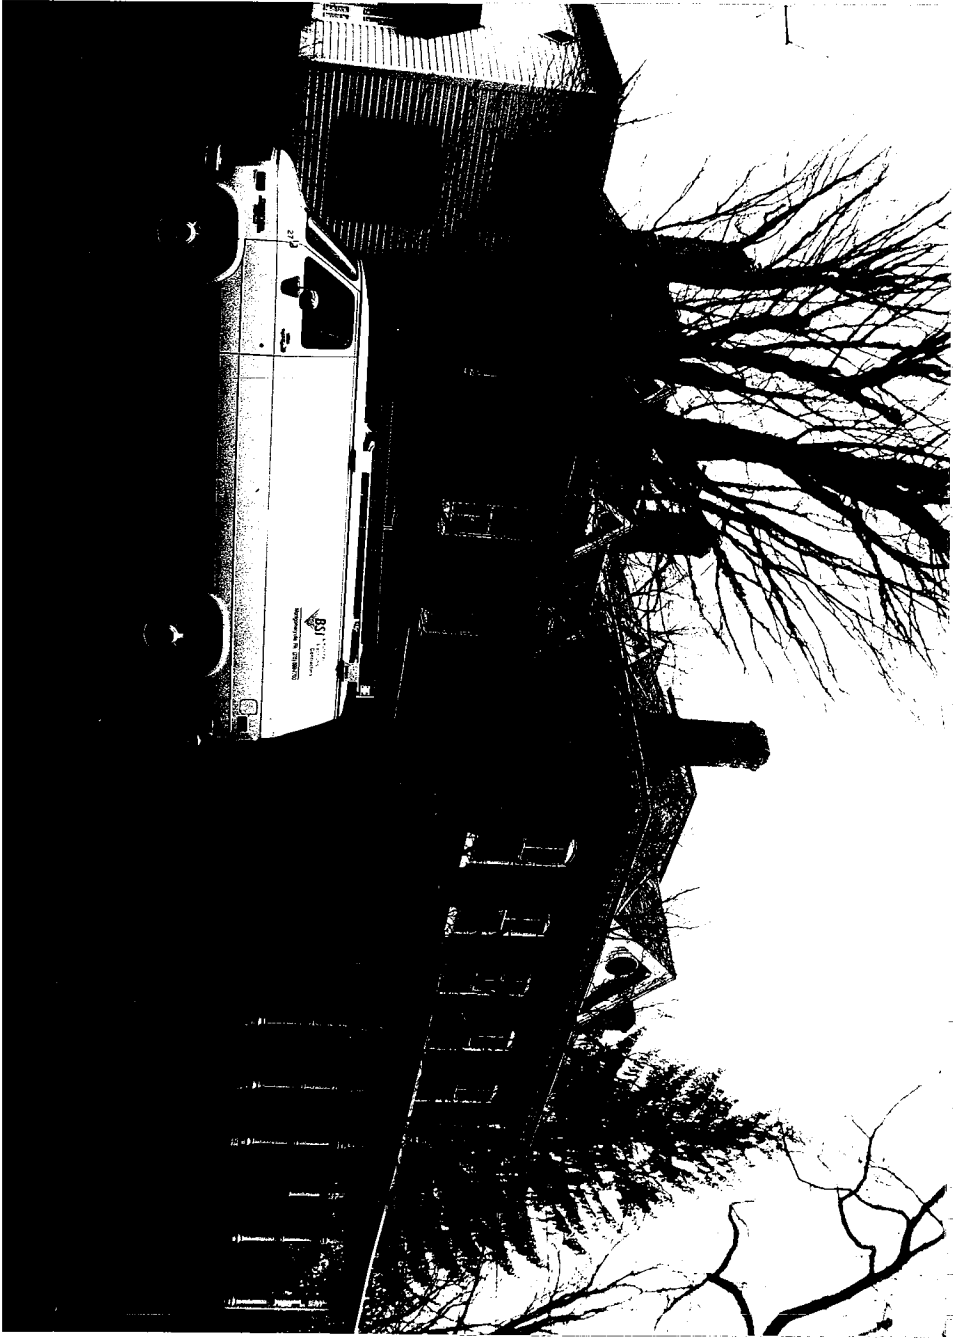
To the left of the front façade is a two story stone addition constructed on the same axis as the core. This addition copies many details from the core: the hipped roof, gabled eyebrow dormers with the circular window, the four over four double hung sash windows with shutters, and the cornice. Windows on the first floor are crowned with a brick arch and have arched shutters. A single chimney composed of decorative stone is an interior end chimney. An entry stoop has a small porch with the Italianate cornice and nice arched brackets. There are three of the small dormers on the façade and none on the ends.

The second addition is a two-story frame structure off the first addition. It has a flat roof and four over four double hung sash windows with shutters. A door on the end of this addition has a gabled roof supported on braces and a diamond-shaped window on the second floor.
