PENNSYLVANIA HISTORIC RESOURCE SURVEY FORM PHOTO/SITE PLAN SHEET

Address: 334 Railroad Avenue

Surveyor Name/Title: Robert Wise Date: 6/16/2000
Project Name: Whitpain Township Historic Resource Survey
Organization: Robert Wise Consulting/Whitpain Township Telephone: (610) 722-5818
Street and No.: Station Square 1, Suite 104, 37 North Valley Road
City, State: Paoli, Pa Zip Code: 19301
Additional Survey Documentation: n/a
Associated Survey Codes: n/a

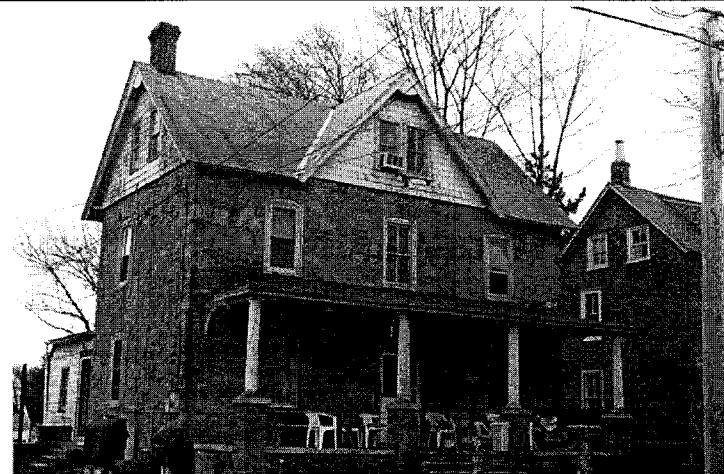
SITE PLAN**PHOTO INFORMATION**

Number	Description of View	Direction of Camera
1	House – façade	
2		
3		
4		
5		
6		
Photographer Name: Robert Wise		Date: 1999
Negative Location: Robert Wise Consulting, Station Square 1, Suite 104, 37 N. Valley Road, Paoli PA 19301

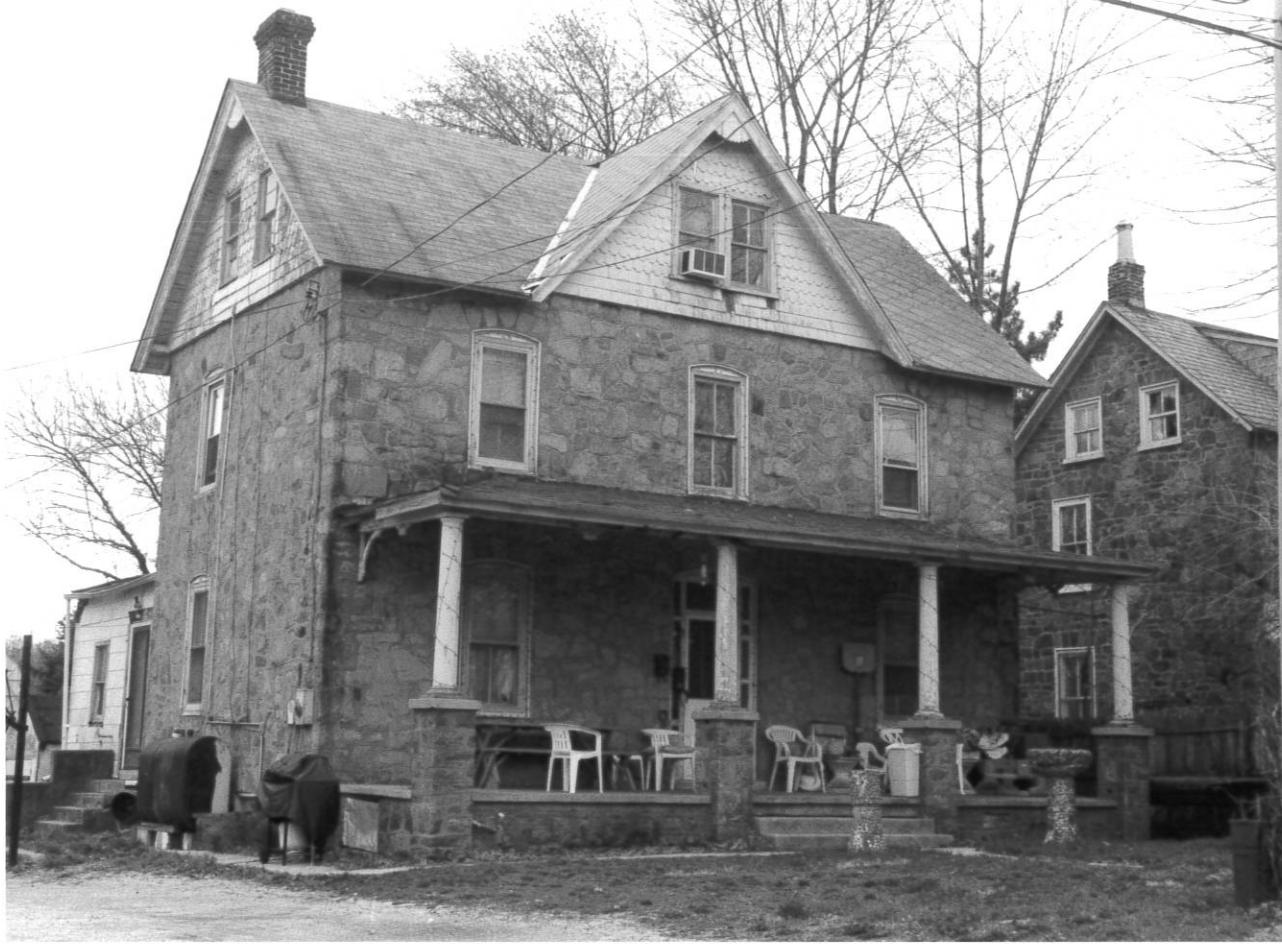
This is a Victorian Gothic-style house built of uncoursed stone. It is a three-bay, two and a half story house. It has one interior end chimney and cross gables. The gables have patterned wood shingles above the second floor and paired windows. The windows are double hung with arched heads matching the arched stonework above them. The centered door has a large rectangular transom and sidelights. Four simple unfluted columns sit on brick bases and support a one-story hipped roof porch on the façade; a decorative corner brace connects the porch to the stonewall. A one-story addition off the back of the house gives it a T-shaped plan. This house is in poor condition.
