PENNSYLVANIA HISTORIC RESOURCE SURVEY FORM PHOTO/SITE PLAN SHEET

Address: 353 Lewis Lane

Surveyor Name/Title: Robert Wise Date: 6/16/2000
Project Name: Whitpain Township Historic Resource Survey
Organization: Robert Wise Consulting/Whitpain Township Telephone: (610) 722-5818
Street and No.: Station Square 1, Suite 104, 37 North Valley Road
City, State: Paoli, Pa Zip Code: 19301
Additional Survey Documentation: n/a
Associated Survey Codes: n/a

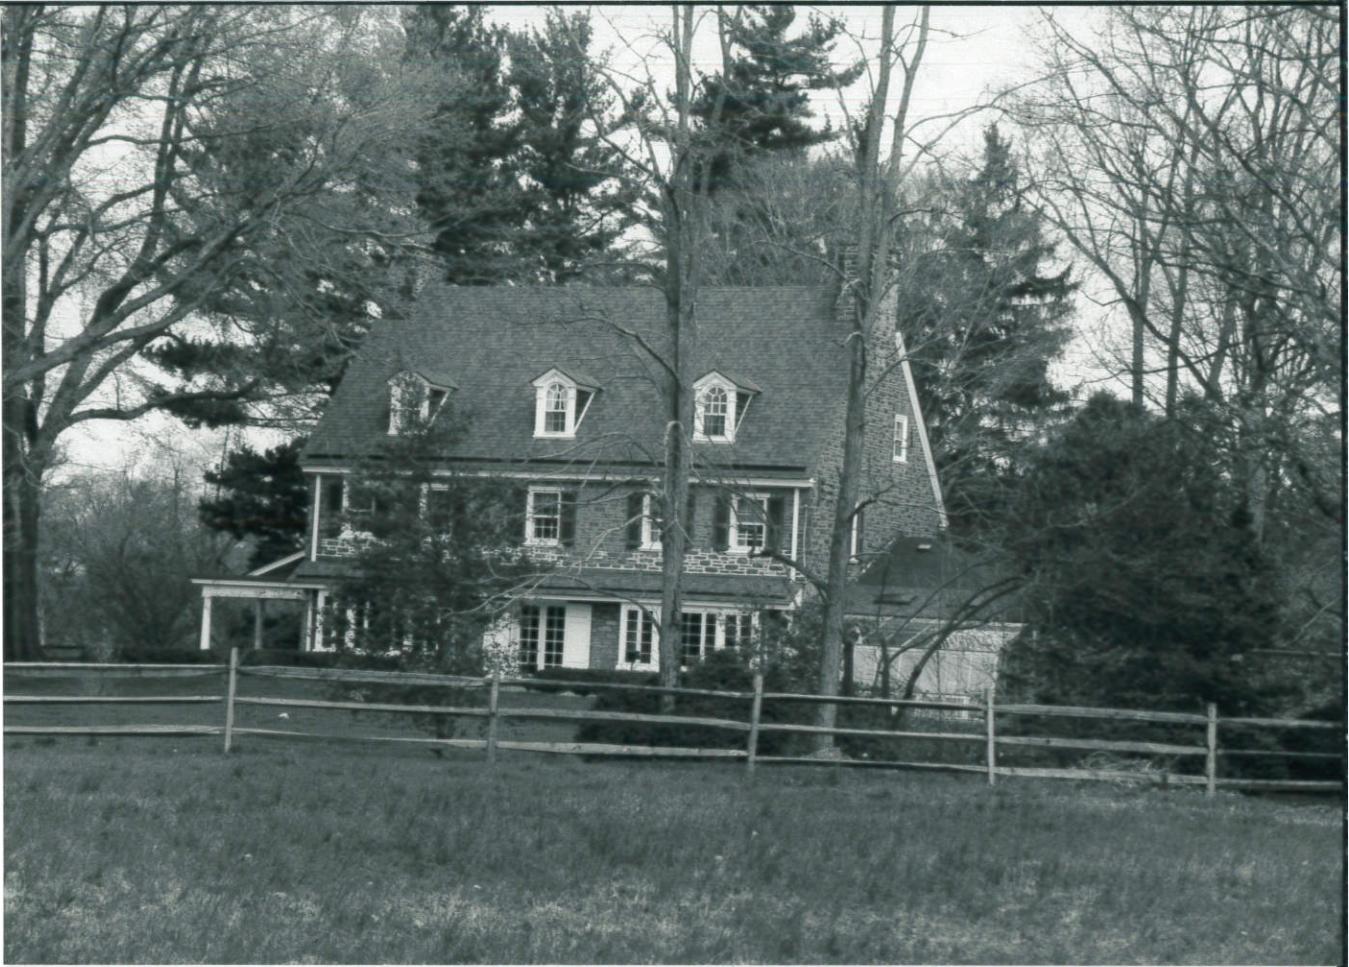
This Colonial Revival house sits perpendicular to Lewis Lane. It is a 2½ story, five bay house with an exterior end chimneys in each gable. The house is composed of semi-coursed stone. Three small gabled roof dormers cut through the roof and have windows with arched sashes. A pent roof divides the façade; the second story windows have shutters, and the first story windows are bands separated by the door. There is an open porch on the left side of the façade resting upon unfluted round columns, while an enclosed porch and greenhouse has been added off the other end of the façade. The rear of the house is surprisingly different. The third dormer is replaced with a large gable. Near the door is a large rounded stair window; most of the windows on the rear of the house are small and cut irregularly into the side of the house. An entry porch rests upon columns and shades the door with its transom and sidelights. To the right of the door is a tripartite window.
