PENNSYLVANIA HISTORIC RESOURCE SURVEY FORM PHOTO/SITE PLAN SHEET

Municipality: Whitpain Township

Address: 520 Plymouth Road

Surveyor Name/Title: Robert Wise Date: 6/16/2000
Project Name: Whitpain Township Historic Resource Survey
Organization: Robert Wise Consulting/Whitpain Township Telephone: (610) 722-5818
Street and No.: Station Square 1, Suite 104, 37 North Valley Road
City, State: Paoli, Pa Zip Code: 19301
Additional Survey Documentation: n/a
Associated Survey Codes: n/a

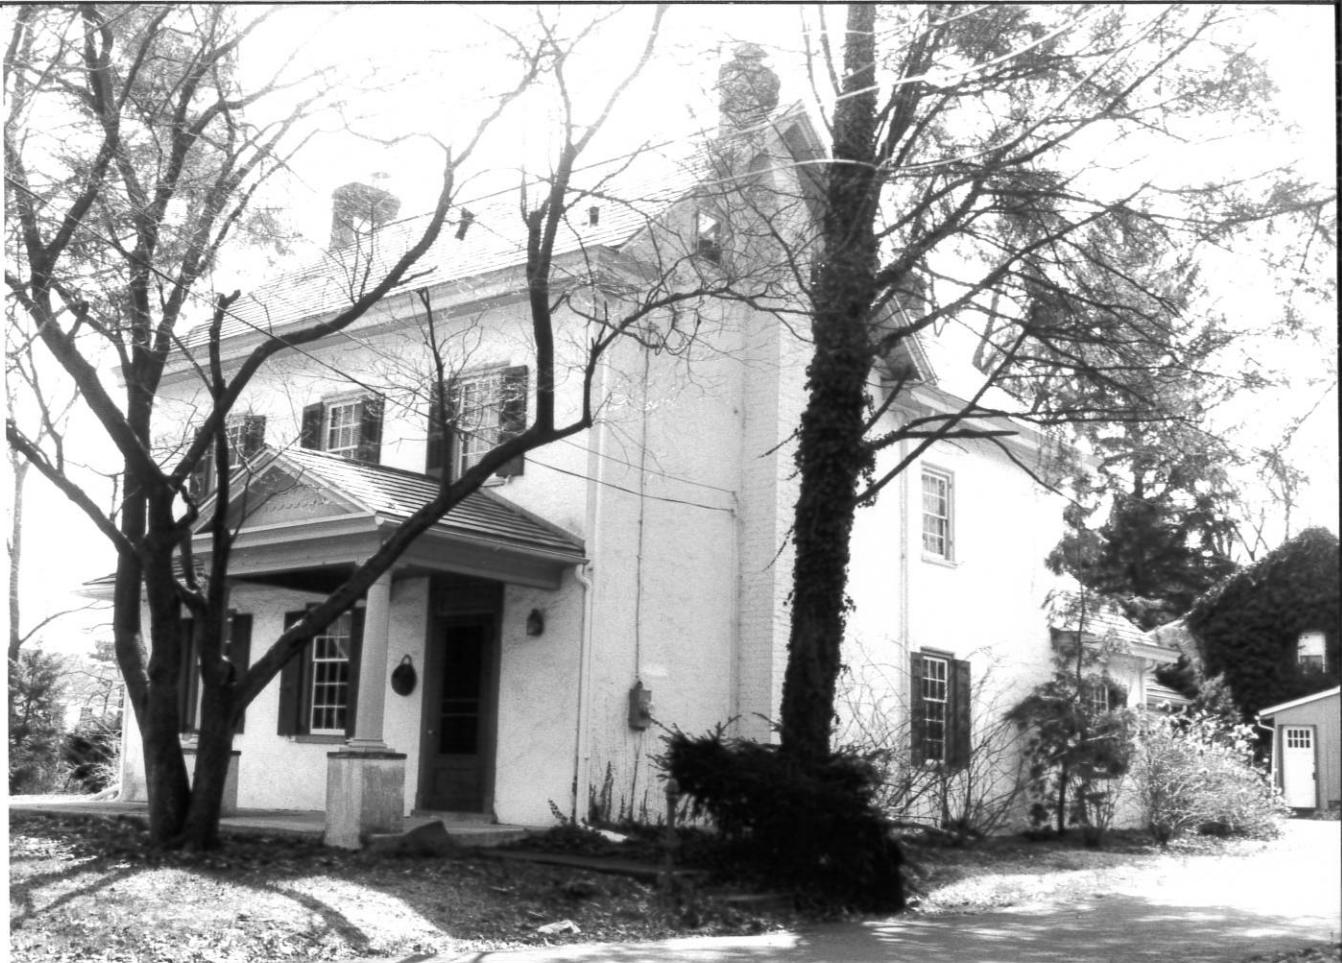
This is a late Federal house with a date stone of 1850. It is a three story, three bay house with end gables and contains a modern, one story addition on the rear. An exterior end chimney cuts through the molded cornice in the west gable but is not centered in the gable. The roof is end gabled and clad in asphalt shingles, and framed in a molded cornice. The walls of the 30 x 30 house are stone and covered with stucco. Each of the windows on the second and third floors is supplied with louvered shutters, and those on the first floor have paneled shutters. The door is centered on the façade under a one-story wrap-around porch supported by square columns. A rear one-story addition to the house accommodates a tripartite window and a small bay. This addition has a hipped roof.

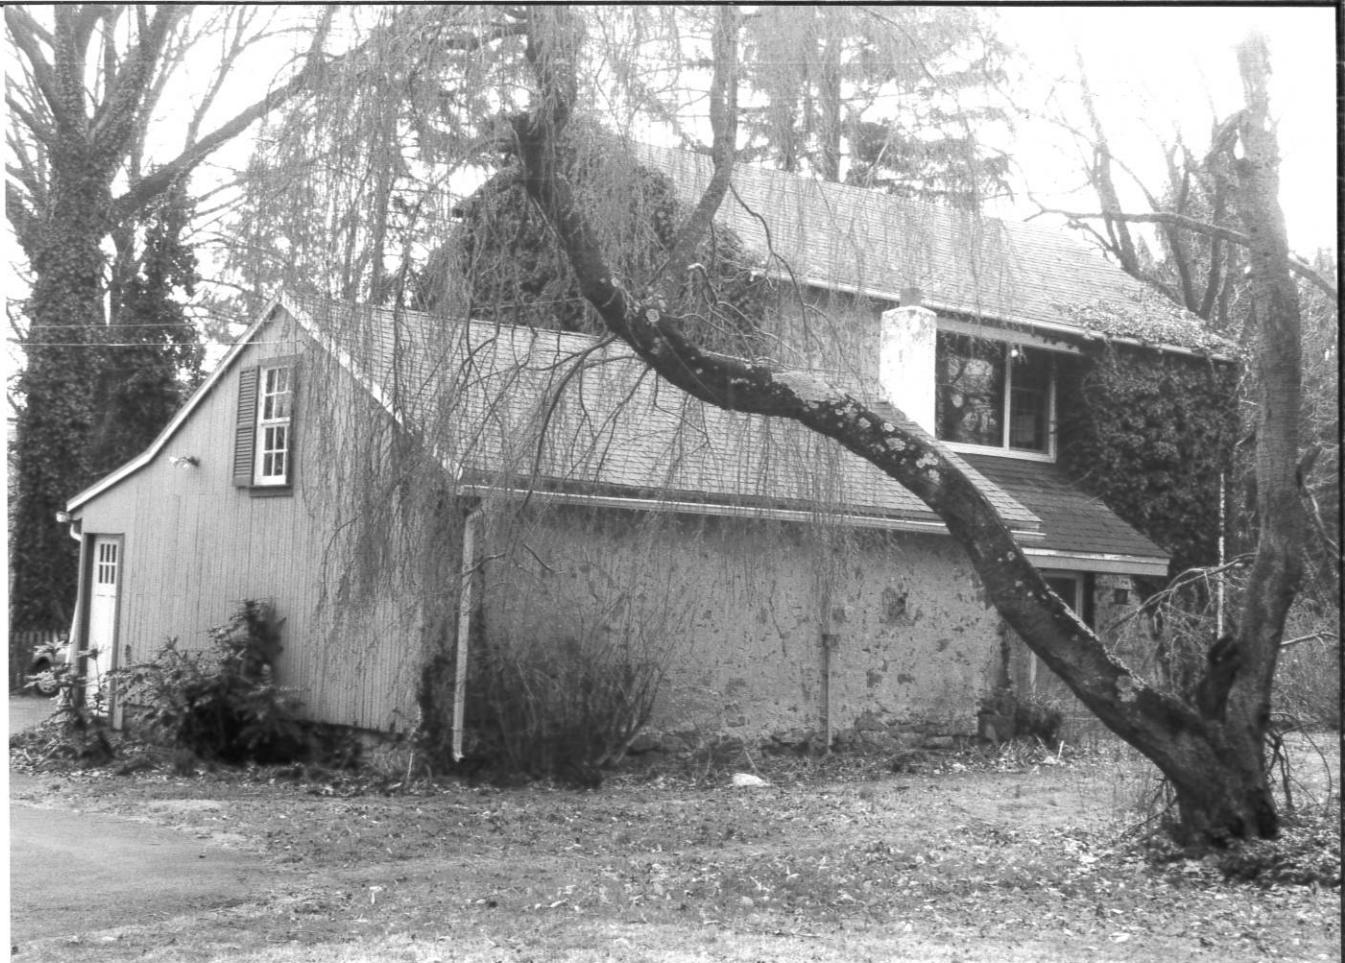
Associated Resource (Barn): This large stone bank barn has an end gabled roof clad in asphalt shingles, stonewalls, and a rear bank and bridge entrance. Attached to the end are a shed and a two story gabled frame addition.
