PENNSYLVANIA HISTORIC RESOURCE SURVEY FORM PHOTO/SITE PLAN SHEET

Address: 555 Lewis Lane

Project Name: Whitpain Township Historic Resource Survey

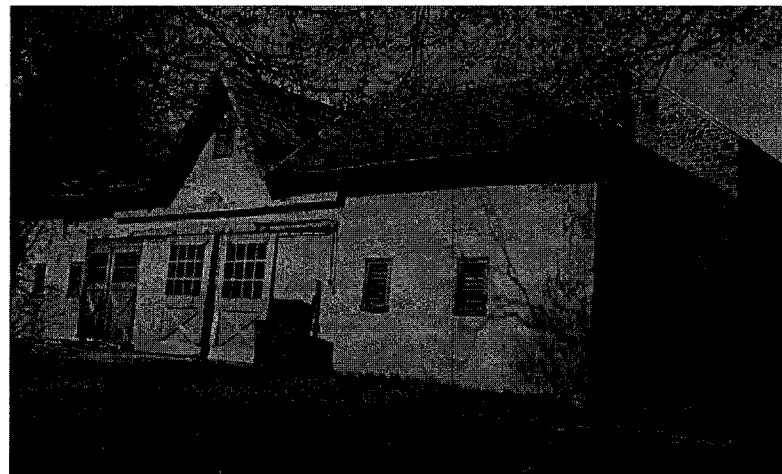
SITE PLAN

Number	Description of View	Direction of Camera
1	Carriage House	
2	Barn	
3	Barn	
4	Open Shed	
5	Barn and Corn Crib	
6		
Photographer Name: Robert Wise		Date: 1999
Negative Location: Robert Wise Consulting, Station Square 1, Suite 104, 37 N. Valley Road, Paoli PA 19301

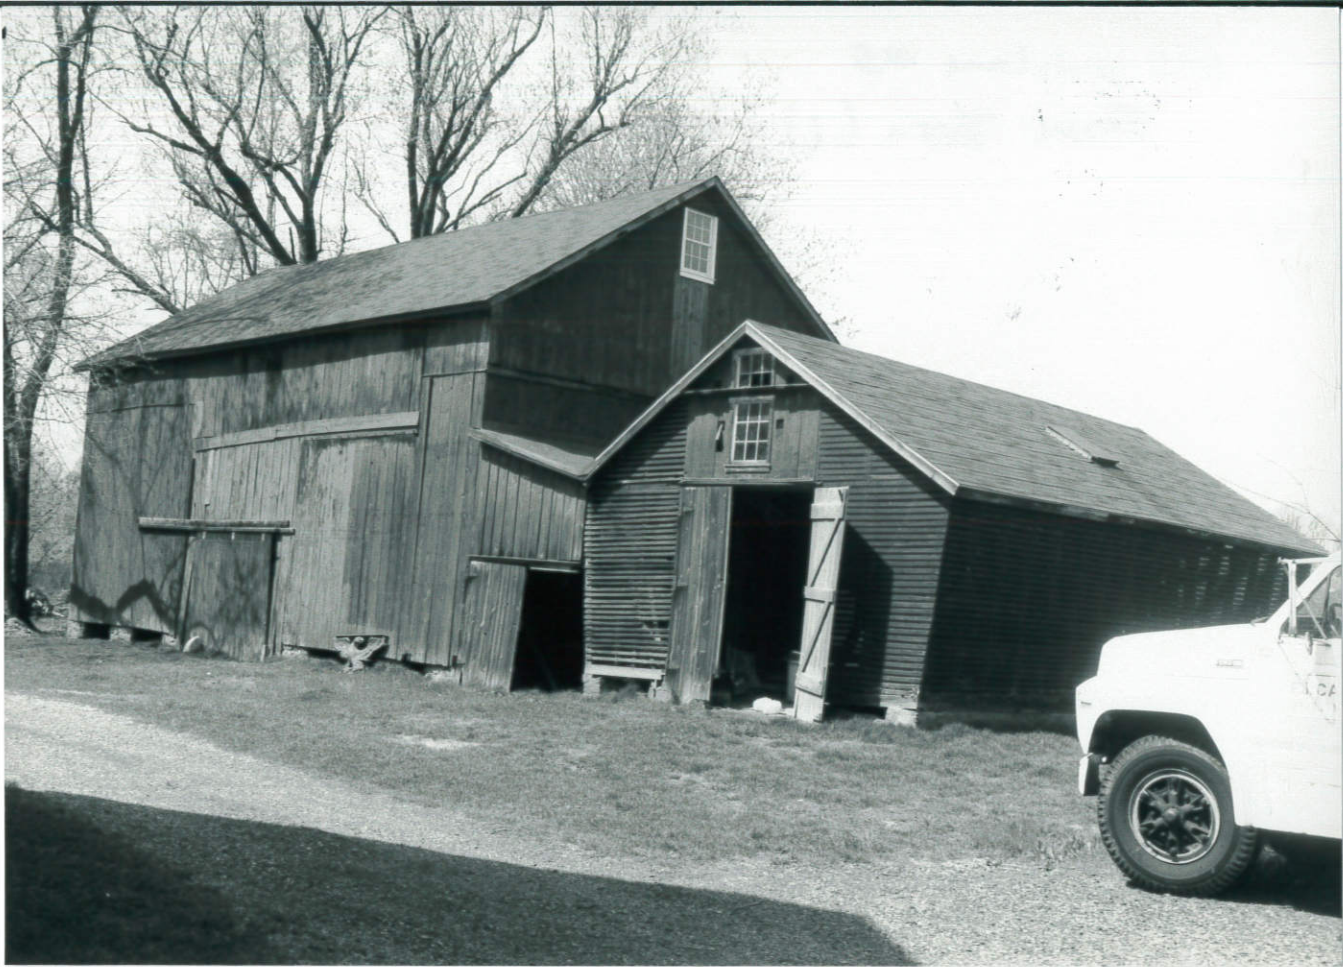
- (1) **Carriage House.** This stucco covered building is a one story building with a hipped roof and a centered cross gable. There are two large sliding doors on the front of the building and small windows. (C)
- (2) **Barn.** Built of uncoursed stone, this barn is in excellent condition. It is an end-gabled structure with few windows. (C)
- (3) **Open Shed.** This structure has a stone foundation covered with stucco and a frame upper story. The shed has three walls and is open on the fourth side. (C)
- (4) **Frame Barn.** This building stands on stone piers and is clad with vertical wood siding. It has sliding doors and a frame shed addition. A single window is located in the gable (C).
- (5) **Corn crib.** This building follows the pattern of many corncribs in Whitpain township with its flared walls and end gable construction. (C)
