PENNSYLVANIA HISTORIC RESOURCE SURVEY FORM PHOTO/SITE PLAN SHEET
Pennsylvania Historic and Museum Commission
Bureau of Historic Preservation
Box 1026, Harrisburg, PA 17108-1026

Address: 564 Skippack Pike

Surveyor Name/Title: Robert Wise Date: 6/16/2000
Project Name: Whitpain Township Historic Resource Survey
Organization: Robert Wise Consulting/Whitpain Township Telephone: (610) 722-5818
Street and No.: Station Square 1, Suite 104, 37 North Valley Road
City, State: Paoli, Pa Zip Code: 19301
Additional Survey Documentation: n/a
Associated Survey Codes: n/a

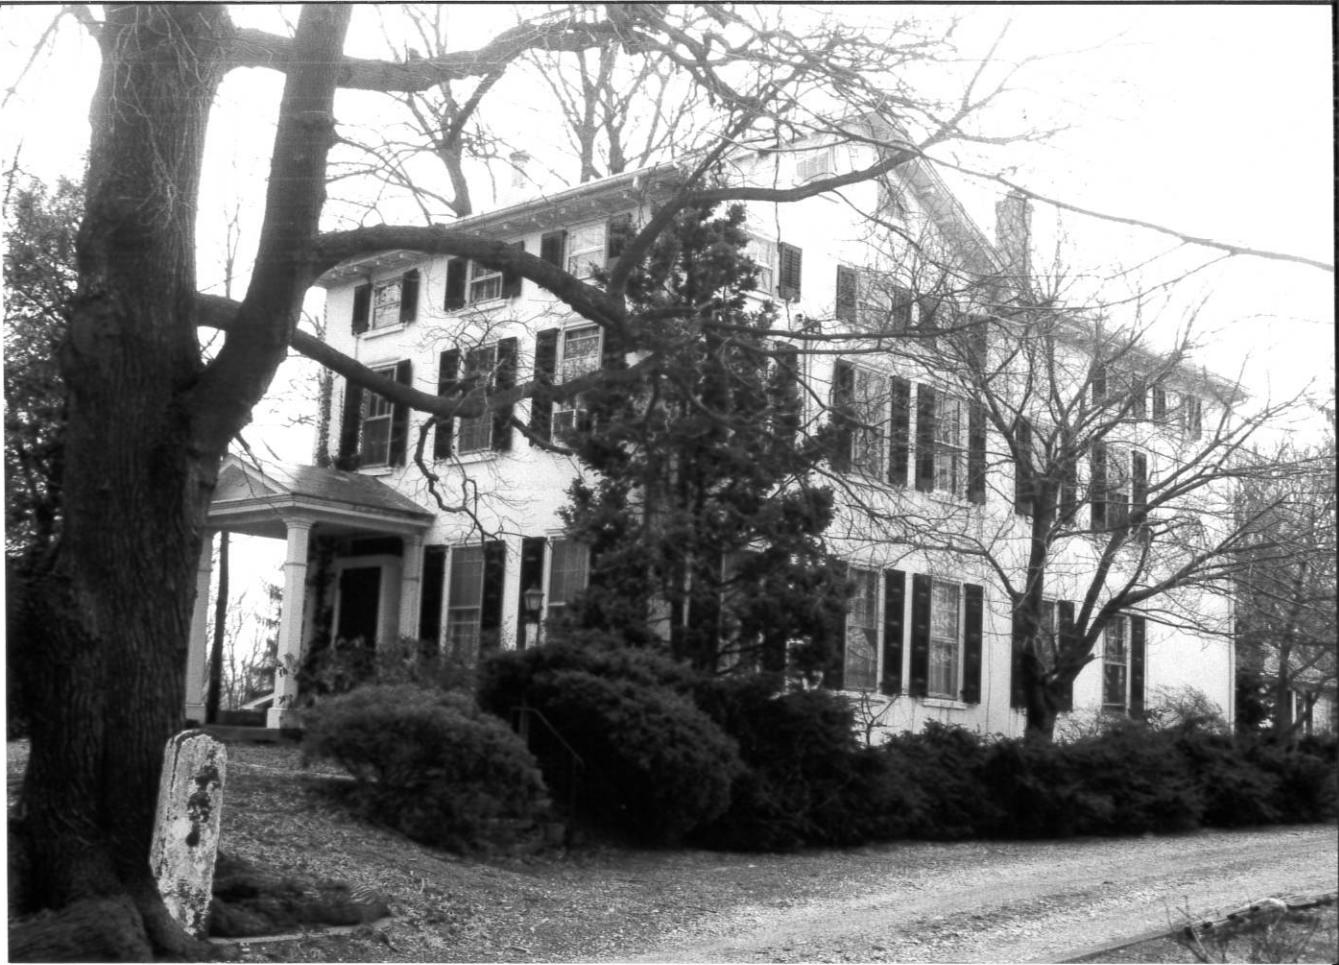
This large, Federal style house was constructed c. 1820. The 3-story building consists of a core, a rear addition, and two single story extensions to the rear. The property also has a masonry bank barn.

The core is a tall, nearly square building consisting of three bays including frieze band window arrangement on the third floor. The end-gabled roof is supported by decorative wood brackets, located under the eaves and gabled ends (as well as the main addition). The brackets may have been added when the rear addition was constructed, and placed there at during the influence of the Italianate style. Two flush chimneys are located at each end of the building, topped with terra-cotta chimney pots. Fenestration consists of 6x6 windows on the first and second floors, and 3x3 sash windows on the third floor frieze band windows. Paneled shutters are found on the first floor windows; louvered shutters on the second and third floors. The large gap between the first and second floor indicates either the earlier presence of a pent roof or a high ceiling height on the first floor. Mirroring many houses in the Township, twin angled windows are located at the attic level under the gables. The front door is located under a pedimented extension, supported by square columns. A transom is located over the door. The core measures approximately 25'x 20".

The roof on the main addition creates an overall cross-gabled roof arrangement. The addition measures approximately 18'x 30'. The walls are stucco over stone. Fenestration on the north side mirrors that of the core. Visible on the southern side is an enclosed sleeping porch, with an enclosed porch underneath. With the porch, the addition is the thickness of the width of the core.

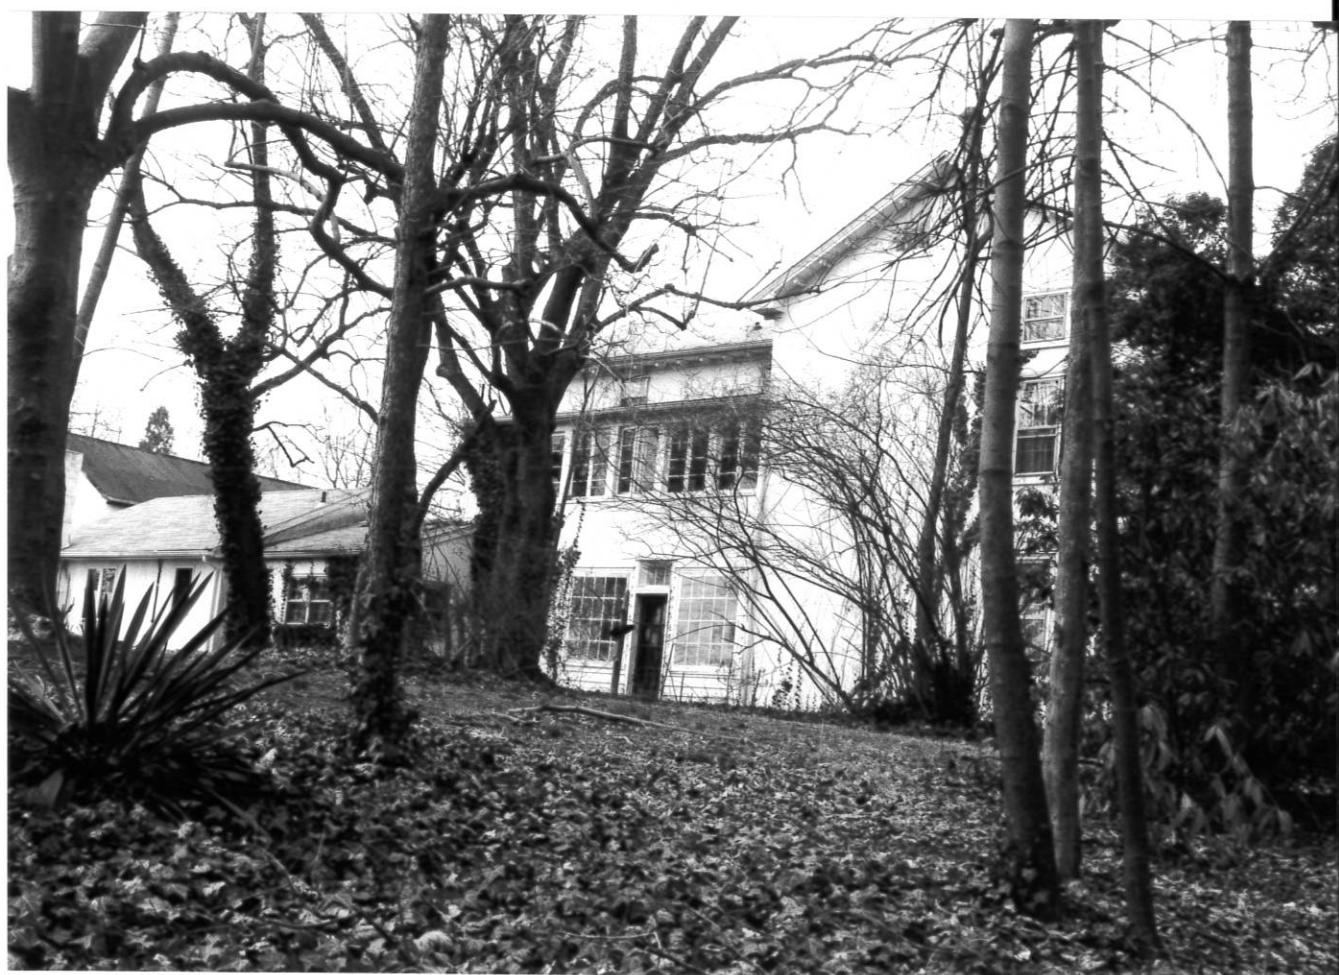
There are two, gabled, single story, masonry additions attached to the rear of the main addition or wing, extending the overall length of the house to approximately 75'. The additions are rather nondescript and do not contribute to the historic architecture of the main structure and wing.

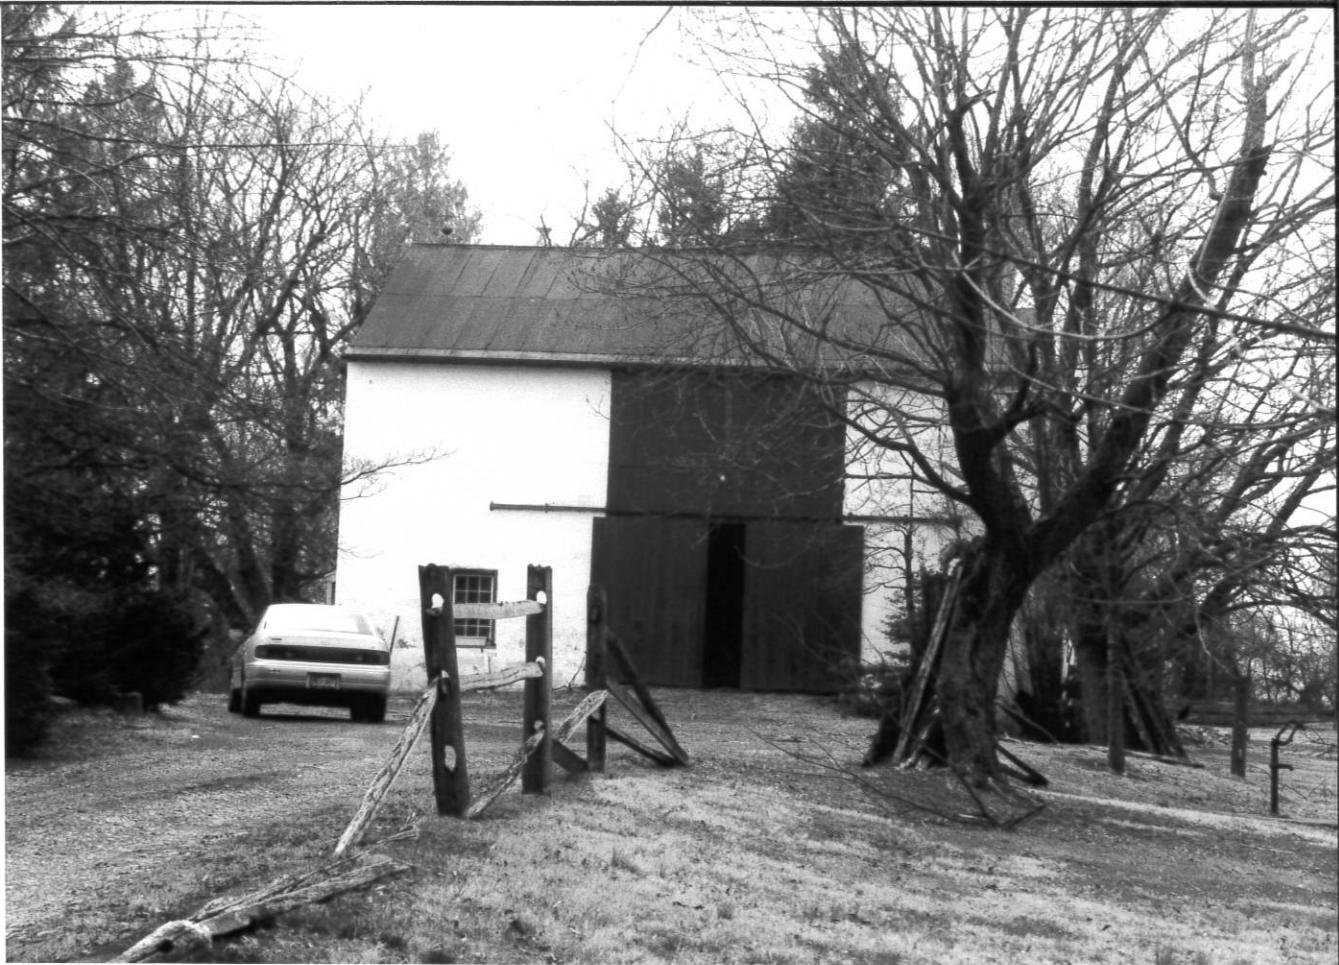
Associated Building: (Barn) Behind the house is a 2-story, stucco-over-stone barn. The main entrance faces east; access is through a double sliding wood door, which is repeated on the second floor. The roof is an end gabled, standing seam tin roof.
