**PENNSYLVANIA HISTORIC RESOURCE SURVEY FORM PHOTO/SITE PLAN SHEET**

Address: 711 Boehms Church Road

Surveyor Name/Title: Robert Wise Date: 6/16/2000  
Project Name: Whitpain Township Historic Resource Survey  
Organization: Robert Wise Consulting/Whitpain Township Telephone: (610) 722-5818  
Street and No.: Station Square 1, Suite 104, 37 North Valley Road  
City, State: Paoli, Pa Zip Code: 19301  
Additional Survey Documentation: n/a  
Associated Survey Codes: n/a

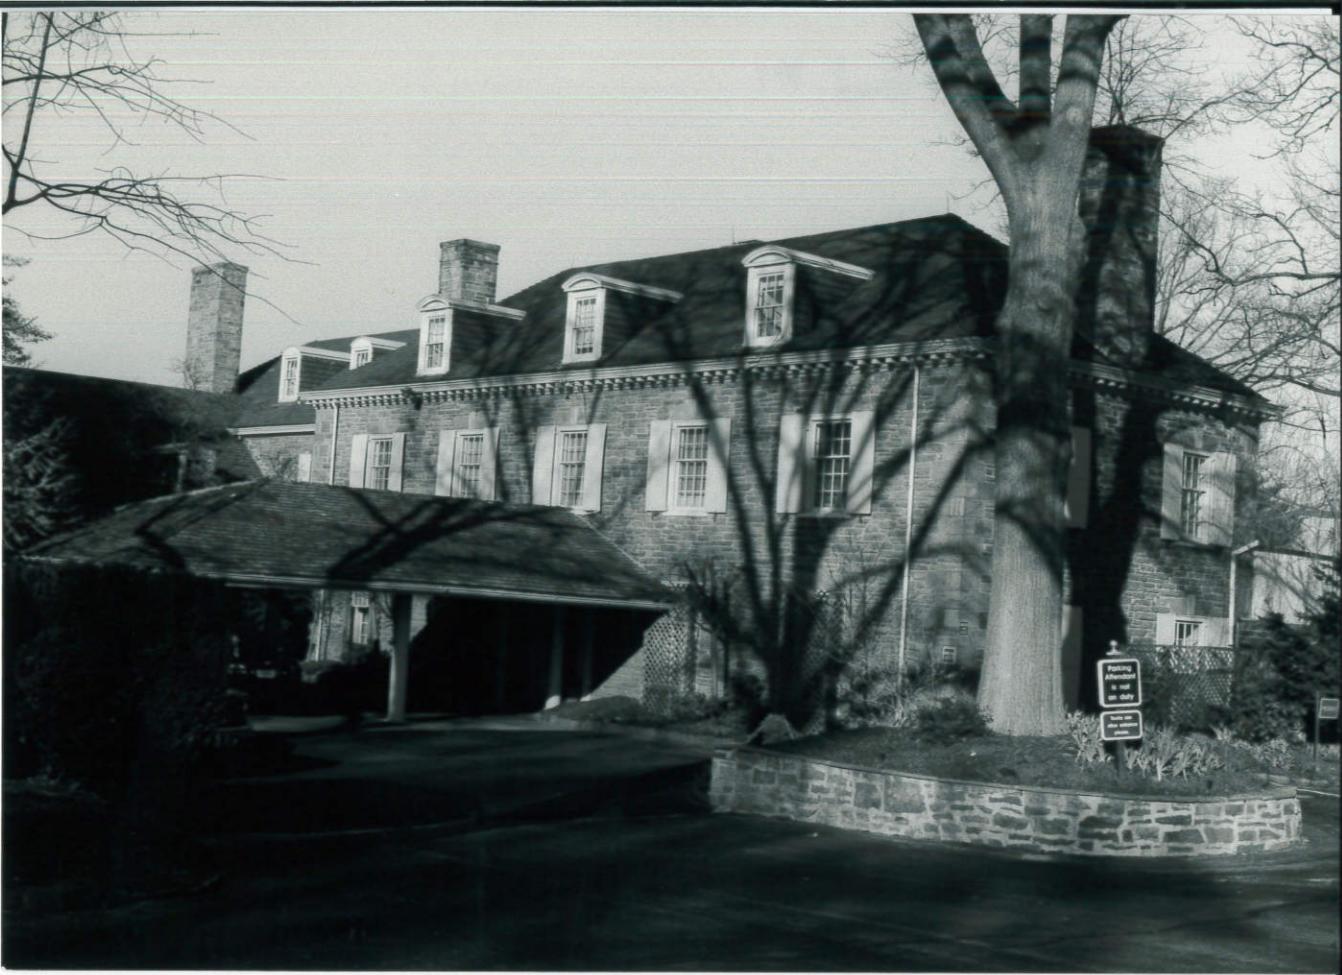
**Classification:** This large stone house has seen many significant alterations and is a Class II resource.

This house (now a golf club clubhouse) is an example of a large Federal Revival-style house c. 1920. It includes the core plus several additions. The core is a five bay, two and a half story house with a hipped, wood shingled roof. The walls are coursed stone. Two interior end chimneys are located at each end of the building, puncturing the roof. Three roof dormers crowned with segmental arched roofs appear on the façade. Large dentil molding adorns the molded cornice under the roof with wood shingles. There are five windows on the second floor, each with paneled shutters and a lintel broken by a keystone. The façade is dominated by a porte cochere with a hipped roof. There have been several additions to the building. A large one story dining room connects to the core by way of a two and a half story stone addition on the east end. The 2½ story addition has smaller dormers than the core and an end chimney.

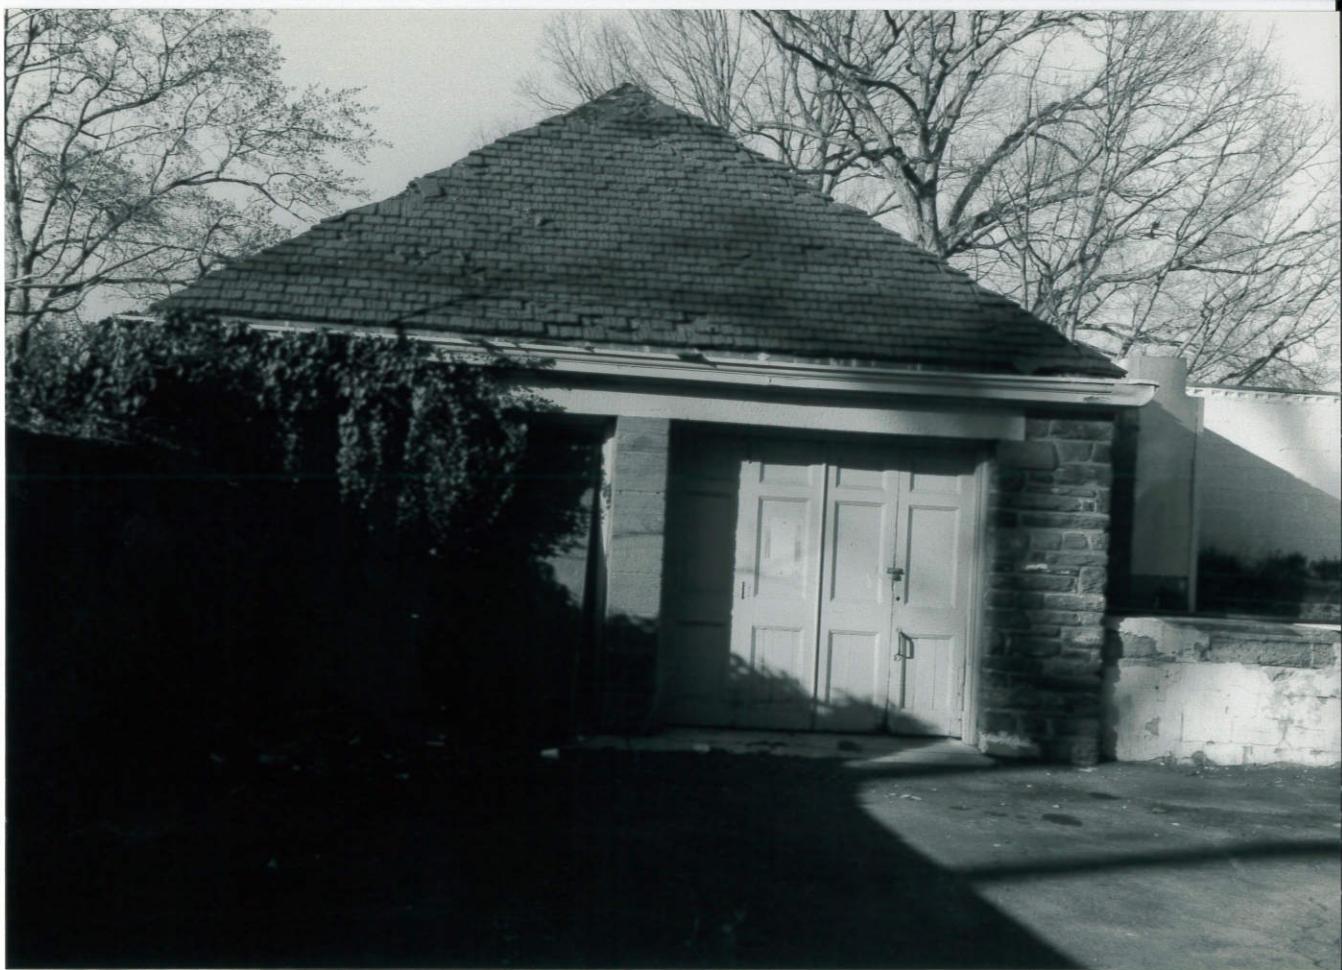
**(1) Garage:** This one story garage has stone walls and a large hipped roof with wood shingles. The doors are vertical rather than horizontal and are paneled.
