PENNSYLVANIA HISTORIC RESOURCE SURVEY FORM PHOTO/SITE PLAN SHEET

Address: 778 DeKalb Pike

Surveyor Name/Title: Robert Wise Date: 6/16/2000
Project Name: Whitpain Township Historic Resource Survey
Organization: Robert Wise Consulting/Whitpain Township Telephone: (610) 722-5818
Street and No.: Station Square 1, Suite 104, 37 North Valley Road
City, State: Paoli, Pa Zip Code: 19301
Additional Survey Documentation: n/a
Associated Survey Codes: n/a

PENNSYLVANIA HISTORICAL RESOURCE SURVEY FORM
NARRATIVE SHEET 89C

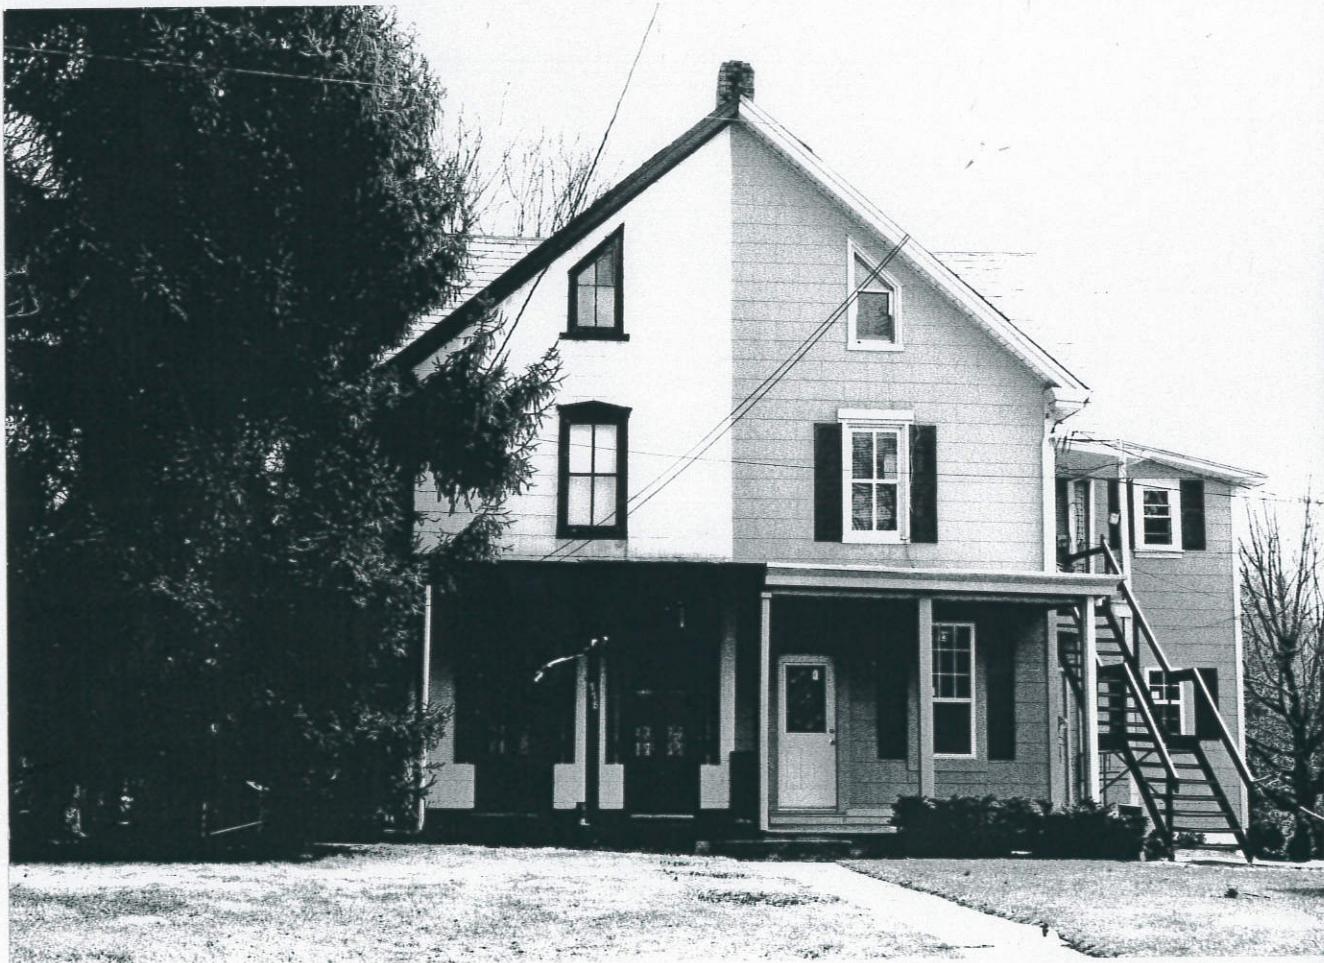
778 DeKalb (Left) #1

Number	Description of View	Direction of Camera
1	House (left) – façade	
2		
3		
4		
5		
6

This Folk Victorian house is the eastern twin of 788 DeKalb. As such, the building will be described as a single unit. The overall structure is cross-shaped, 2.5-stories tall, and has an asphalt-shingled, cross-axial roof. Twin-angled windows, found on third levels under gables throughout the township, are located under each gable. For the most part, windows are tall, 2x2 sash, with lintels.

Unlike 788 DeKalb, 778 Dekalb is highly intact. It maintains its wooden eaves, its fenestration is original, and there have been no visible additions. One key detail is the pair of French doors on the main facade. Both act as entrance doors as well as windows. A two-pane transom tops each door. In addition, second floor windows, at least that on the main facade, retains its wooden pediment lintel.

Classification: Because 778 DeKalb is attached to the highly altered 788, it too is Class II.
