PENNSYLVANIA HISTORIC RESOURCE SURVEY FORM PHOTO/SITE PLAN SHEET

Address: 788 DeKalb Pike

Project Name: Whitpain Township Historic Resource Survey

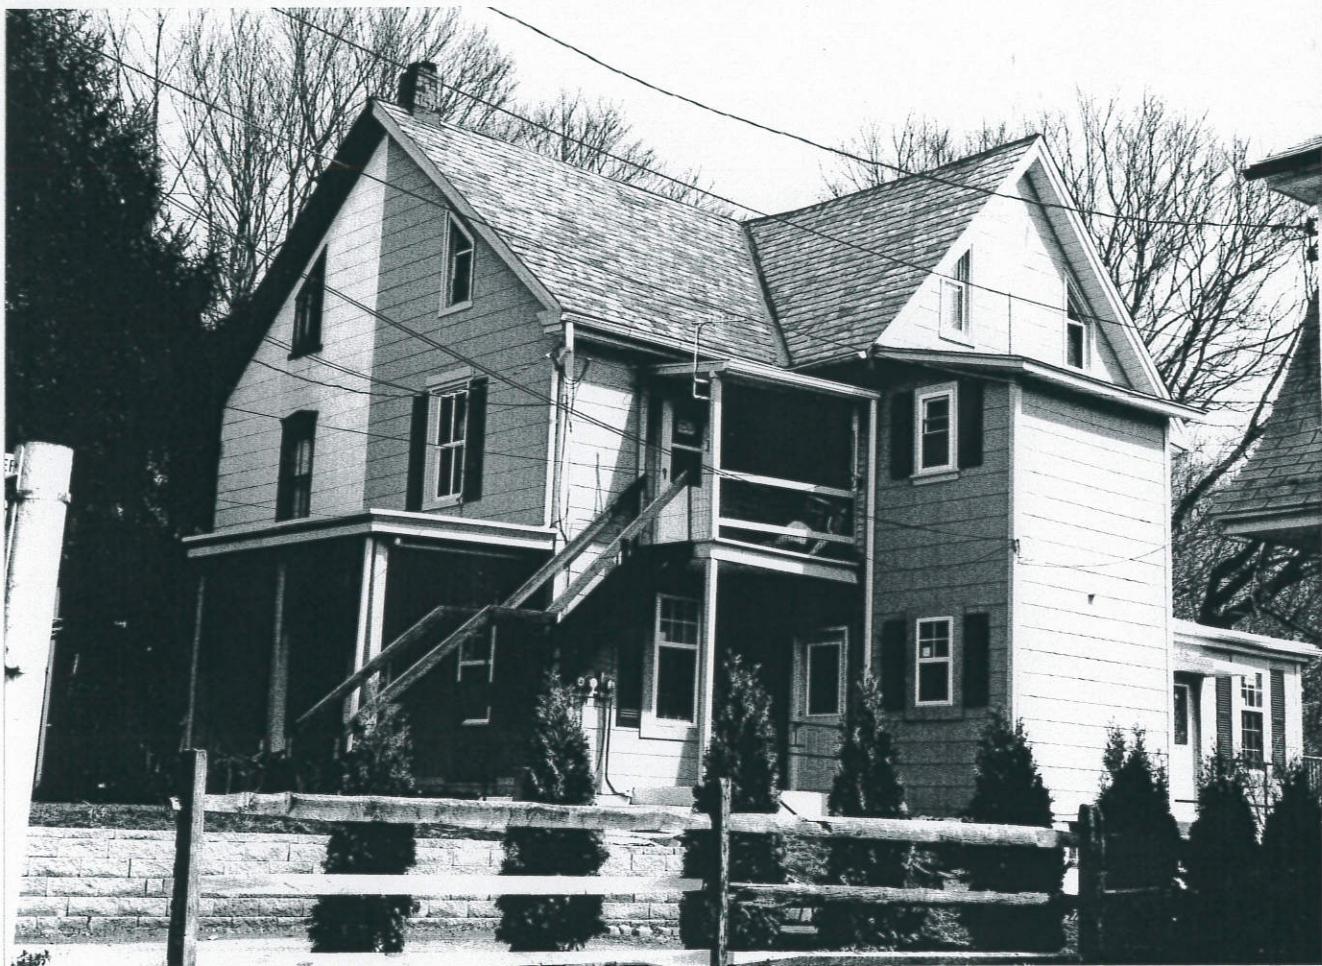
788 DeKalb Pike #1

Number	Description of View	Direction of Camera
1	House (right) – façade	
2		
3		
4		
5		
6

This Folk Victorian house is the western twin of 778 DeKalb. As such, the building will be described as a single unit. The overall structure is cross-shaped, 2.5-stories tall, and has an asphalt shingled, cross axial roof. Twin-angled windows, found on third levels under gables throughout the township, are located under each gable. For the most part, windows are tall, 2x2 sash, with lintels. The main facade contains a full length, flat roofed porch.

Number 788 Dekalb is highly altered. It has a 2 story, shed roofed addition on its western side, reached from a large exterior staircase running along the side of the house and out into the front yard. A small, shed roofed balcony protects a door on the second door, presumably for an apartment. There is also a 1 story, shed roofed addition on the rear of the house. New sash windows have replaced the original windows and doors on the first floor level, front facade.
