PENNSYLVANIA HISTORIC RESOURCE SURVEY FORM PHOTO/SITE PLAN SHEET

Address: 830 Hoover Road

Blue Bell Senior Boys Club a.k.a. Camp Blue Bell

Surveyor Name/Title: Robert Wise Date: 6/16/2000
Project Name: Whitpain Township Historic Resource Survey
Organization: Robert Wise Consulting/Whitpain Township Telephone: (610) 722-5818
Street and No.: Station Square 1, Suite 104, 37 North Valley Road
City, State: Paoli, Pa Zip Code: 19301
Additional Survey Documentation: n/a
Associated Survey Codes: n/a

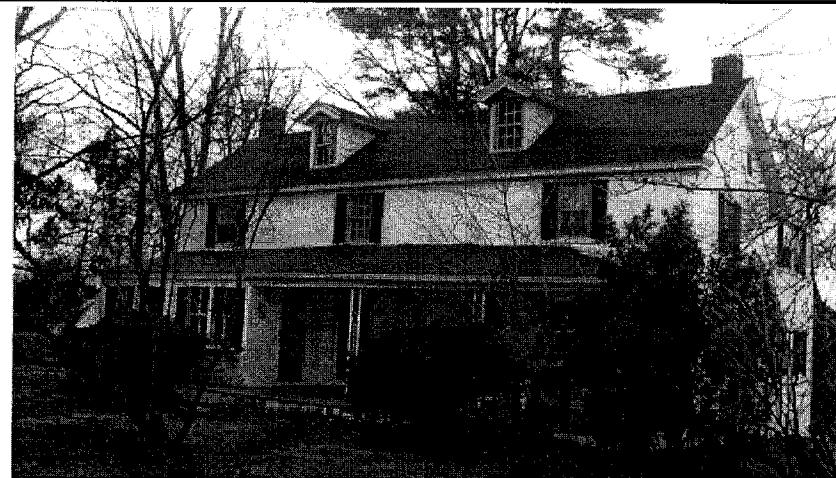
SITE PLAN**PHOTO INFORMATION**

Number	Description of View	Direction of Camera
1	House – façade	
2	House – rear	
3	Barn	
4	Barn	
5	Kennel	
6	Tenant House	
Photographer Name: Robert Wise		Date: 1999
Negative Location: Robert Wise Consulting, Station Square 1, Suite 104, 37 N. Valley Road, Paoli PA 19301

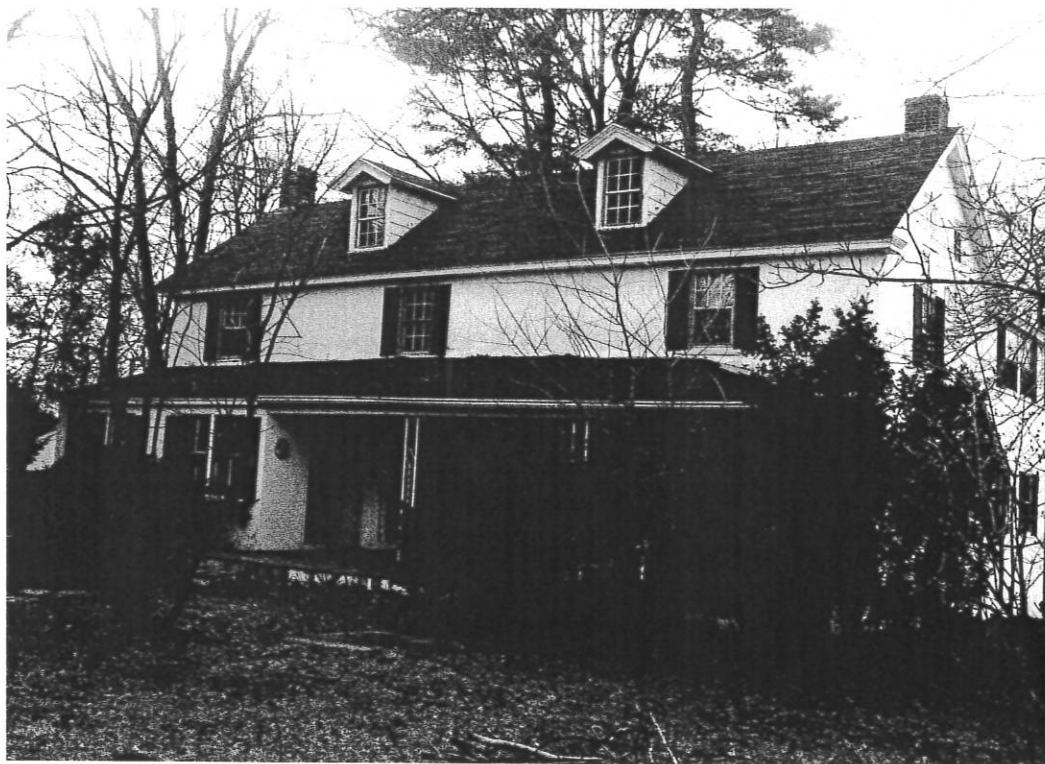
830 Hoover Rd #1
House

House: Circa 1800, the Federal-style farmhouse is the closest resource to Hoover Road. It consists of several additions. The main façade, facing SE, consists of two sections under an end gable, asphalt shingled roof. The 2.5 story building has stucco over masonry walls. Features include two gabled dormers on the roof with 6x6 sash windows and molded cornice; two flush brick chimneys with one each end; a molded cornice along eaves; full length shed roofed front porch with the southern end enclosed, 6x6 sash windows with shutters. The house forms an el-shape with the addition of a two-story extension on the northwest end. The second floor appears to be an enclosed sleeping porch. There is also a frame, shed roofed addition on the southern side of the el. The house measures 45' by 30' with additions.

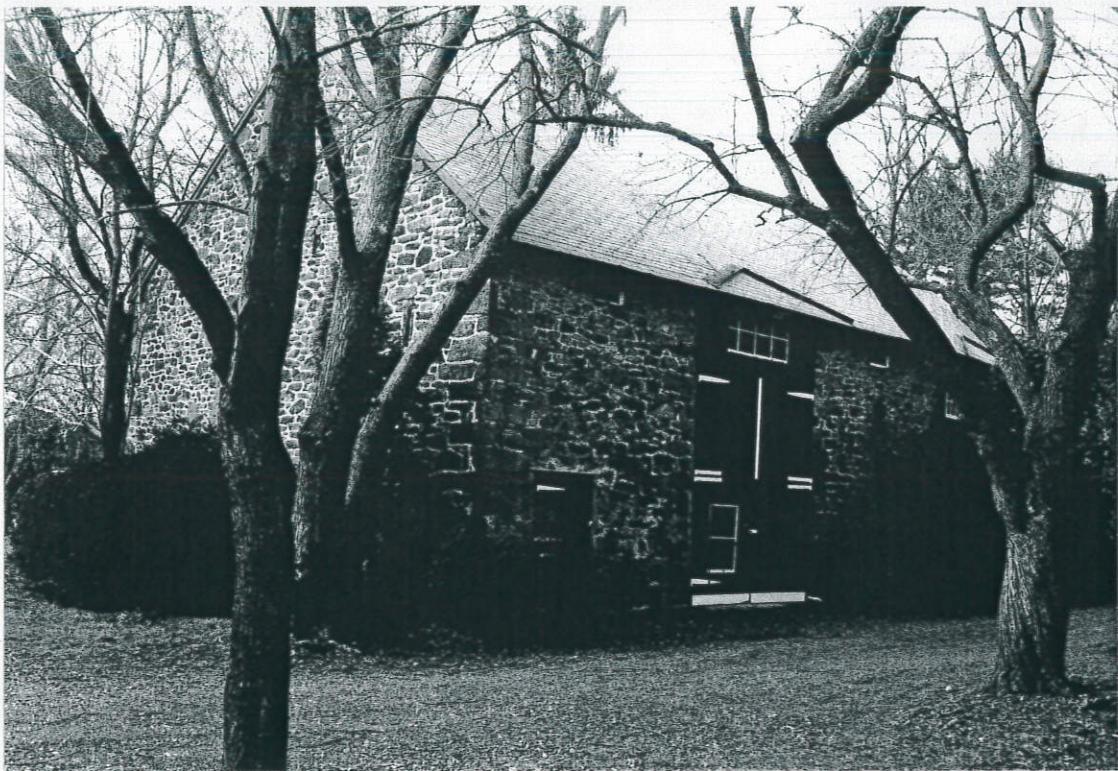
830 Hoover Rd #3
Barn

Barn: SW of the house is a medium-sized fieldstone barn with large quoins, c. 1800. Other details include an end gabled, asphalt shingled roof, large hinged doors on the NW side, and a shed roofed addition on the south end.

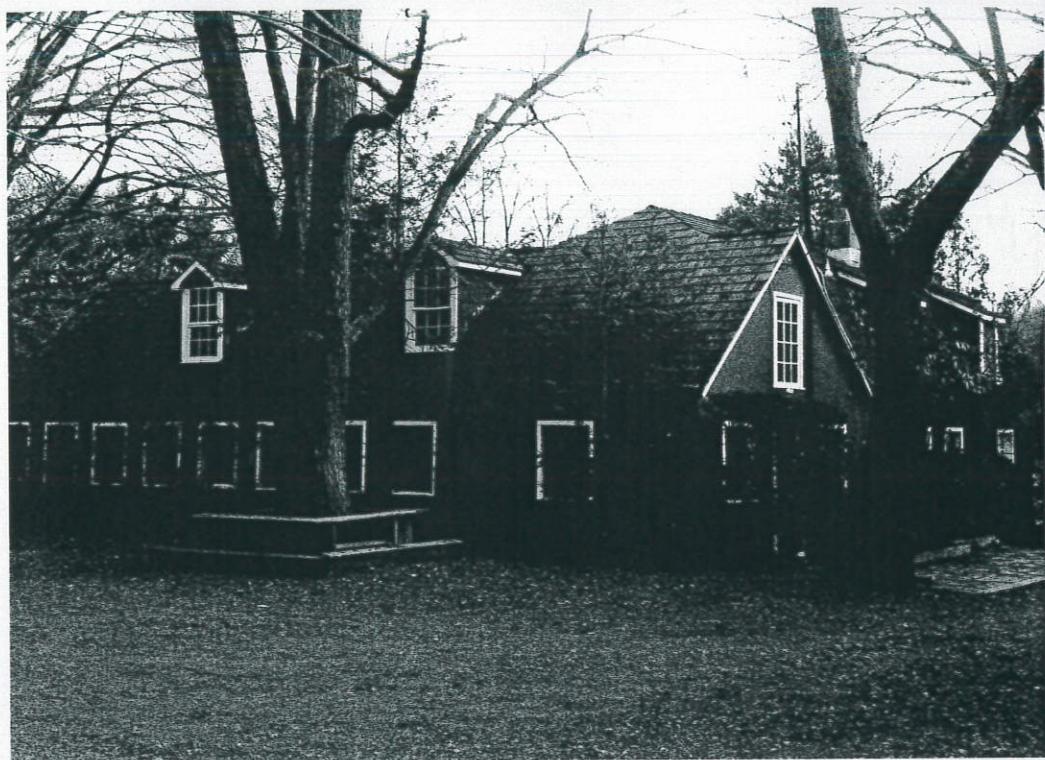
830 Hoover Rd #5
Kennel

Kennel: SE of the barn is the kennel. It is a multi sectional, 1.5 story frame building with wood shingled roof. The main section includes an end gabled roof with gabled dormers. The rear section has a gambrel roof with shed dormers. The walls are stucco.

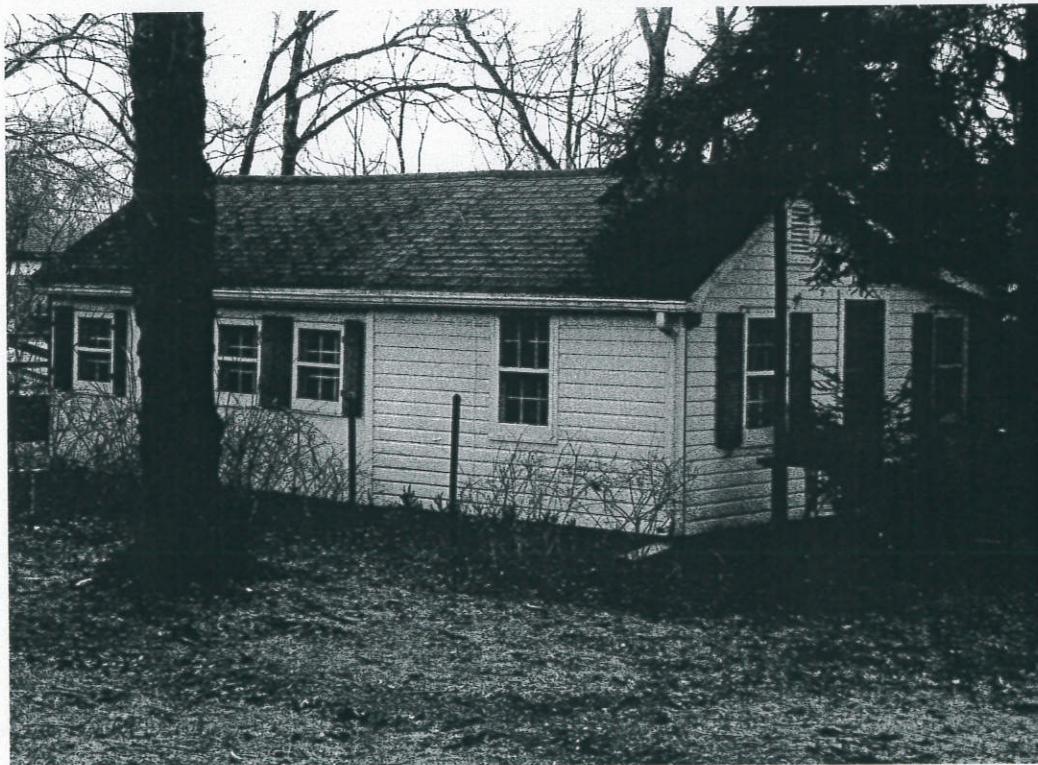
830 Hoover Rd. #6
Tenant House

Tenant House: SW of the barn is the 1-story, frame tenant house. The two-part building has a cross-gabled, asphalt-shingled roof over walls consisting of stucco and German beveled siding. The notable feature is its large painted stone chimney.

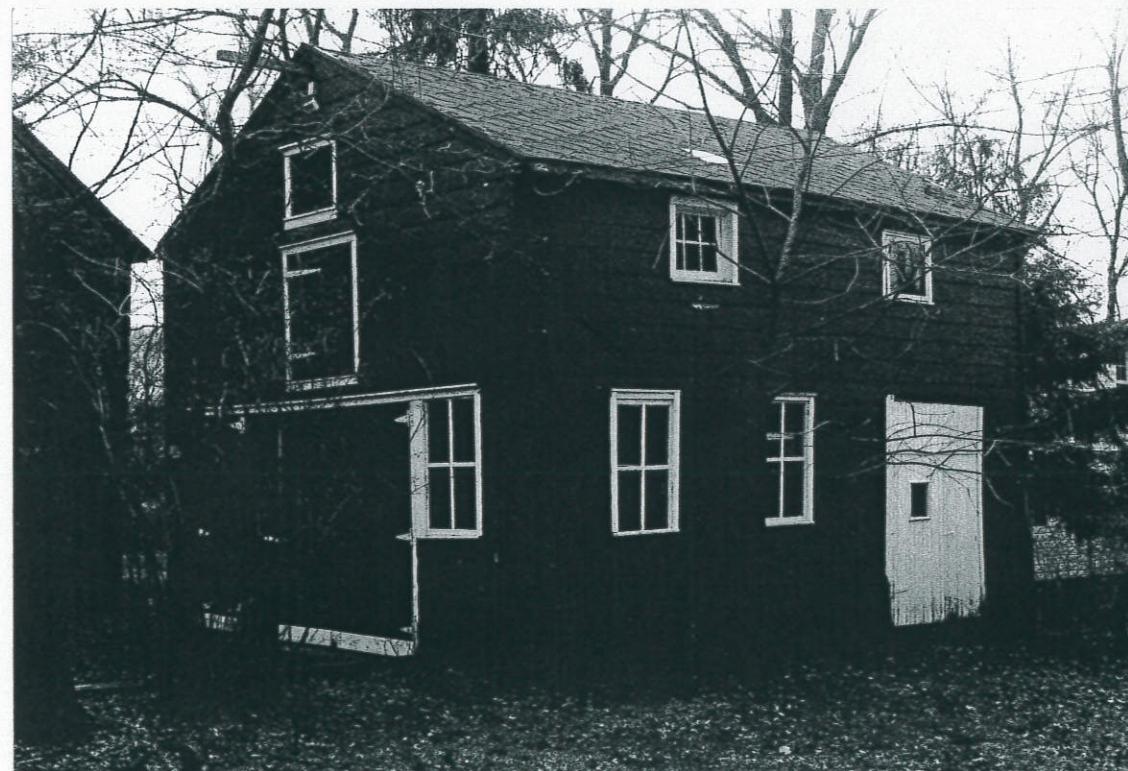
830 Hoover Rd. #8
Shed

Shed: NW of the barn is the two-story, clapboard equipment shed. The building has a front end gabled, asphalt shingled roof, a large sliding garage door, and, on the first floor, large 4-light windows.

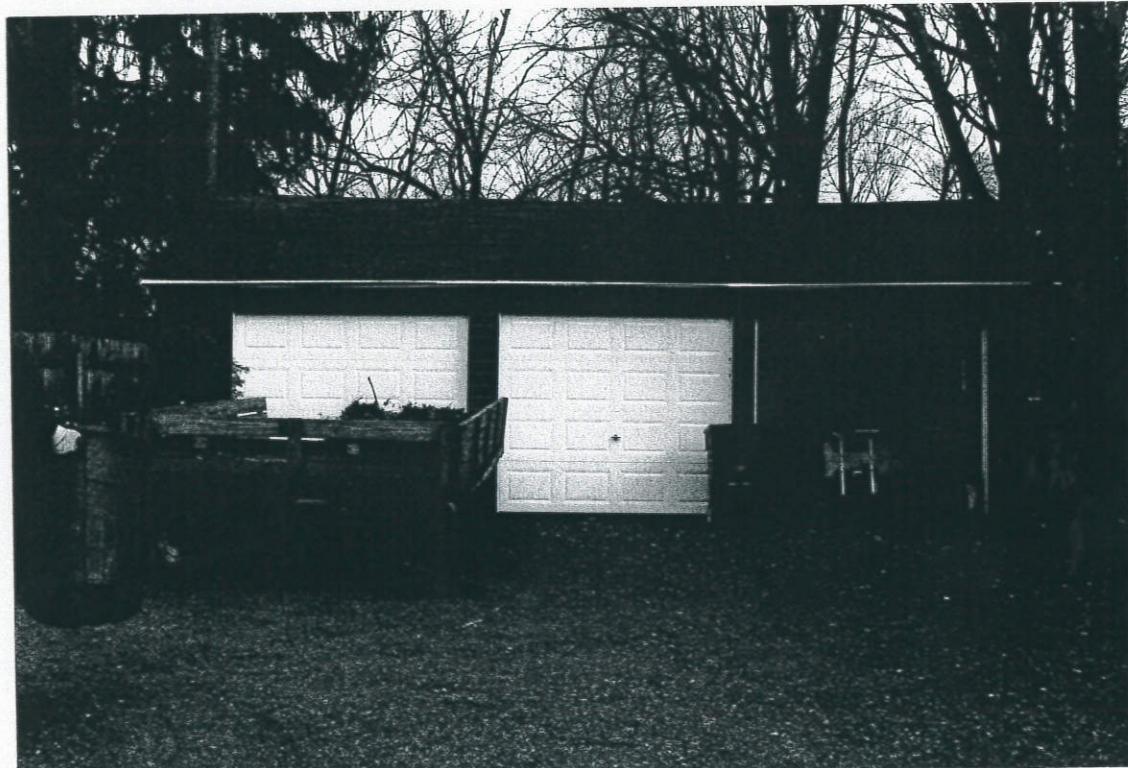
830 Hoover Rd. #9
Garage

Garage: There is a gambrel roofed SW of the barn. (no photograph).
