PENNSYLVANIA HISTORIC RESOURCE SURVEY FORM PHOTO/SITE PLAN SHEET

Address: 851 Second Avenue

Surveyor Name/Title: Robert Wise Date: 6/16/2000
Project Name: Whitpain Township Historic Resource Survey
Organization: Robert Wise Consulting/Whitpain Township Telephone: (610) 722-5818
Street and No.: Station Square 1, Suite 104, 37 North Valley Road
City, State: Paoli, Pa Zip Code: 19301
Additional Survey Documentation: n/a
Associated Survey Codes: n/a

PENNSYLVANIA HISTORICAL RESOURCE SURVEY FORM
NARRATIVE SHEET 89C

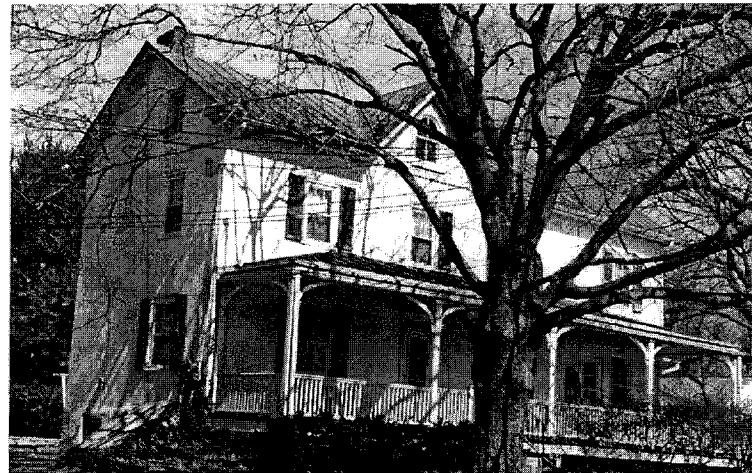
SITE PLAN**PHOTO INFORMATION**

Number	Description of View	Direction of Camera
1	House – façade (left)	
2	House – façade (right)	
3		
4		
5		
6		
Photographer Name:	Robert Wise	Date: 1999
Negative Location:	Robert Wise Consulting, Station Square 1, Suite 104, 37 N. Valley Road, Paoli PA 19301

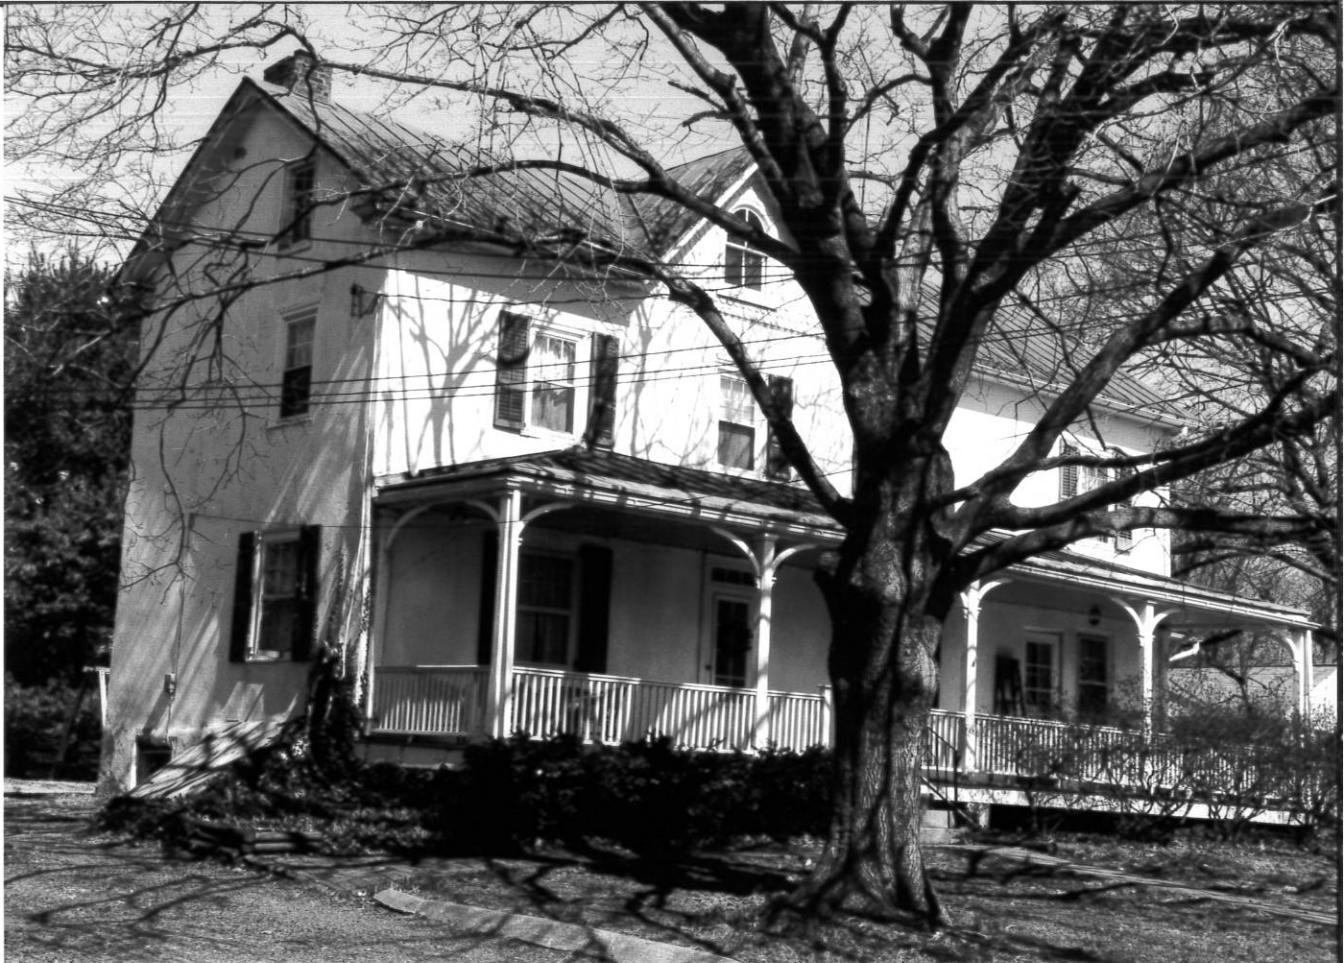
This building is a two-story, four bay, end gabled, two-part building with a small, one story frame addition on the north end. The house is built in the Victorian Gothic style. The core is a three bay, white stucco clad structure with a centered, cross-gabled roof. A single, four paned, round arched window is located under the front gable. A transom is located over the centered door. Plain, flush, brick chimneys are located at each end of the building

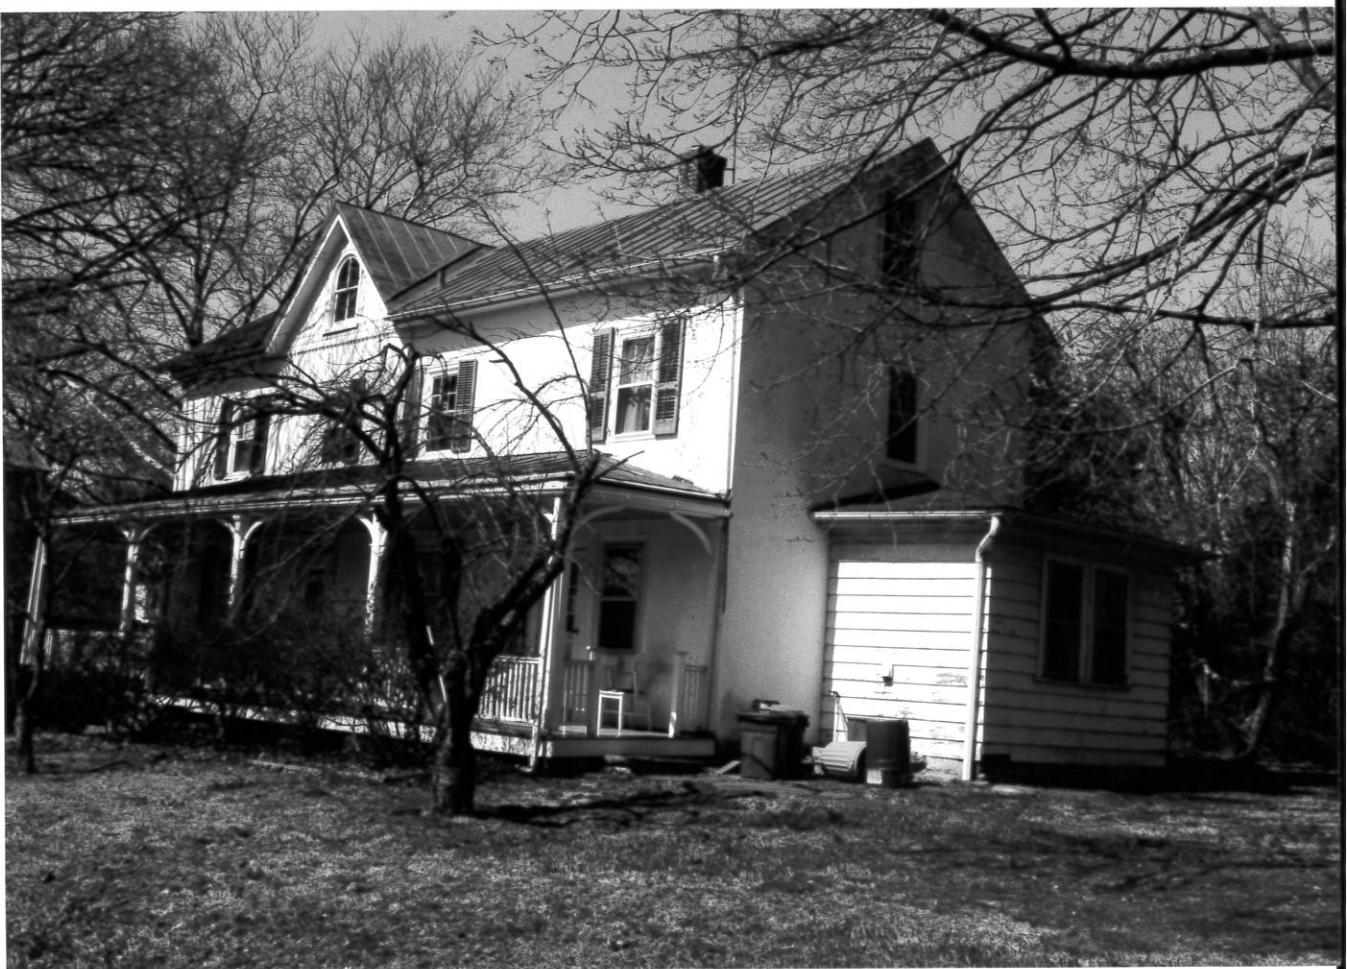
The north section is a two bay, two story extension, with a single entrance on the front facade. The resulting, rectangular shaped building is approximately 45' x 20'. A standing seam tin roof protects the building. A hipped roofed porch, supported by bracketed columns, runs the full length of the building. Windows are 6x1, with shutters on the front facade.
