PENNSYLVANIA HISTORIC RESOURCE SURVEY FORM PHOTO/SITE PLAN SHEET

Address: 938 DeKalb Pike

Surveyor Name/Title: Robert Wise Date: 6/16/2000
Project Name: Whitpain Township Historic Resource Survey
Organization: Robert Wise Consulting/Whitpain Township Telephone: (610) 722-5818
Street and No.: Station Square 1, Suite 104, 37 North Valley Road
City, State: Paoli, Pa Zip Code: 19301
Additional Survey Documentation: n/a
Associated Survey Codes: n/a

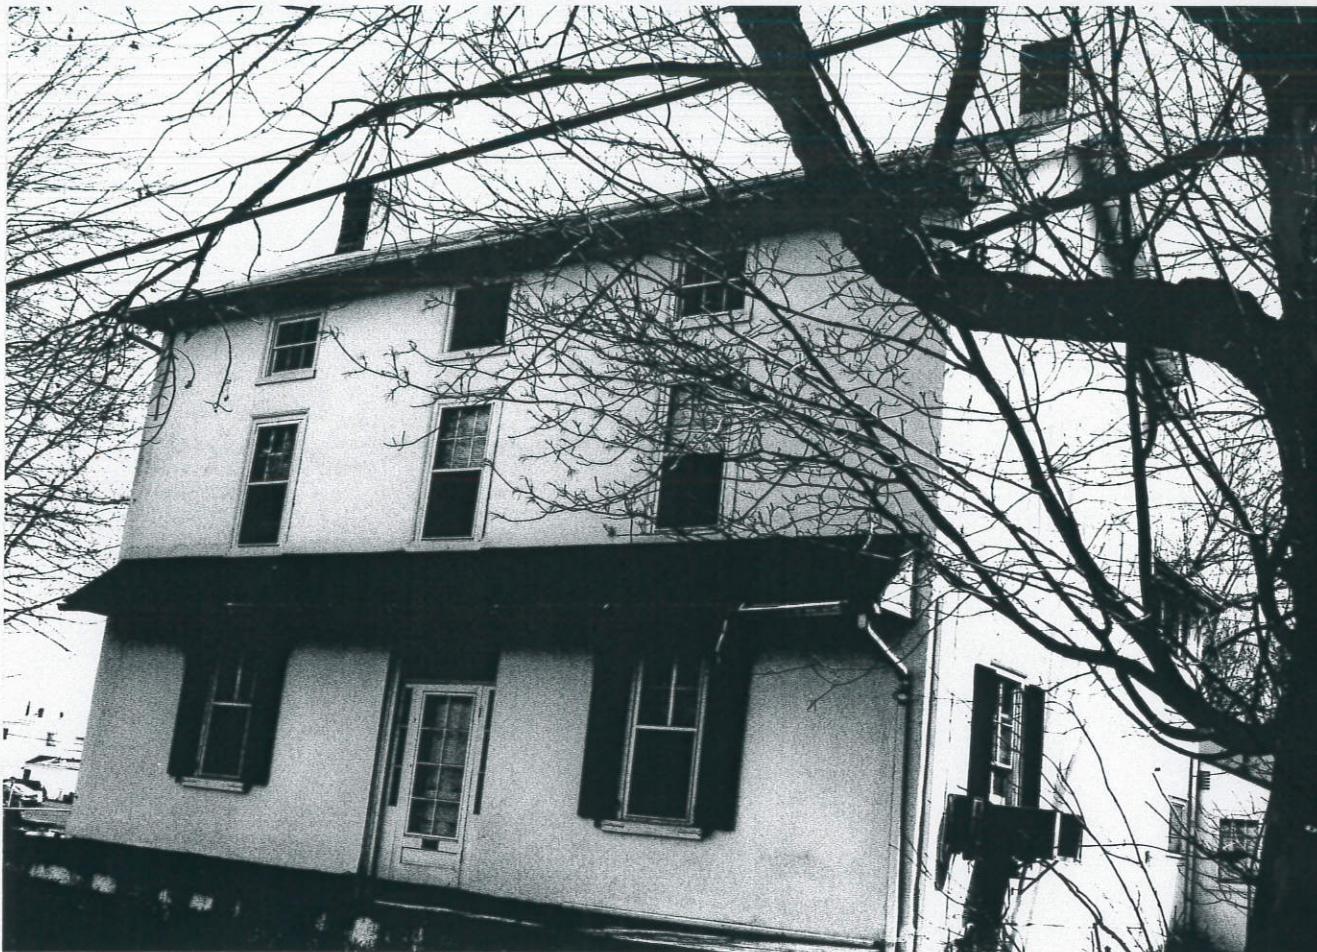
938 DeKalb #1

This Federal style house consists of a 2.5 story, three bay wide core and numerous additions on the rear. The core is similar to 956 DeKalb. It consists of stucco over stone walls, a center entrance with transom and sidelights, an end gabled, asphalt shingle roof, and full length pent roof on the main facade. Two plain, brick, flush chimneys are located at the ends of the house. Fenestration includes 4x4 sash windows on the first and second levels, and 3x3 sash windows occupying the frieze band. The core measures 30'x20'.

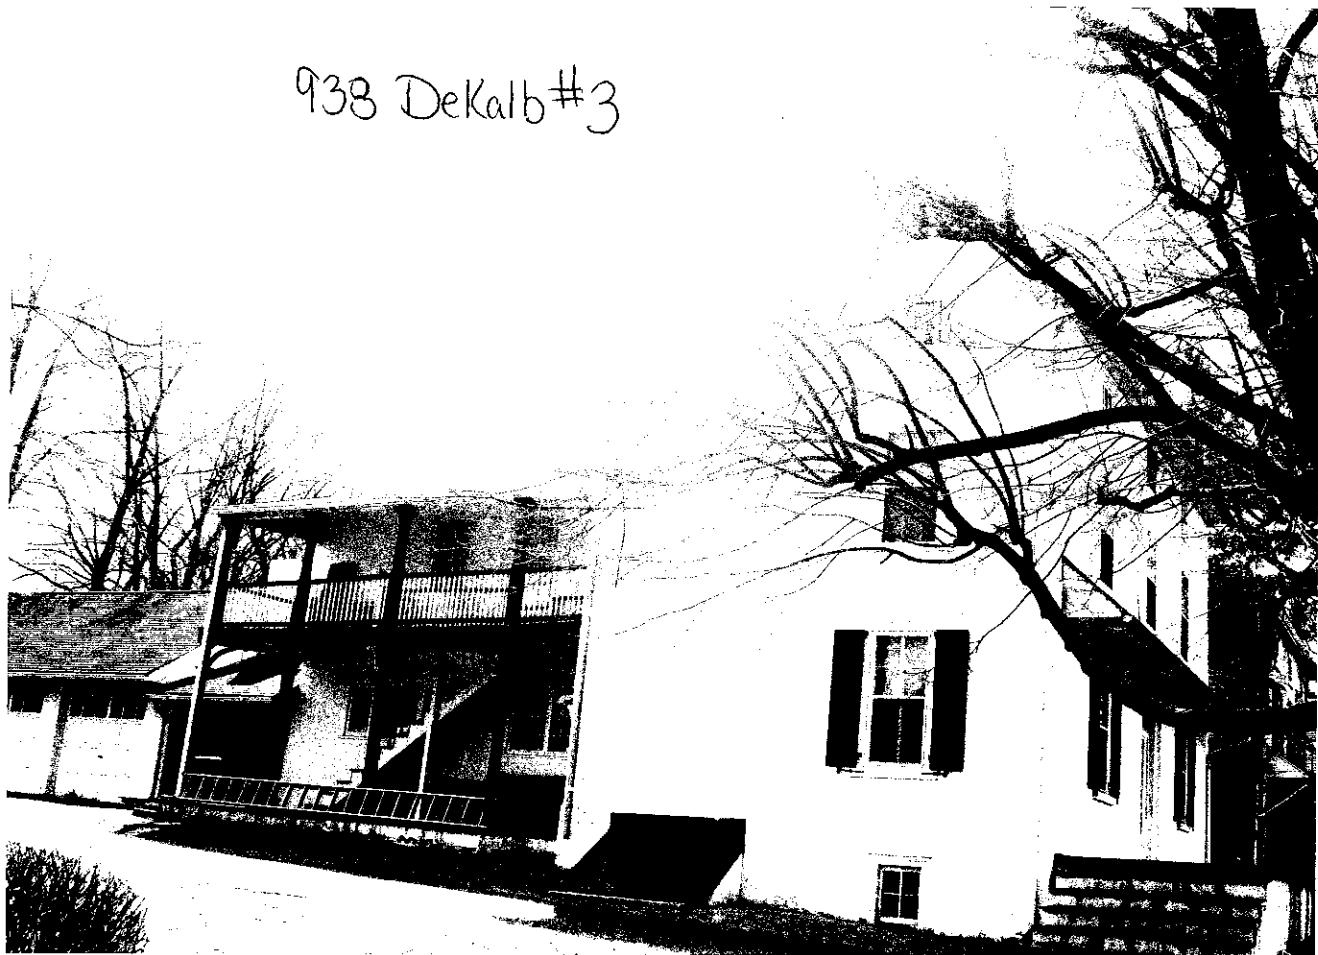
938 DeKalb #3

The addition attached to the core is a two-story arrangement creating an overall cross-axial roof, and an ell-shape to the overall structure. It features a second story Victorian era porch running along the eastern side. Attached to the rear of the addition is a garage that opens to the east. Attached to the south side of that garage addition is another garage, also facing east.
