PENNSYLVANIA HISTORIC RESOURCE SURVEY FORM PHOTO/SITE PLAN SHEET

Address: 983 Butler Pike

Address: 983 Butler Pike Historic Name: Wyntrust

Surveyor Name/Title: Robert Wise Date: 6/16/2000
Project Name: Whitpain Township Historic Resource Survey
Organization: Robert Wise Consulting/Whitpain Township Telephone: (610) 722-5818
Street and No.: Station Square 1, Suite 104, 37 North Valley Road
City, State: Paoli, Pa Zip Code: 19301
Additional Survey Documentation: n/a
Associated Survey Codes: n/a

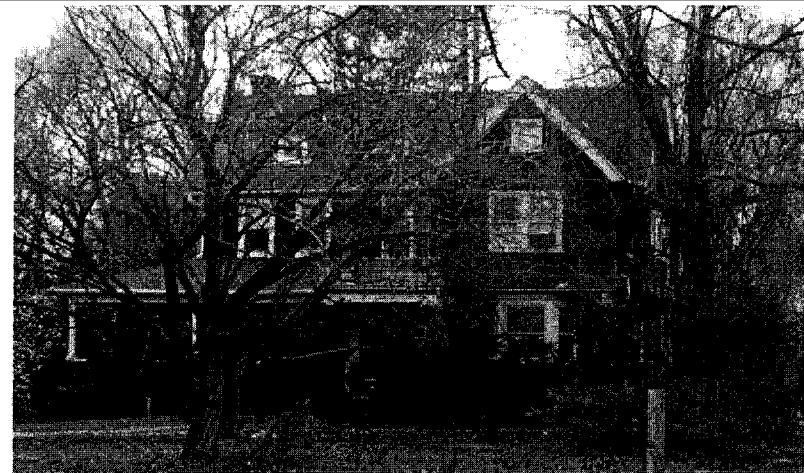
Number	Description of View	Direction of Camera
1	House – façade	
2		
3		
4		
5		
6		
Photographer Name: Robert Wise		Date: 1999
Negative Location: Robert Wise Consulting, Station Square 1, Suite 104, 37 N. Valley Road, Paoli PA 19301

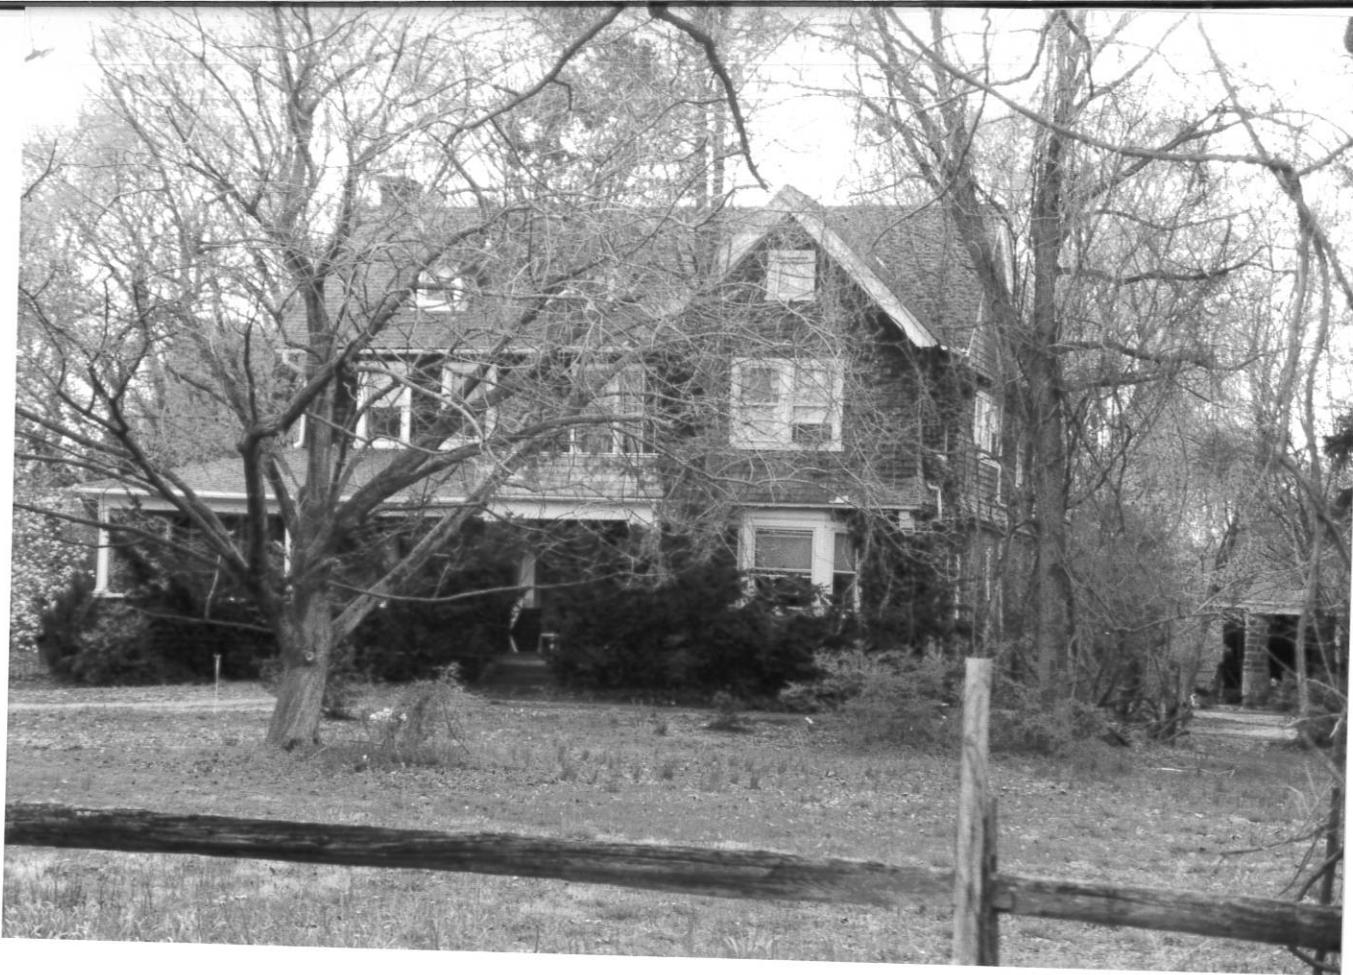
“Wyntrust” is an example of Victorian architecture. It is a 2½ story house with end gables and a projecting gable forming a gable roof (asphalt shingles). A single end chimney punctures one of the gable ends. The roof and the walls are covered with wood shingles, and two small dormers appear on the façade. The walls flare over the first floor. Windows are double sash. A one story wrap-around porch with a hipped roof covers most of the façade of the house; it is supported by several columns. A balcony is located in the center over the front porch on the main façade.

Associated resources. (1) Frame garage on a stone foundation with shingle siding.
(2) Large stone gate post.
(3) Stuccoed gazebo.
