PENNSYLVANIA HISTORIC RESOURCE SURVEY FORM PHOTO/SITE PLAN SHEET

Address: 998 DeKalb Pike

Surveyor Name/Title: Robert Wise Date: 6/16/2000
Project Name: Whitpain Township Historic Resource Survey
Organization: Robert Wise Consulting/Whitpain Township Telephone: (610) 722-5818
Street and No.: Station Square 1, Suite 104, 37 North Valley Road
City, State: Paoli, Pa Zip Code: 19301
Additional Survey Documentation: n/a
Associated Survey Codes: n/a

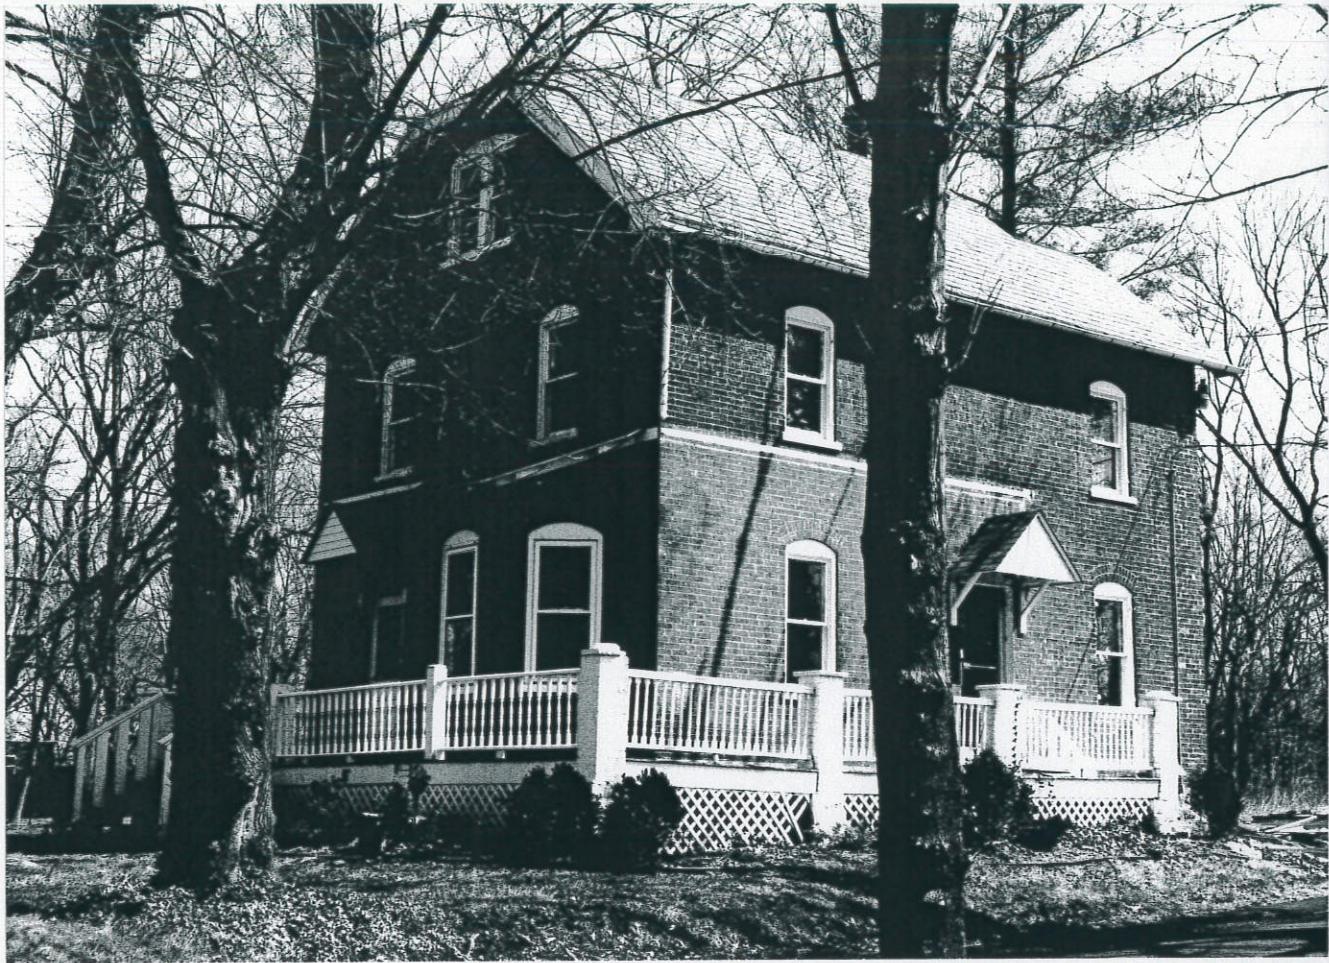
998 DeKalb
#1

This Vernacular building with Victorian features is a 2 story, brick clad residence with a front-end gable, hipped slate roof. The foundation is cut stone. The window openings are segmented arch, yet the windows are regular 1x1 sash. The two bay wide building also has a brick, bay window with an octagonal shed roof. (This roof is all that remains of a porch roof that once occupied the entire front of the house and wrapped 2/3 of the way around the western side. (The porch, now roofless, continues to occupy wrap around this area.) A small gabled hood protects the front door entrance. The door also occupies a space under a segmental arch and flat transom. A corbelled brick chimney is located on the southern or rear end of the house. Also on the rear of the house is a single story, shed addition with German siding.
