**PENNSYLVANIA HISTORIC RESOURCE SURVEY FORM PHOTO/SITE PLAN SHEET**

Address: 1069 Walton Road

Surveyor Name/Title: Robert Wise Date: 6/16/2000  
Project Name: Whitpain Township Historic Resource Survey  
Organization: Robert Wise Consulting/Whitpain Township Telephone: (610) 722-5818  
Street and No.: Station Square 1, Suite 104, 37 North Valley Road  
City, State: Paoli, Pa Zip Code: 19301  
Additional Survey Documentation: n/a  
Associated Survey Codes: n/a

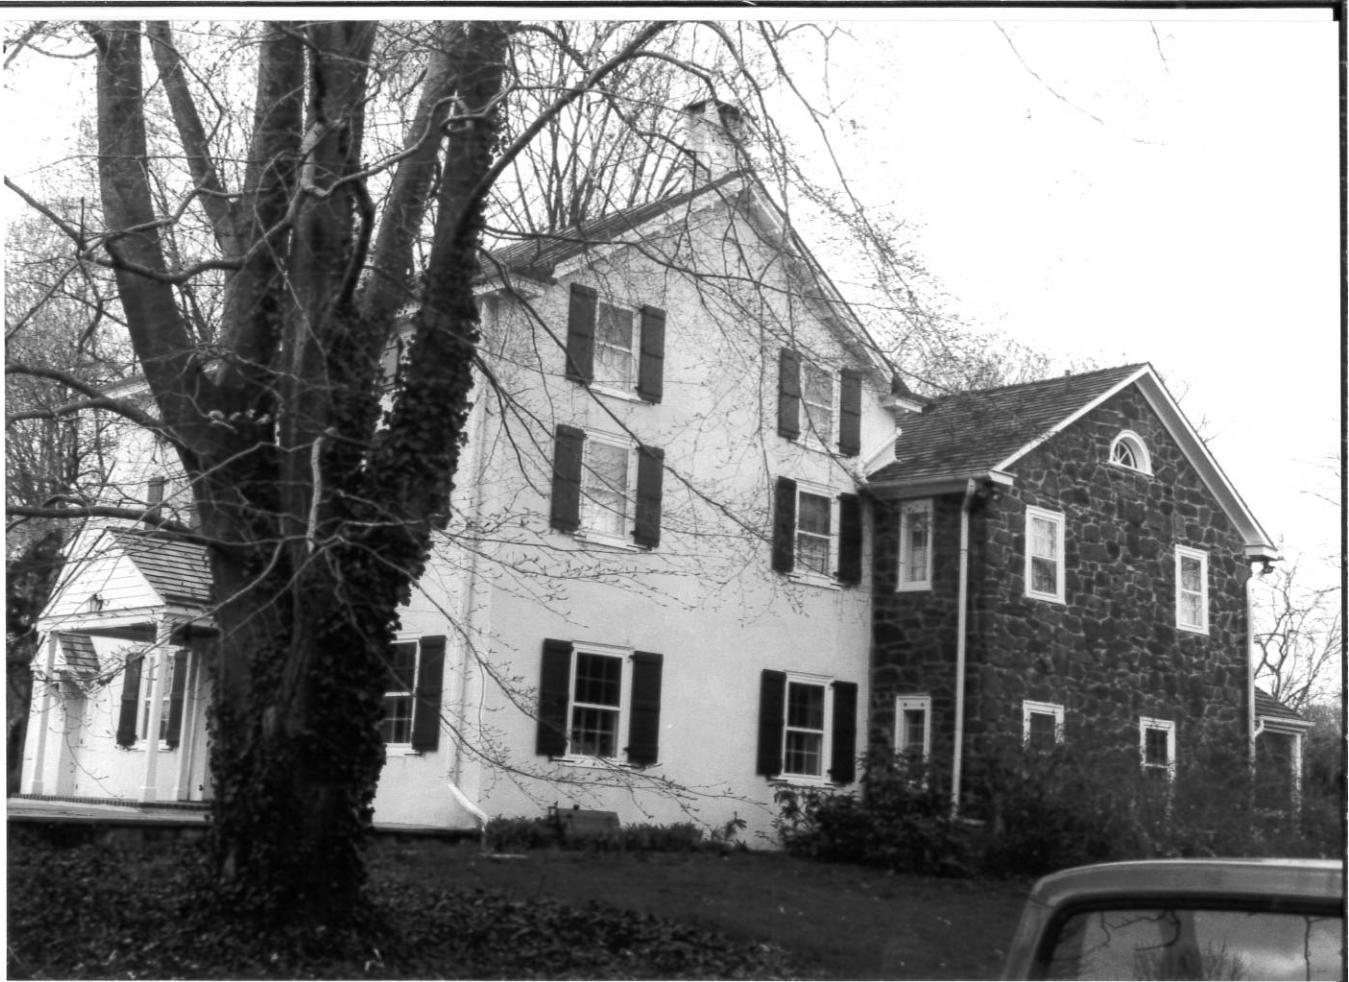
This is an excellent specimen of Federal architecture. The core was built c. 1815 and a rear addition was constructed later. The core is a two and a half story, four bay, end-gable building clad in stucco. There are two interior end chimneys. Third floor windows are three over three double hung with shutters on the sides; all other windows are six over six double hung with shutters. A gabled entry porch rests on square un-fluted columns and pilasters.
