PENNSYLVANIA HISTORIC RESOURCE SURVEY FORM PHOTO/SITE PLAN SHEET
Pennsylvania Historic and Museum Commission
Bureau of Historic Preservation
Box 1026, Harrisburg, PA 17108-1026

Address: 1330 Walton Road

Surveyor Name/Title: Robert Wise Date: 6/16/2000
Project Name: Whitpain Township Historic Resource Survey
Organization: Robert Wise Consulting/Whitpain Township Telephone: (610) 722-5818
Street and No.: Station Square 1, Suite 104, 37 North Valley Road
City, State: Paoli, Pa Zip Code: 19301
Additional Survey Documentation: n/a
Associated Survey Codes: n/a

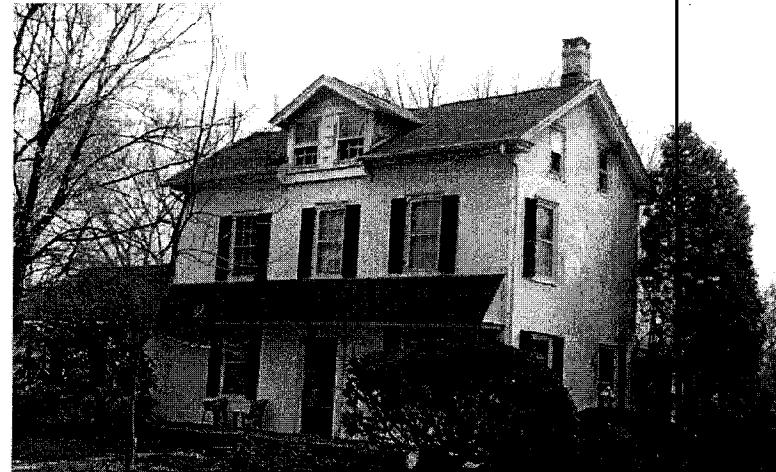
SITE PLAN

Number	Description of View	Direction of Camera
1	House – façade	
2	House – addition	
3		
4		
5		
6		
Photographer Name: Robert Wise		Date: 1999
Negative Location: Robert Wise Consulting, Station Square 1, Suite 104, 37 N. Valley Road, Paoli PA 19301

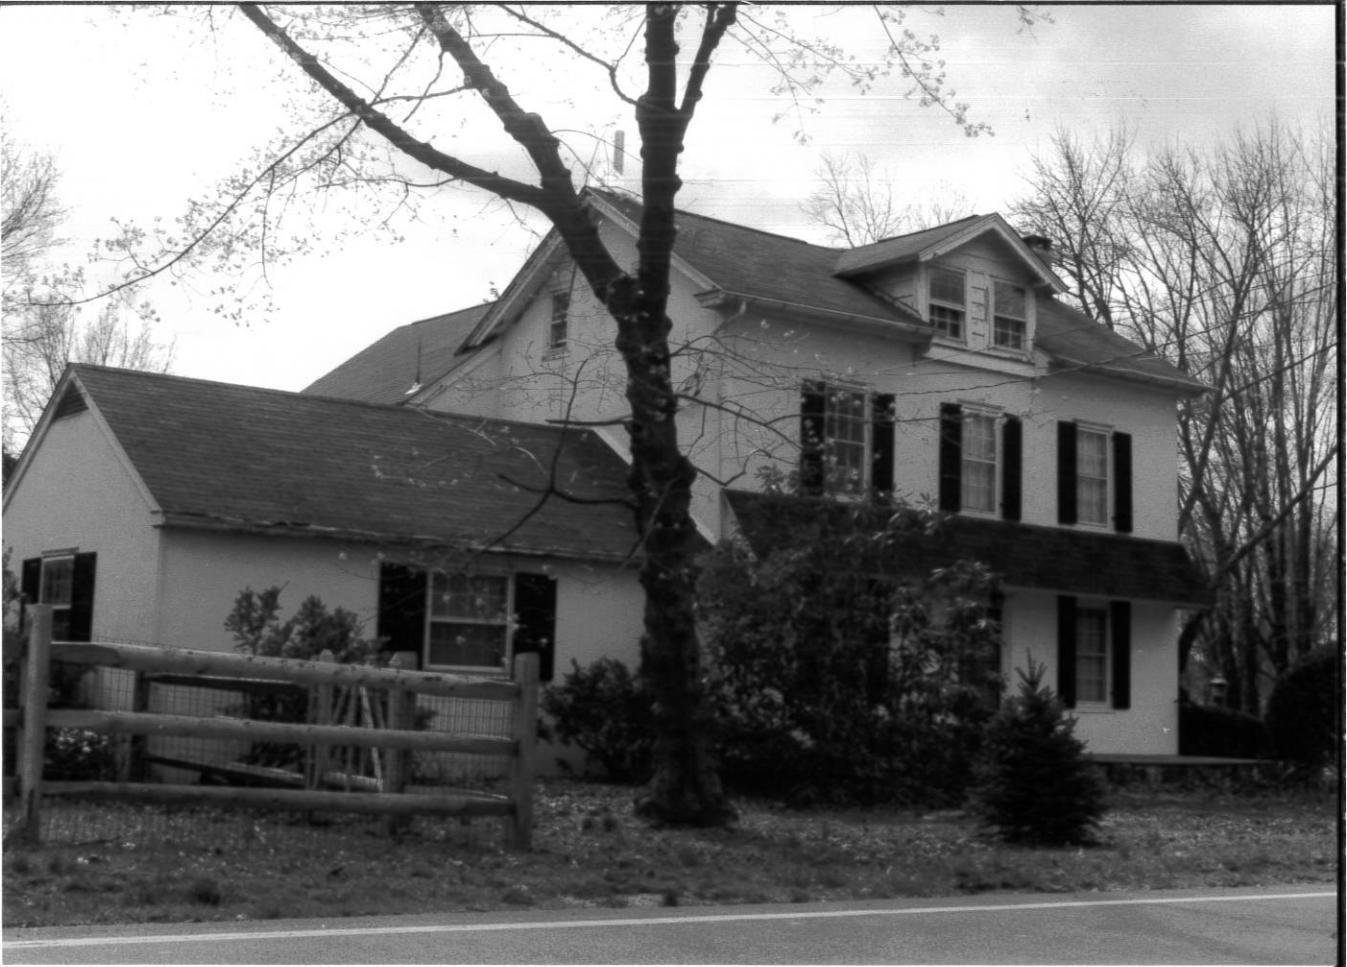
This is a Federal style house with two additions. The core is a three-bay, two and a half story end gable house with one interior end chimney. It has an end gable asphalt shingle roof and molded cornice. A wall dormer has been added; this gabled dormer has two six over six double-hung windows with shutters. Two other items of note are the pent roof and Greek Revival-style door framing (the door jambs are fluted pilasters). The first addition is one-story, gabled, with eight over eight windows double hung with shutters. The rear addition is two story on a perpendicular axis.

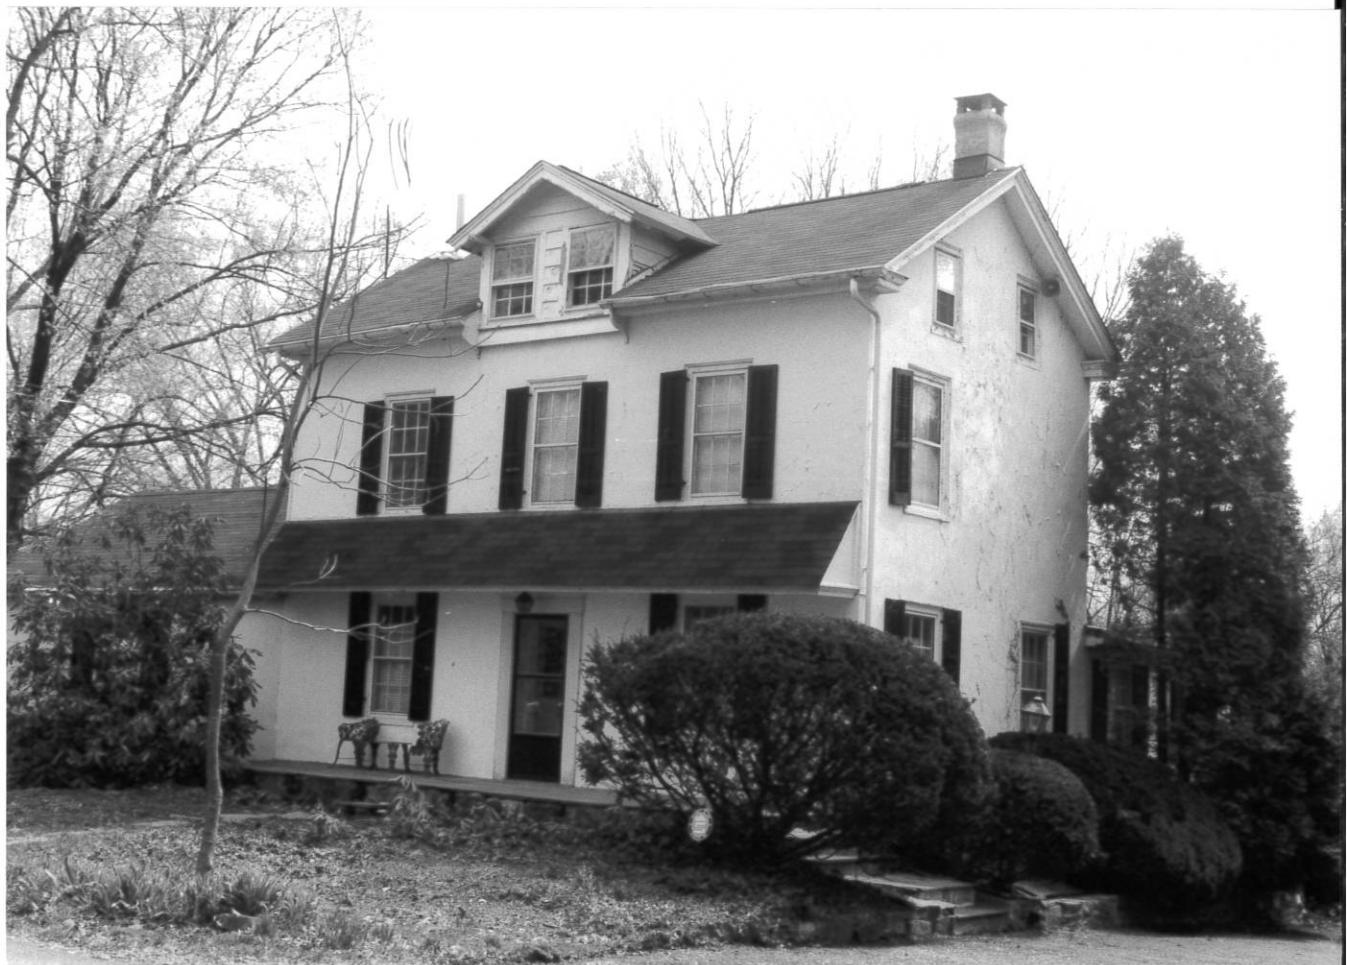
Classification: This house is in fair condition. The end addition and dormer make the house a Class II resource.
