**PENNSYLVANIA HISTORIC RESOURCE SURVEY FORM PHOTO/SITE PLAN SHEET**

Address: 1400 Royal Oak Drive

Surveyor Name/Title: Robert Wise Date: 6/16/2000  
Project Name: Whitpain Township Historic Resource Survey  
Organization: Robert Wise Consulting/Whitpain Township Telephone: (610) 722-5818  
Street and No.: Station Square 1, Suite 104, 37 North Valley Road  
City, State: Paoli, Pa Zip Code: 19301  
Additional Survey Documentation: n/a  
Associated Survey Codes: n/a

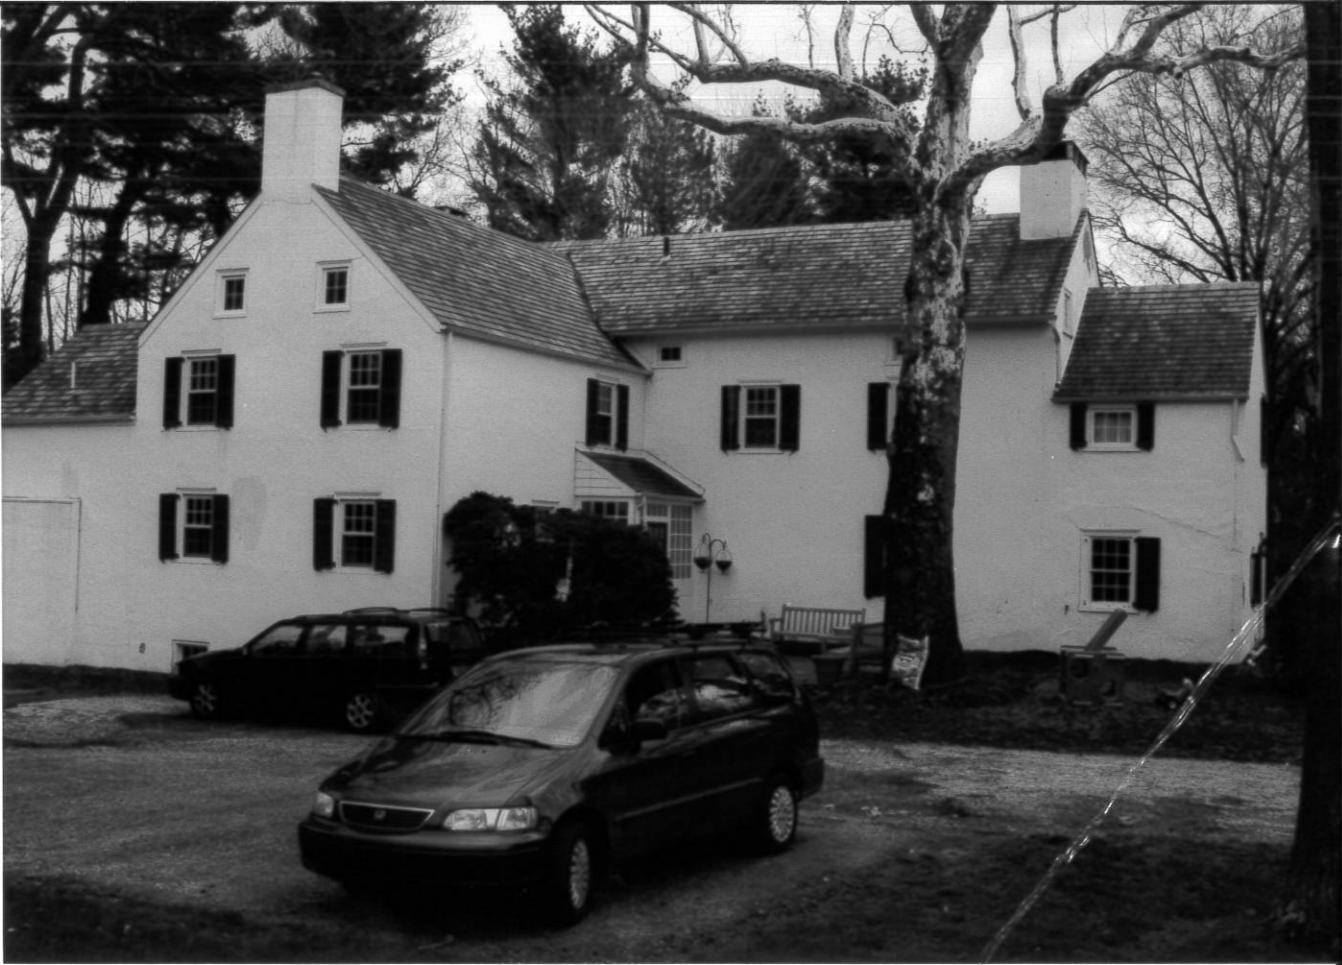
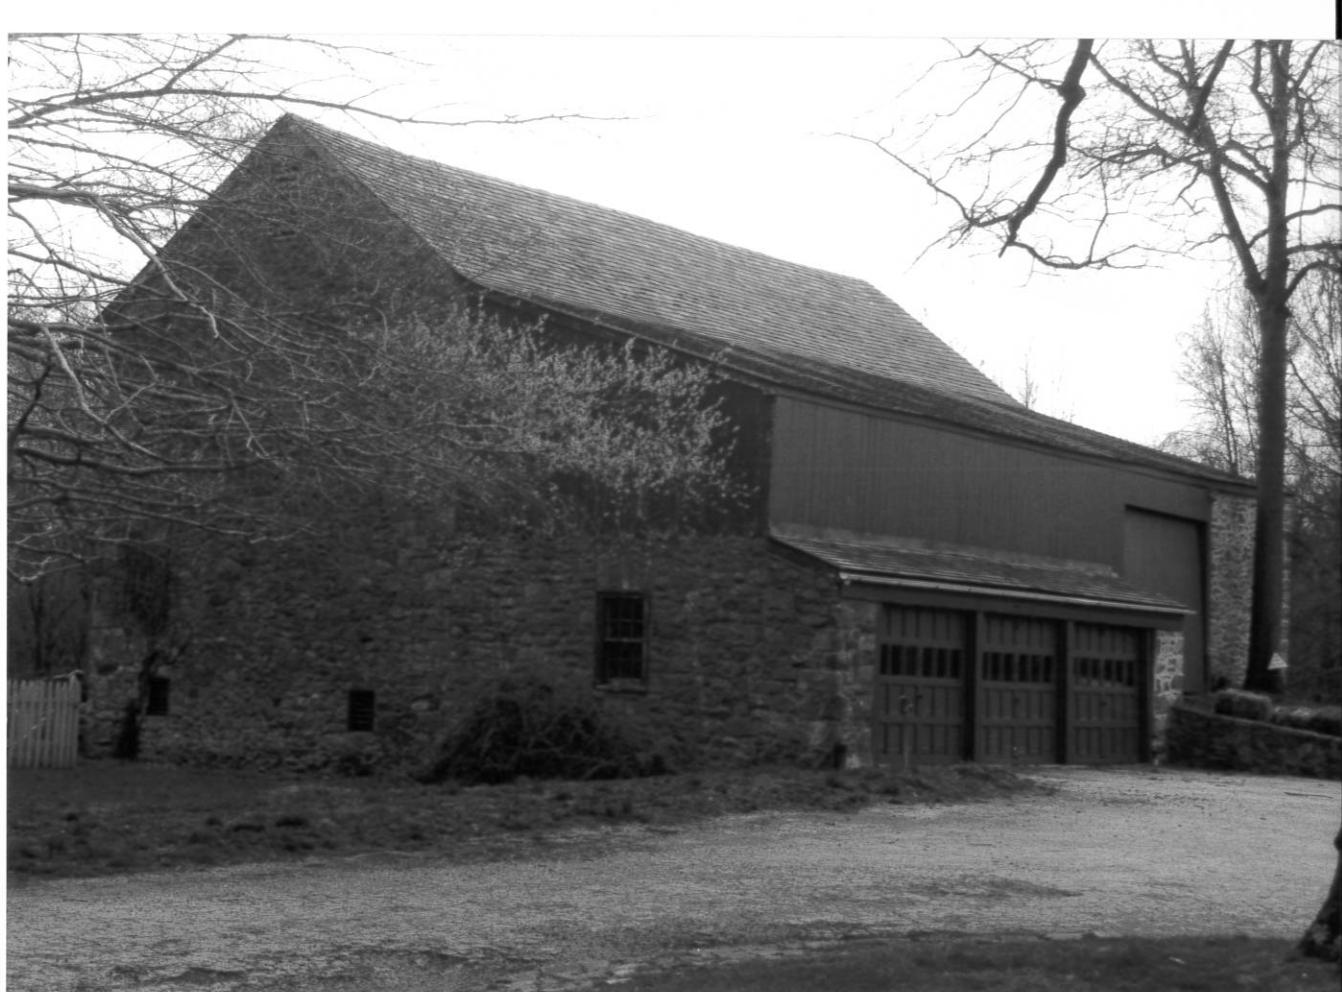
This is a Federal house at the corner of Royal Oak and Stenton. The core of the house was built c. 1800 and is two stories tall. It has wood shingles and an end chimney; the walls and chimney are stuccoed. The windows are double hung with shutters. An extension off the back of the house has a slightly higher roofline but otherwise matches the pattern of stucco siding, windows with shutters, and wood shingles. This extension has a larger interior end chimney in the gable end and frieze band windows (which were common in the Greek Revival era). Off the gable end of the extension is a two-story addition with a slightly smaller profile. There is also a one-story addition off the core. A small-enclosed entry porch with a shed roof appears at the juncture of the core and the extension. The whole house is clad in stucco and is well-maintained.

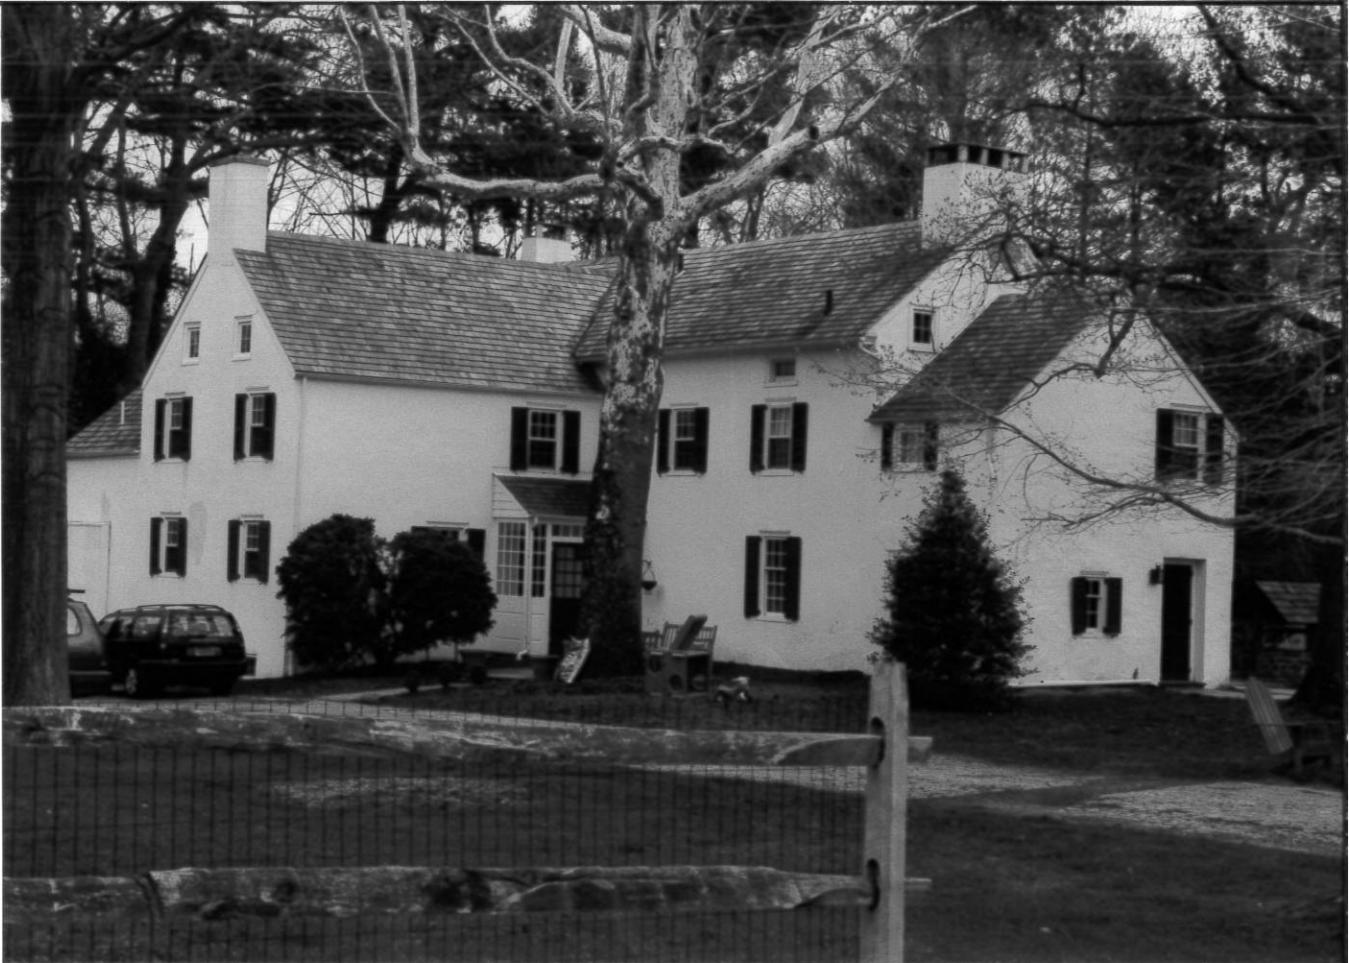
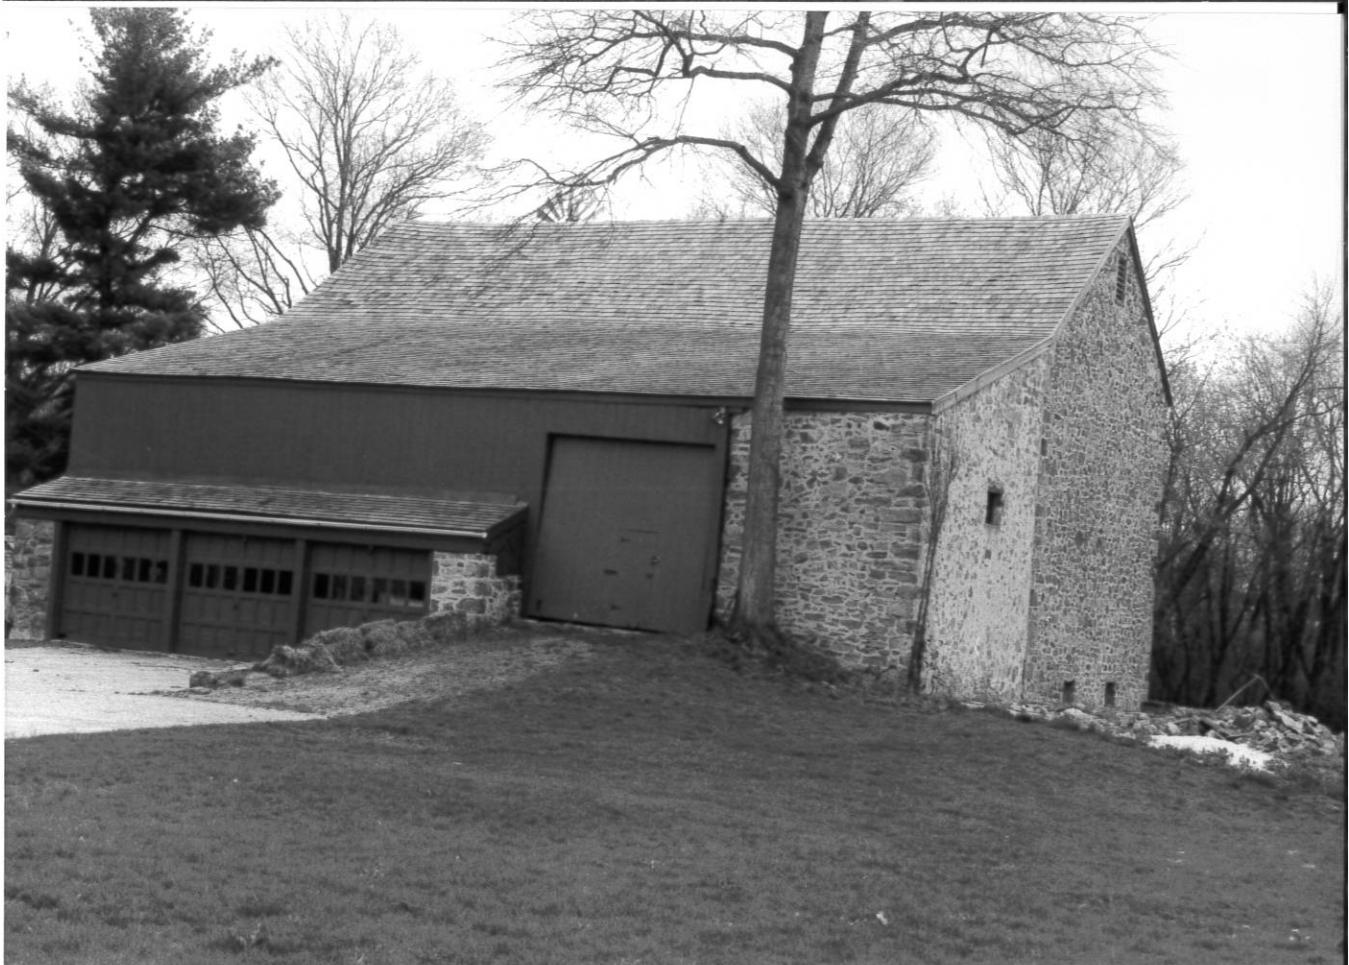
**Associated Resources:** (1) **Stone Barn.** This large stone and frame barn, built with uncoursed stone, has a stone shed addition. Modern garage doors have been added to the lower entryways into the barn. The windows are irregularly placed; those in the shed addition have a stone jack arch. The roof is covered with wood shingles.
