PENNSYLVANIA HISTORIC RESOURCE SURVEY FORM PHOTO/SITE PLAN SHEET

Address: 1433 Skippack Pike

Project Name: Whitpain Township Historic Resource Survey

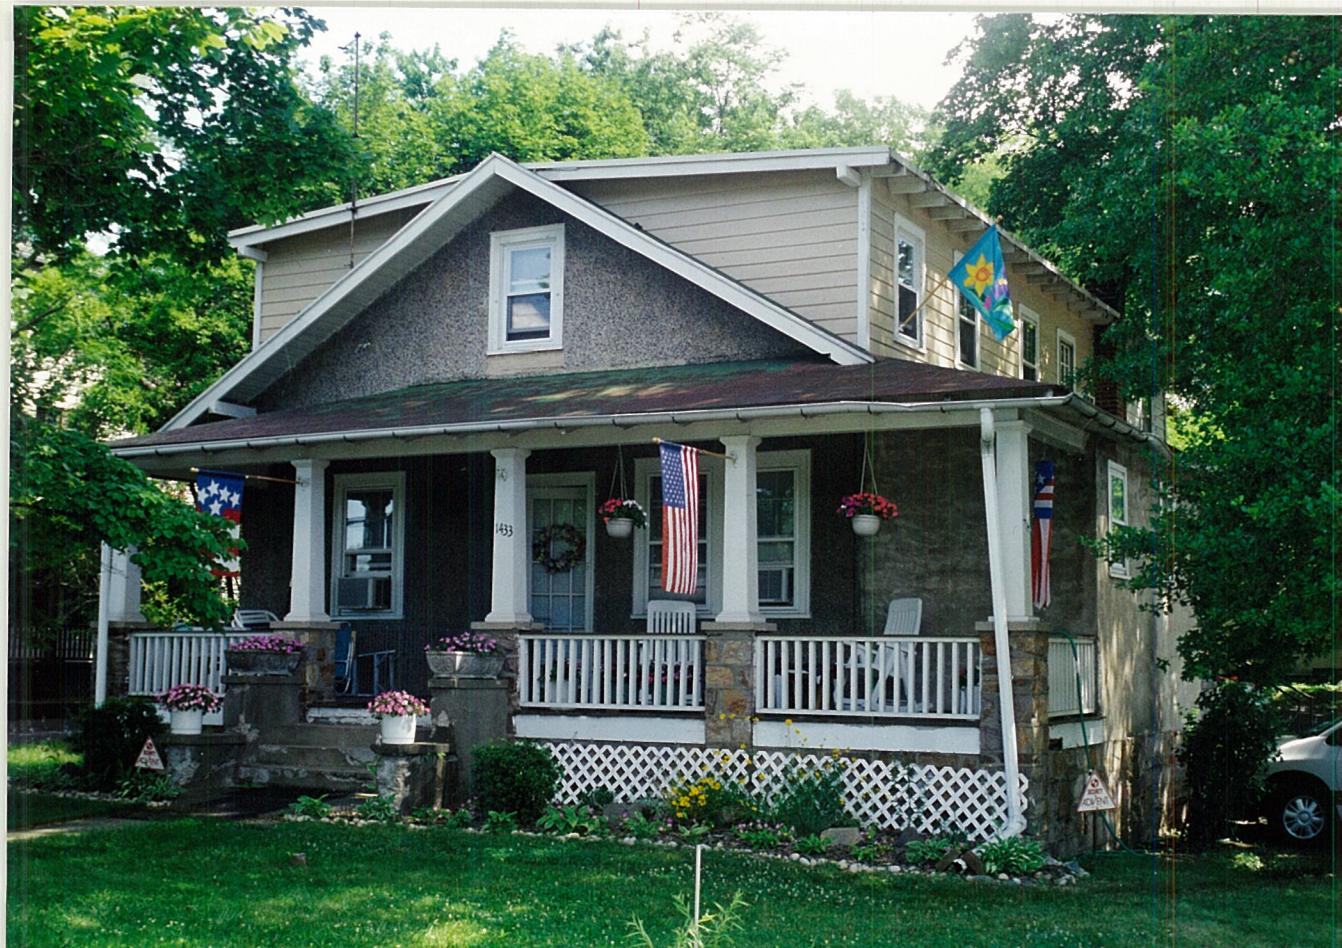
This house was built in the Bungalow tradition with two additions. The core is a 1.5 story, three bay house clad in dark colored stucco with a one-story wrap-around porch. There is a window in the front gable and a double window in the right bay on the first floor. Frames around the door and windows have a simple profile. The door has a series of glass panes rather than panels. The standard porch rests on columns composed of a stone base supporting short square columns. The exposed rafters on the porch are partially hidden by the gutter. A wood railing connects the stone column bases to help enclose the porch. An addition to the side of the house is a one-story element with smaller windows. It is clad in stucco of a light brown color and possibly replaces a portion of the original wrap-around porch. A second addition was the construction of monitor dormers to enlarge the second floor. The rafter ends of the roof are exposed over the monitor dormers, reflecting the original style of the house.
