PENNSYLVANIA HISTORIC RESOURCE SURVEY FORM PHOTO/SITE PLAN SHEET

Municipality: Whitpain Township

Address: 1463 Skippack Pike

Surveyor Name/Title: Robert Wise Date: 6/16/2000
Project Name: Whitpain Township Historic Resource Survey
Organization: Robert Wise Consulting/Whitpain Township Telephone: (610) 722-5818
Street and No.: Station Square 1, Suite 104, 37 North Valley Road
City, State: Paoli, Pa Zip Code: 19301
Additional Survey Documentation: n/a
Associated Survey Codes: n/a

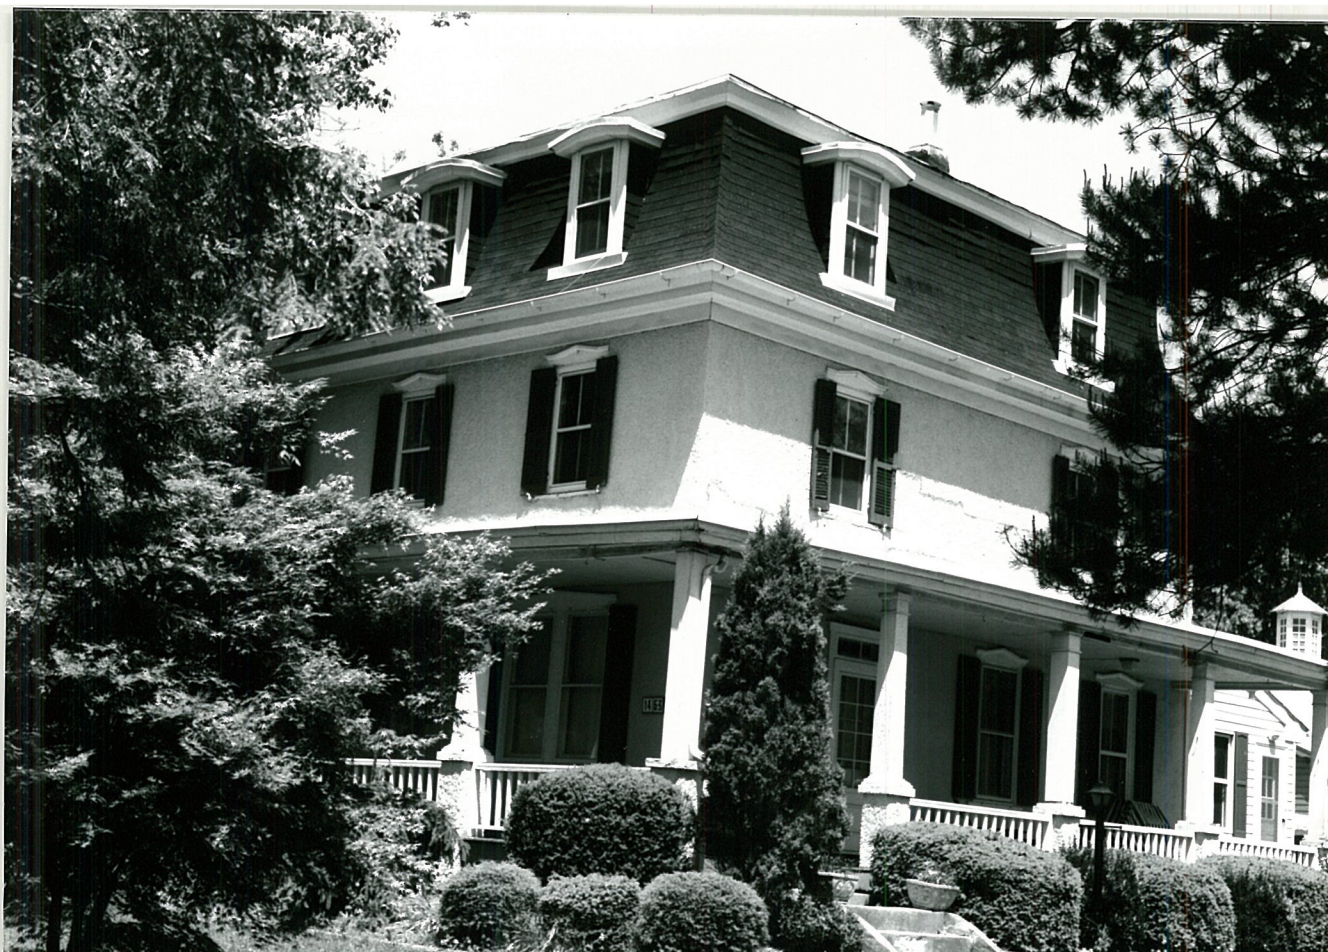
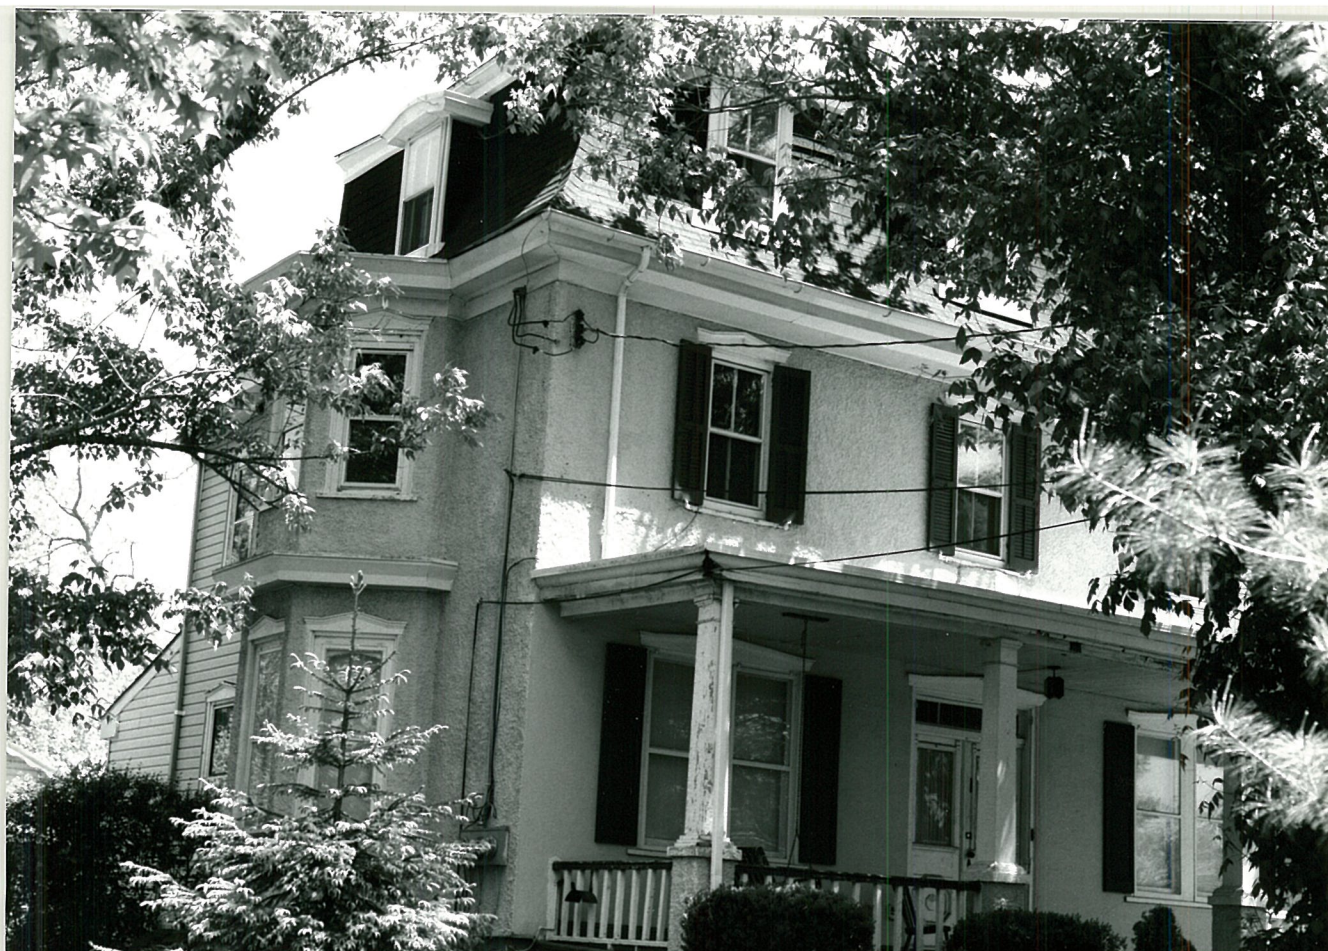
Number	Description of View	Direction of Camera
1	House – façade	
2	House – façade	
3	Barn	
4		
5		
6		
Photographer Name: Robert Wise		Date: 1999
Negative Location: Robert Wise Consulting, Station Square 1, Suite 104, 37 N. Valley Road, Paoli PA 19301

This Second Empire-style, Mansard roofed house (c. 1880) consists of a three-story core with a two-story rear addition. The house is an example of the Township's Second Empire influence and is similar to 1451 Skippack Pike. This Second Empire-style house (c. 1880) consists of a three-story core, a two-story rear addition, and a single story, shed roofed addition attached to the rear of the larger addition. The core measures 30' across (three bay) and is 40' deep with the additions. The roof consists of a concave shape clad in asphalt shingles and framed with cornices on the roof and cornice line. Barrel topped, molded dormers are located across the front and side facades. A wrap-around porch with a square corner is located on the front and east facades. The nearly flat porch roof appears to have 1920-era square posts. Fenestration consists of 2x2 sash windows and a French door main entrance. A two-light transom is located over the door. An additional entrance is located on the east side of the house. Windows are topped with pedimented lintels. Louvered shutters flank the windows on the second floor; paneled shutters flank the first floor windows. The west end has a two-story bay window arrangement. The core is clad in coarse stucco. The rear addition has a flat roof with a similar cornice system to that of the core. The windows of the addition also have pedimented lintels and the walls are clad in weatherboard.

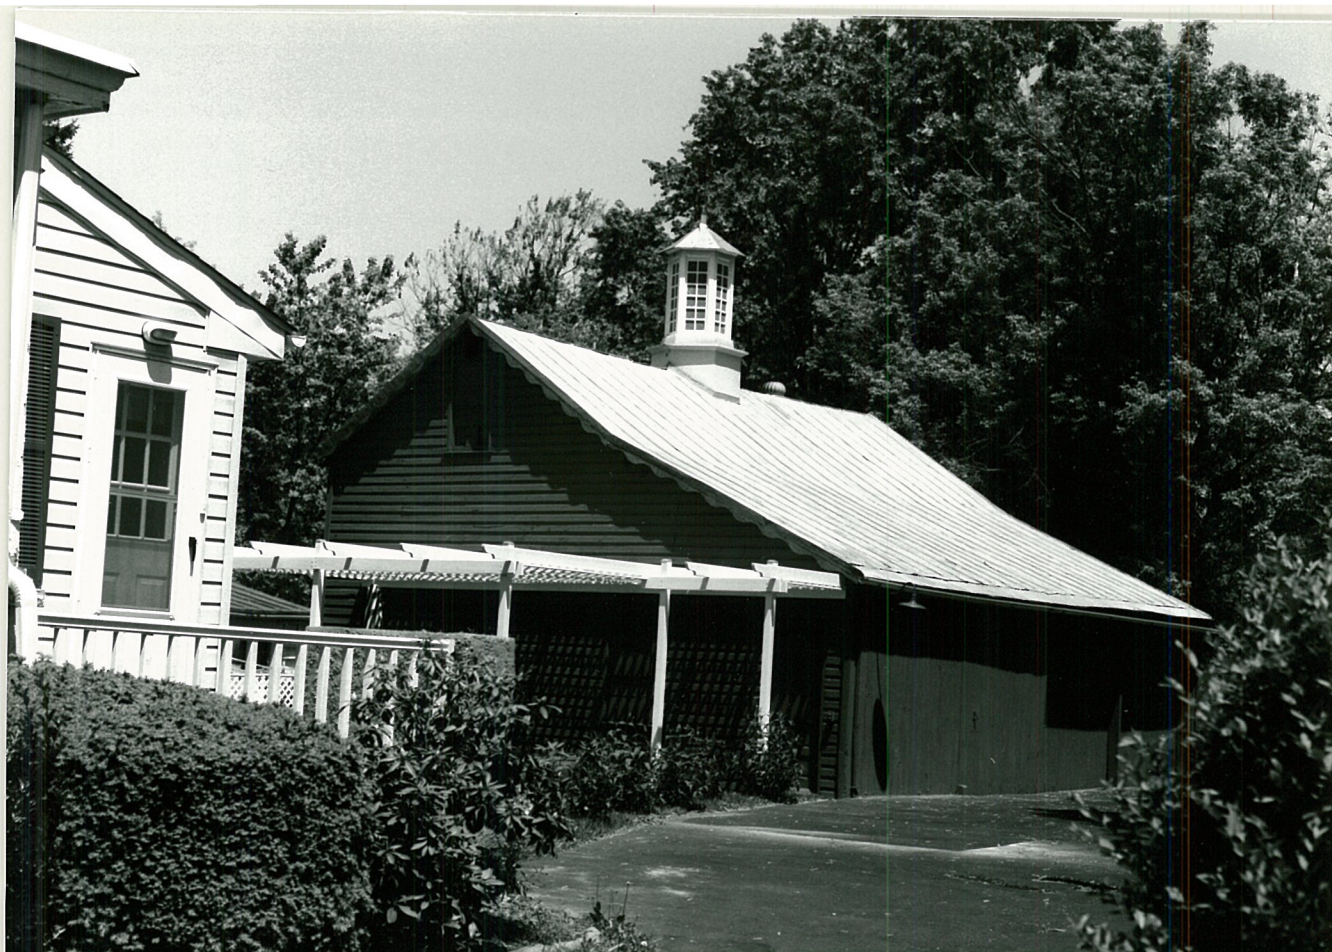
Associated Building: (Barn) To the rear of the house is a 1.5-story, frame barn. The building features an end-gabled, standing seam tin roof and is clad in German beveled siding. It has large sliding doors and is capped with a multi-light cupola. The barn is a contributing feature of the property.
