PENNSYLVANIA HISTORIC RESOURCE SURVEY FORM PHOTO/SITE PLAN SHEET

Address: 1810 Skippack Pike

Surveyor Name/Title: Robert Wise Date: 6/16/2000
Project Name: Whitpain Township Historic Resource Survey
Organization: Robert Wise Consulting/Whitpain Township Telephone: (610) 722-5818
Street and No.: Station Square 1, Suite 104, 37 North Valley Road
City, State: Paoli, Pa Zip Code: 19301
Additional Survey Documentation: n/a
Associated Survey Codes: n/a

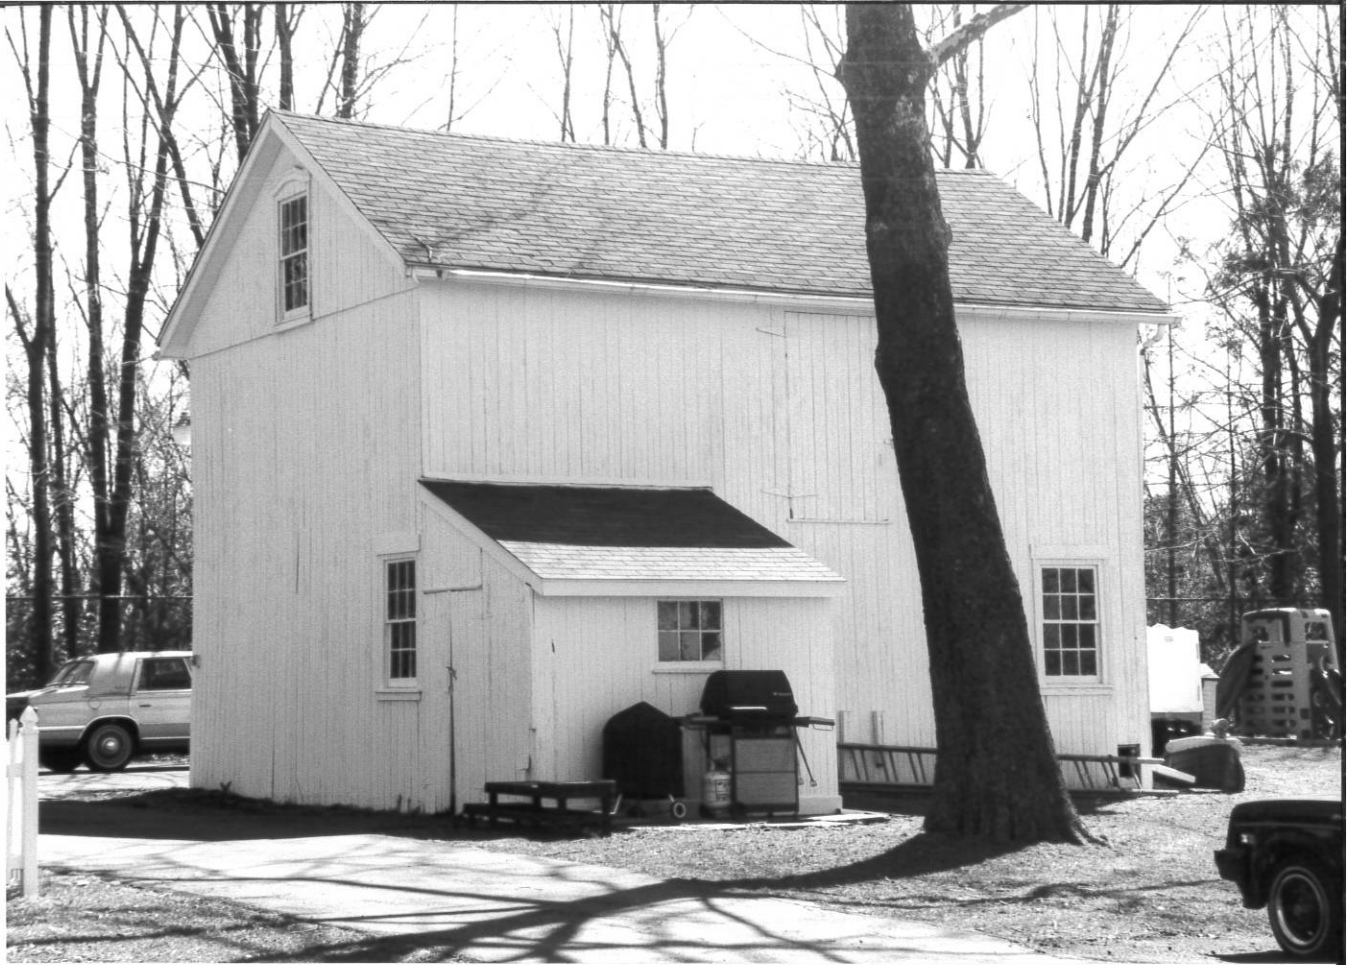
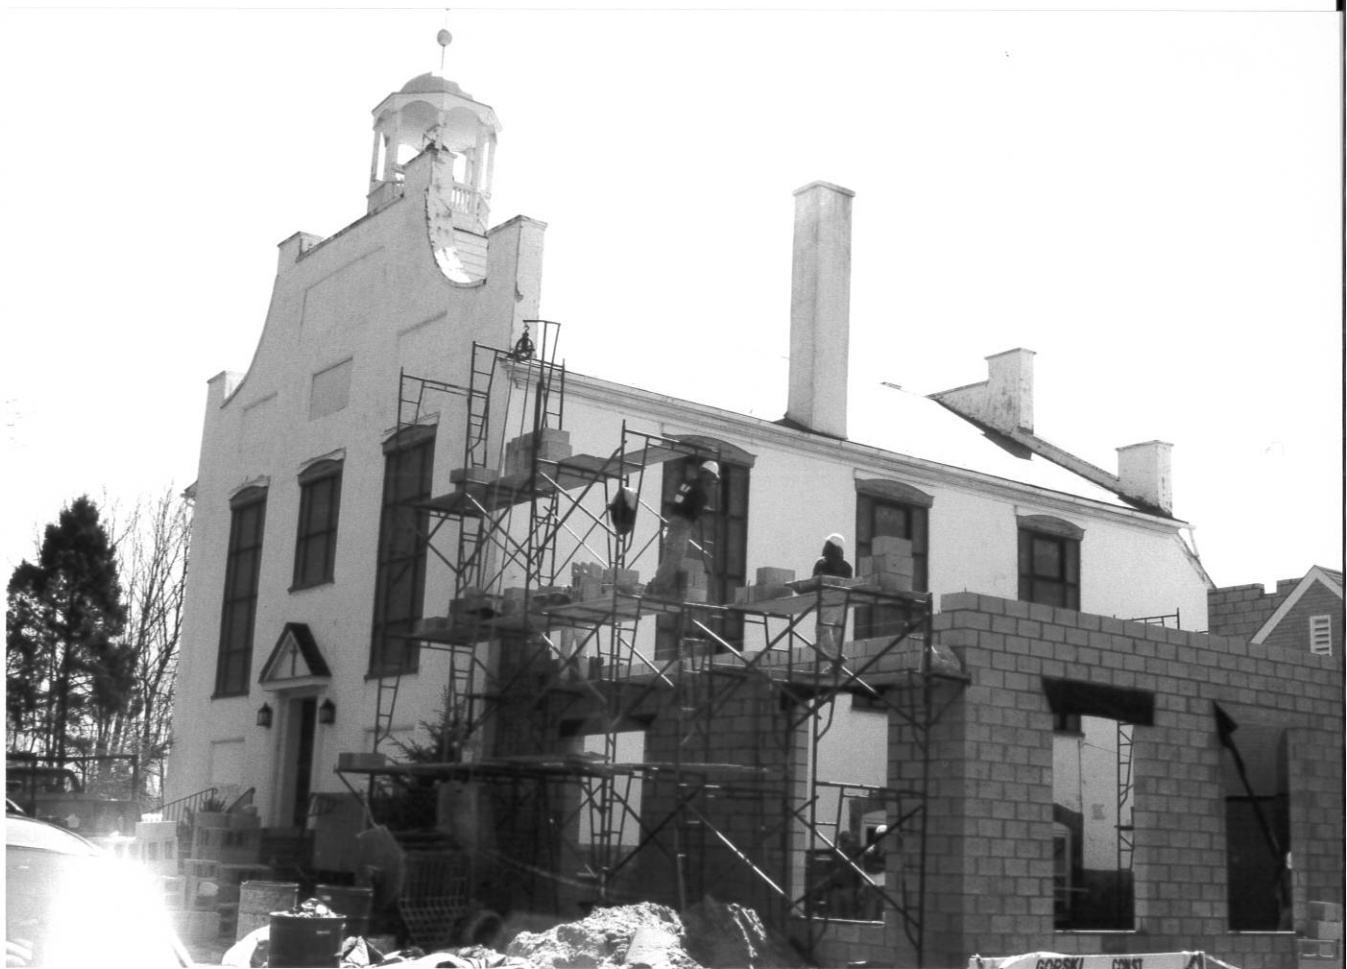
Number	Description of View	Direction of Camera
1	Church House	
2	Church House	
3	Parsonage	
4	Parsonage	
5	Garage	
6	Sexton's House	
Photographer Name: Robert Wise		Date: 1999
Negative Location: Robert Wise Consulting, Station Square 1, Suite 104, 37 N. Valley Road, Paoli PA 19301

The exterior of the church has been somewhat influenced by the Mission style. It consists of a large, stucco-clad end wall with curved parapet. Atop the front end gabled roof is a cupola holding the bell. Overall the walls are stucco over brick or stone. Windows are large, vertical arrangements with pedimented lintels. There are three across the front end, and three along the sides. (Unfortunately, a new extension added to the north side of the church covers these windows.) The windows have stained glass. The main entrance is located at a level below the windows, and is protected by a pedimented entrance extending approximately 1' from the wall. The building measures 30' x 45'.

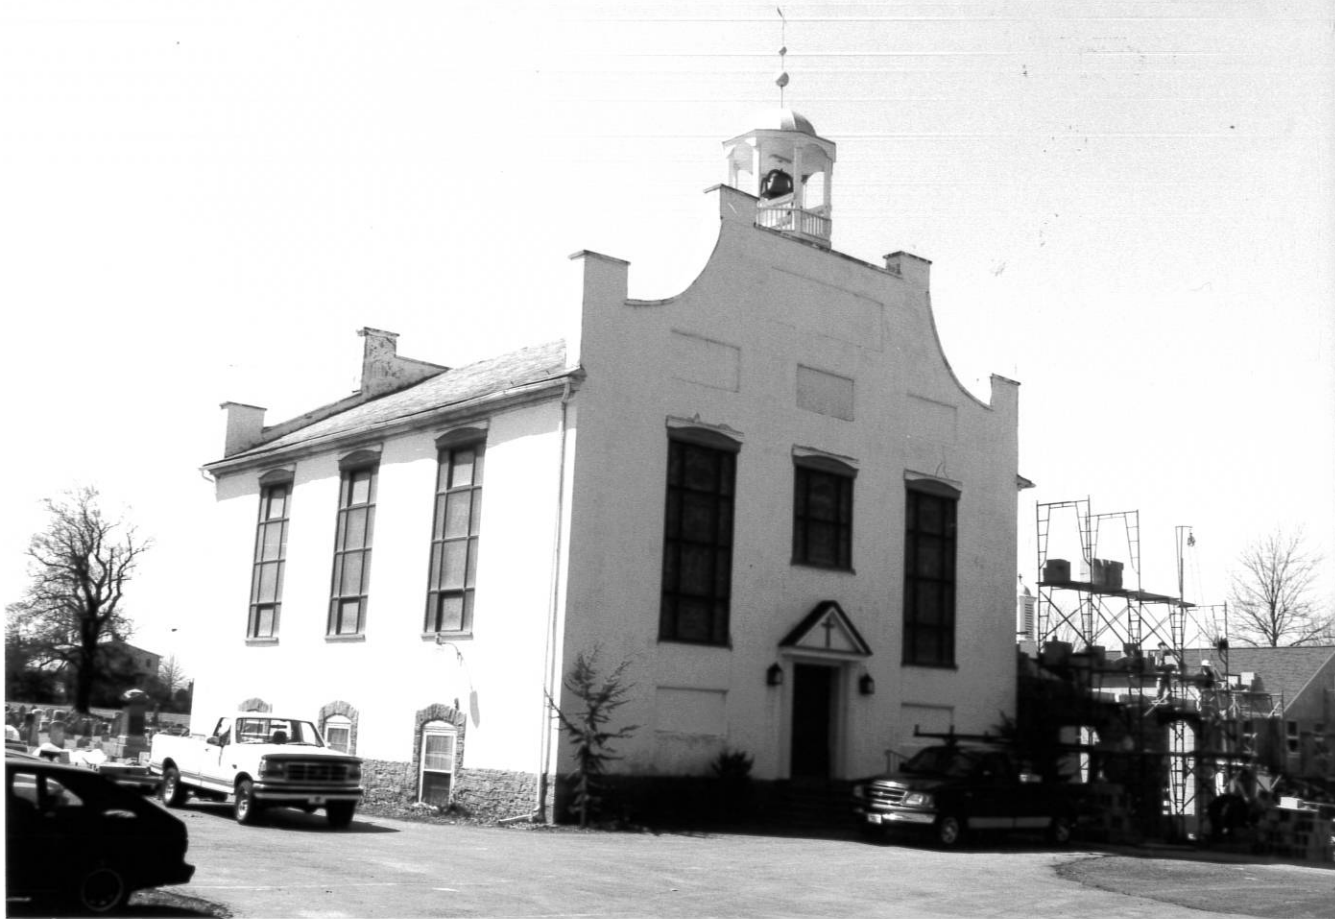
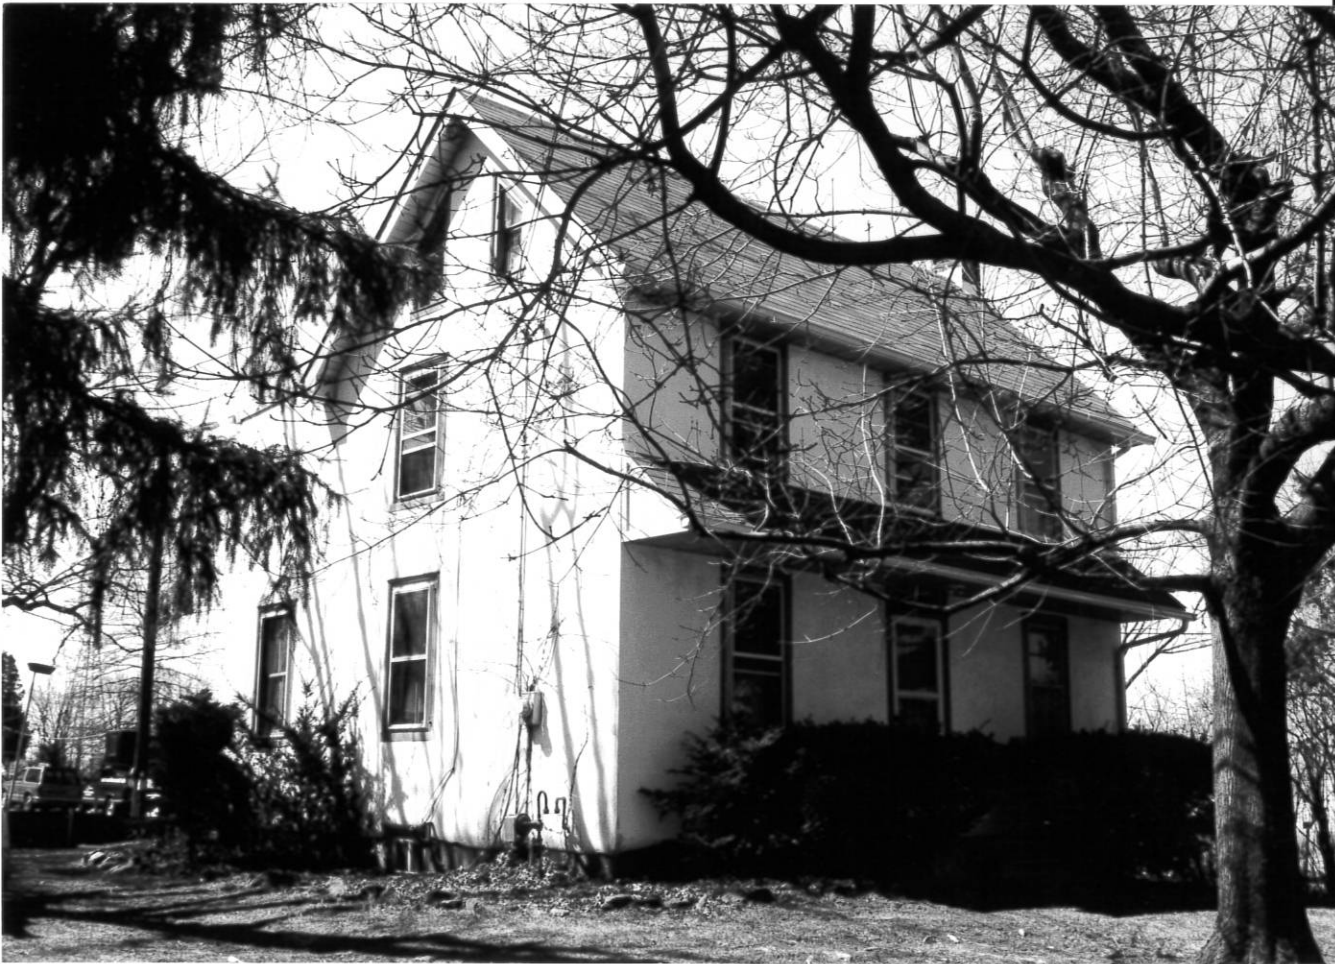
Associated Resources: (1) Parsonage The Parsonage is a 2.5-story, Queen Anne style house with a cross gable roof. The roof, clad in asphalt shingles, consists of both gable and gambrel design. The gambrel shape faces Skippack Pike. One significant feature is the fascia board and modillion course decorating the eaves around the entire house. This is typical of the Queen Anne style. The frame house is clad in vinyl siding with decorative wood shingles under the gable ends at the third floor level. The foundation is fieldstone. A pent roof with extended pedimented porch over the door is attached to the front of the house. The house is 4-bay wide with 1x1 plate glass sash windows. There are also twin windows under the gambrel end at the third floor level.
