PENNSYLVANIA HISTORIC RESOURCE SURVEY FORM PHOTO/SITE PLAN SHEET

Survey Code: 061 Tax Parcel/Other No.: 66-00-04112-02-5 Block 010C Unit 085
 County: 1. Montgomery 2. _____
 Municipality: 1. Whitpain Township 2. _____
 Address: Morris Road Historic Name: Franklinville School House
 Other Name: _____
 Owner Name/Address: Historical Society of Whippain c/o J. Peirce Anderson 1710 Walton Rd. Blue Bell Pa 19422
 Owner Category: x Private _____ Public-local _____ Public-state _____ Public-federal _____
 Resource Category: x Building _____ District _____ Site _____ Structure _____ Object _____
 Number/Approximate Number of Resources Covered by This Form: 1
 USGS Quad: 1. Lansdale 2. _____
 UTM A. _____ C. _____
 References: B. _____ D. _____

Surveyor Name/Title: Robert Wise Date: 6/16/2000
Project Name: Whitpain Township Historic Resource Survey
Organization: Robert Wise Consulting/Whitpain Township Telephone: (610) 722-5818
Street and No.: Station Square 1, Suite 104, 37 North Valley Road
City, State: Paoli, Pa Zip Code: 19301
Additional Survey Documentation: n/a
Associated Survey Codes: n/a

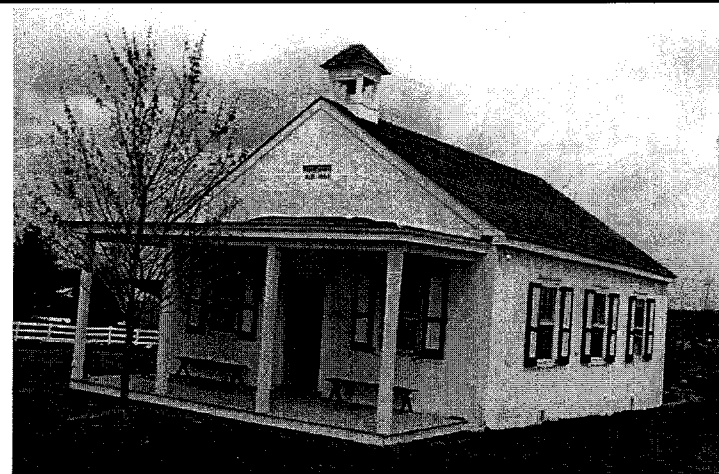
Number	Description of View	Direction of Camera
1	Façade	
2		
3		
4		
5		
6		
Photographer Name: Robert Wise		Date: 1999

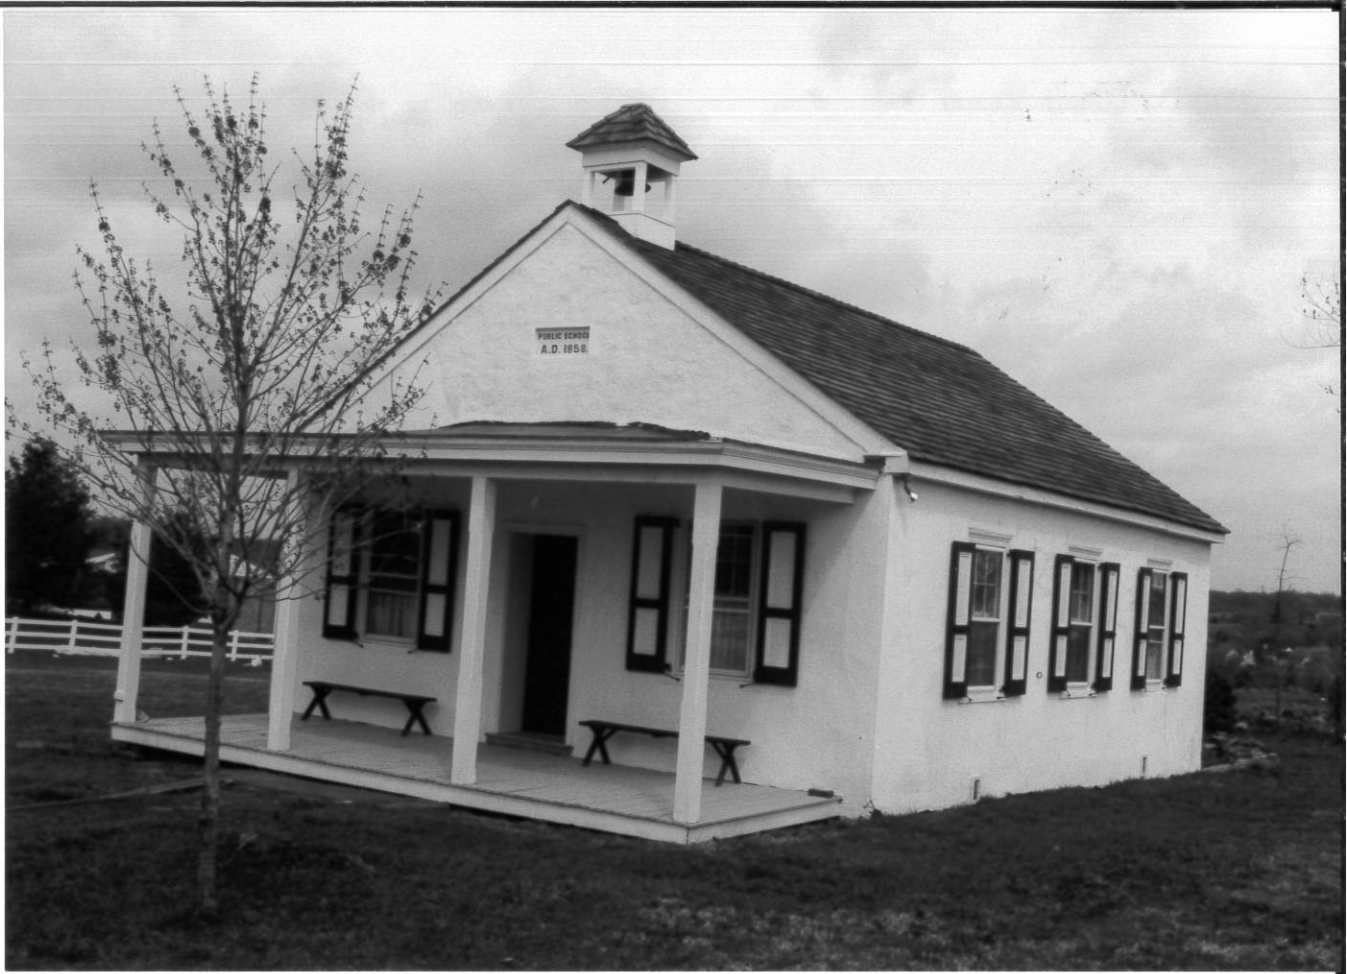
The Franklinville School House represents the one-room schoolhouses that proliferated throughout the nineteenth century. It is a one story building with end gables; a bell tower appears above the gable facing the street. Just inside this gable is an inscription "Public School A.D. 1858." The house is 20 x 30 feet and has three bays on both the ends and the sides. It is clad in stucco and has wooden shingles. Just below the bell tower and inscription is a one-story porch with a flat roof. The porch rests upon square columns. A paneled door is centered under the porch.
