**PENNSYLVANIA HISTORIC RESOURCE SURVEY FORM PHOTO/SITE PLAN SHEET**

Survey Code/Tax Parcel/Other No.: 036 / 66 00 03011 02 8 Block-Unit #022D-013County: MontgomeryMunicipality: Whitpain TownshipAddress: 225 Kerry Lane

Project Name: Whitpain Township Historic Resource Survey

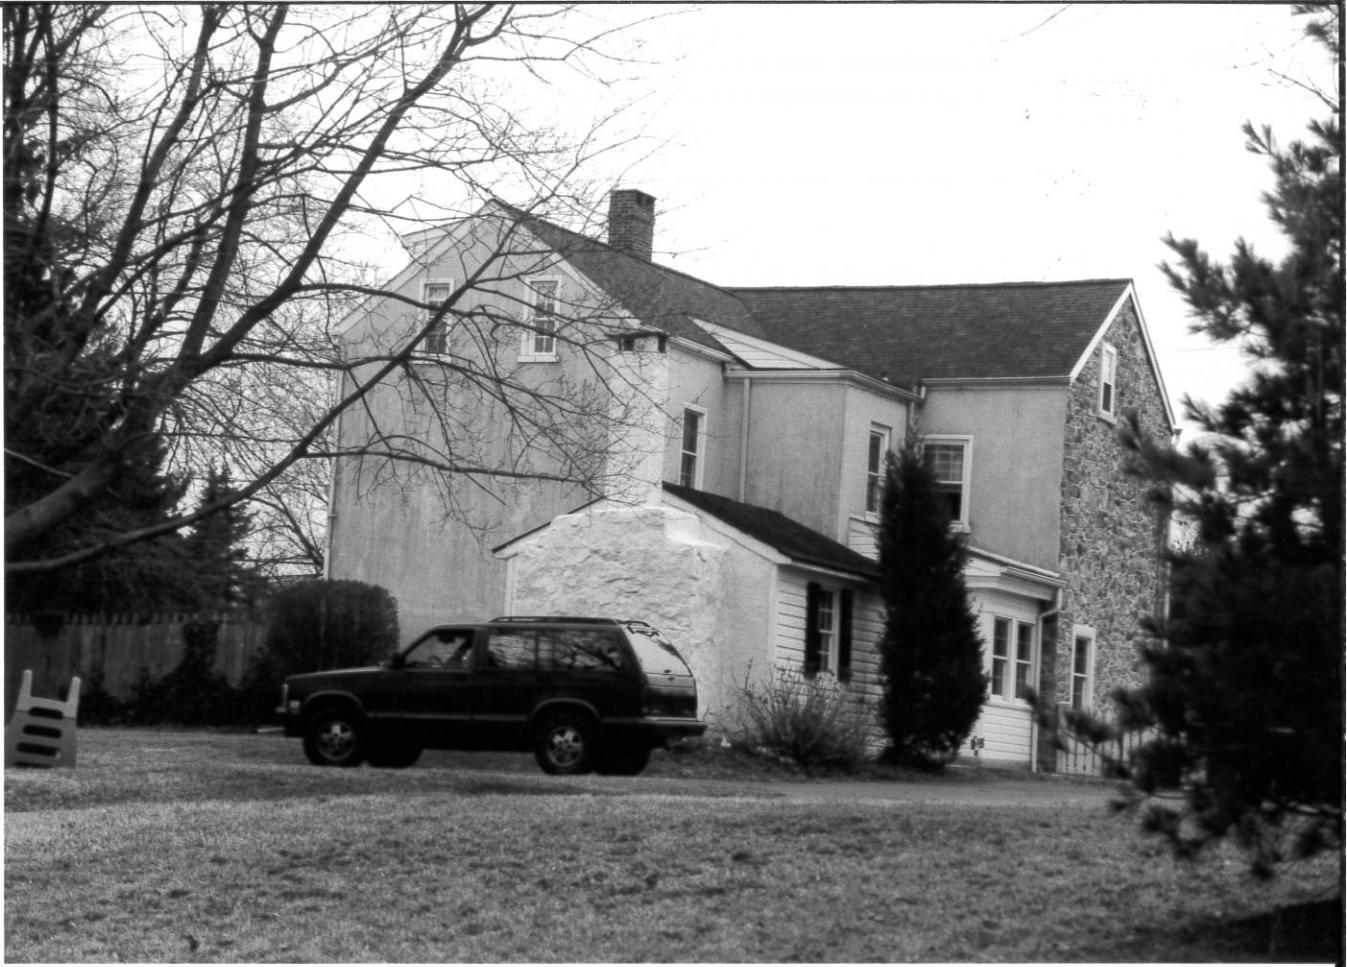
| Number | Description of View | Direction of Camera |
|---|---|---|
| 1 | House – façade (left) | |

The oldest units of this house were constructed c. 1850 following vernacular prototypes with three later additions. The core is a two and a half story, three-bay structure with uncoursed stone walls. The roof is end-gabled with asphalt shingles. Each of the two dormers on the core has two windows. Windows are six over six double hung; those second story windows on the façade have shutters. A stone arch over the door crowns an elliptical fanlight.
