PENNSYLVANIA HISTORIC RESOURCE SURVEY FORM PHOTO/SITE PLAN SHEET

Municipality: Whitpain Township Address: 475 Skippack Pike

Surveyor Name/Title: Robert Wise Date: 6/16/2000
Project Name: Whitpain Township Historic Resource Survey
Organization: Robert Wise Consulting/Whitpain Township Telephone: (610) 722-5818
Street and No.: Station Square 1, Suite 104, 37 North Valley Road
City, State: Paoli, Pa Zip Code: 19301
Additional Survey Documentation: n/a
Associated Survey Codes: n/a

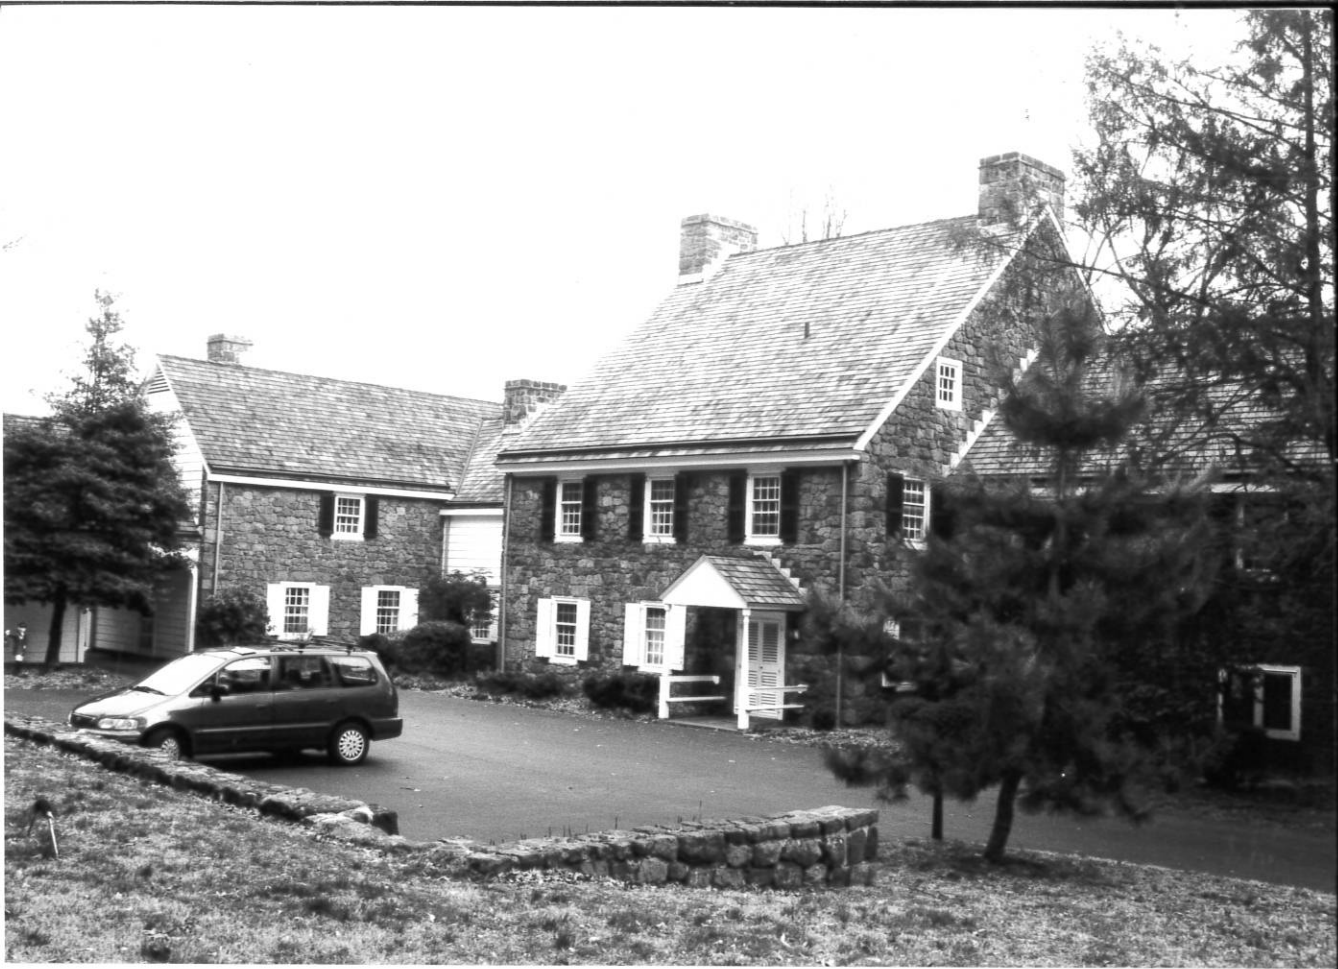
This Colonial Revival style resource, which consists of a c. 1920 stone manor house and an early 19th century stone bank barn sits approximately ¼ mile north of Skippack Pk. The primary resource is a 4 part, 2-story stone house with attached garage arranged in an ell-shape. The roof is wood shingle. The central part of the house is a two story, three bay unit with a steeply pitched roof (there may be a dormer on the rear of the house), much taller than the other sections of the house. A gabled hood protects the main entrance on the right side of the central section. There are also large stone, flush chimneys on each end of the core. The core measures approximately 35'x 30'.

Attached to the ends of the core are three, 2 story additions, set back from the main portion, and arranged in a manorial fashion. The northern most section is turned to create the building's ell-shape. Fenestration throughout the resource consists of 8x12 sash windows with thick wooden mullions. Attached to the turned section, via a gabled roof drive through, is the garage. A low stone retaining wall sits opposite of the house. It frames the courtyard (parking area) in the Shawvian Manorial fashion. In total, the building measures approximately 95'x 60'.

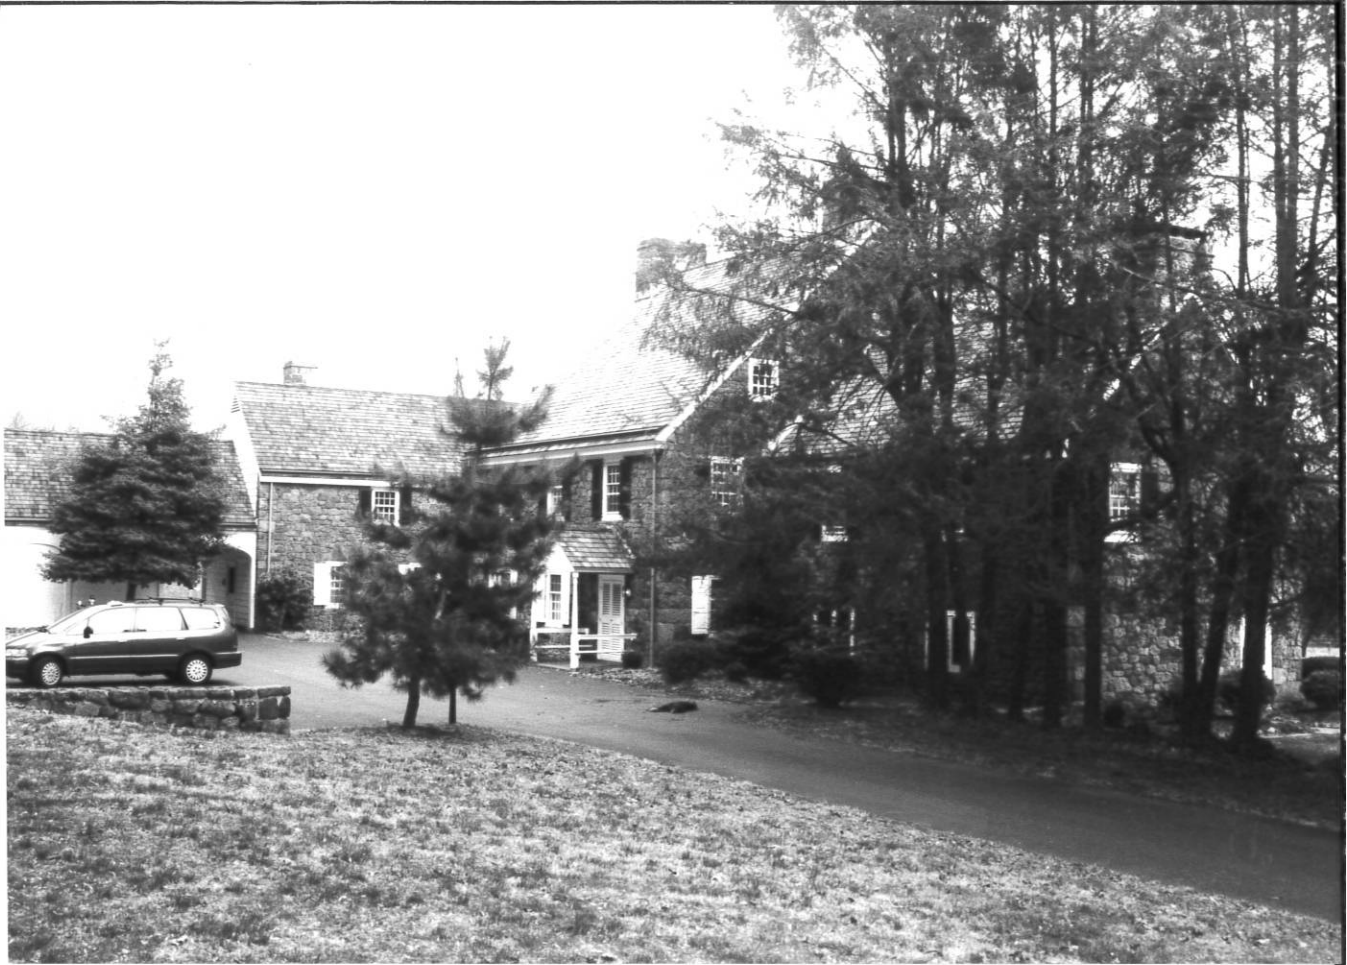
Associated Resource Barn: Located east of the house is a late 18th century or early 19th century stone bank barn. The double crib barn consists of a stone core and several frame additions to the front or fore bay side. The core consists of rough course stone foundation and walls and an end gabled, asphalt-shingled roof. The barn is entered from its earth ramp (with stone masonry retaining walls) on the south side through large wooden sliding doors. The core measures approximately 40'x 20'. Several rear stone and frame additions, including a large stonewall, create an ell shape, with an over all measurement of 70'x 50'. These additions include two shed roof additions on the south end of the barn, and a large, end gabled additions, with a stone gabled end wall, attached to the rear of the core.
