PENNSYLVANIA HISTORIC RESOURCE SURVEY FORM PHOTO/SITE PLAN SHEET

Municipality: Whitpain Township Address: 481 Skippack Pike

Project Name: Whitpain Township Historic Resource Survey

PENNSYLVANIA HISTORICAL RESOURCE SURVEY FORM
NARRATIVE SHEET 89C

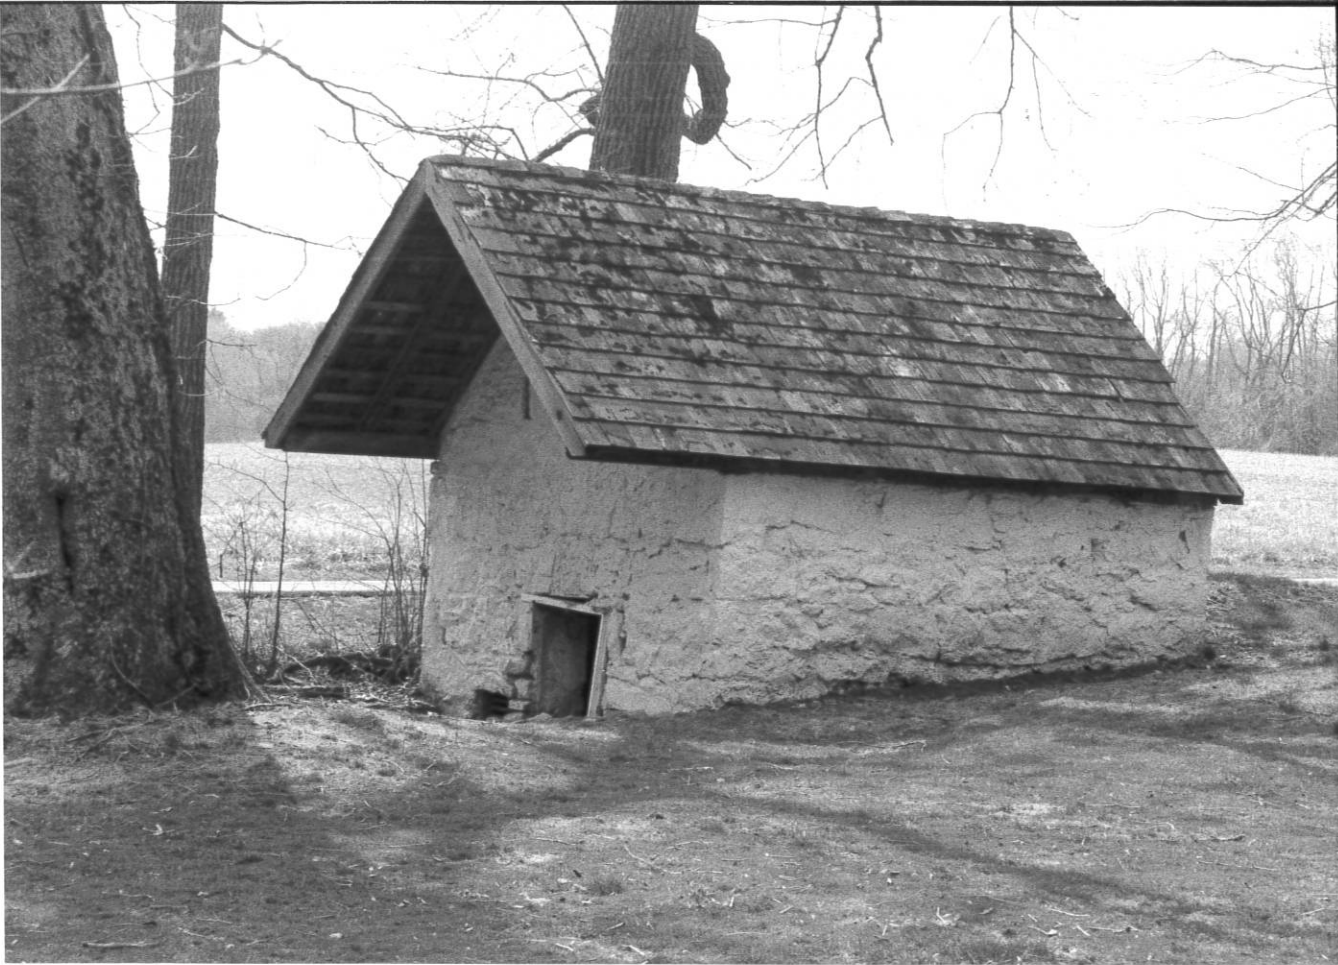
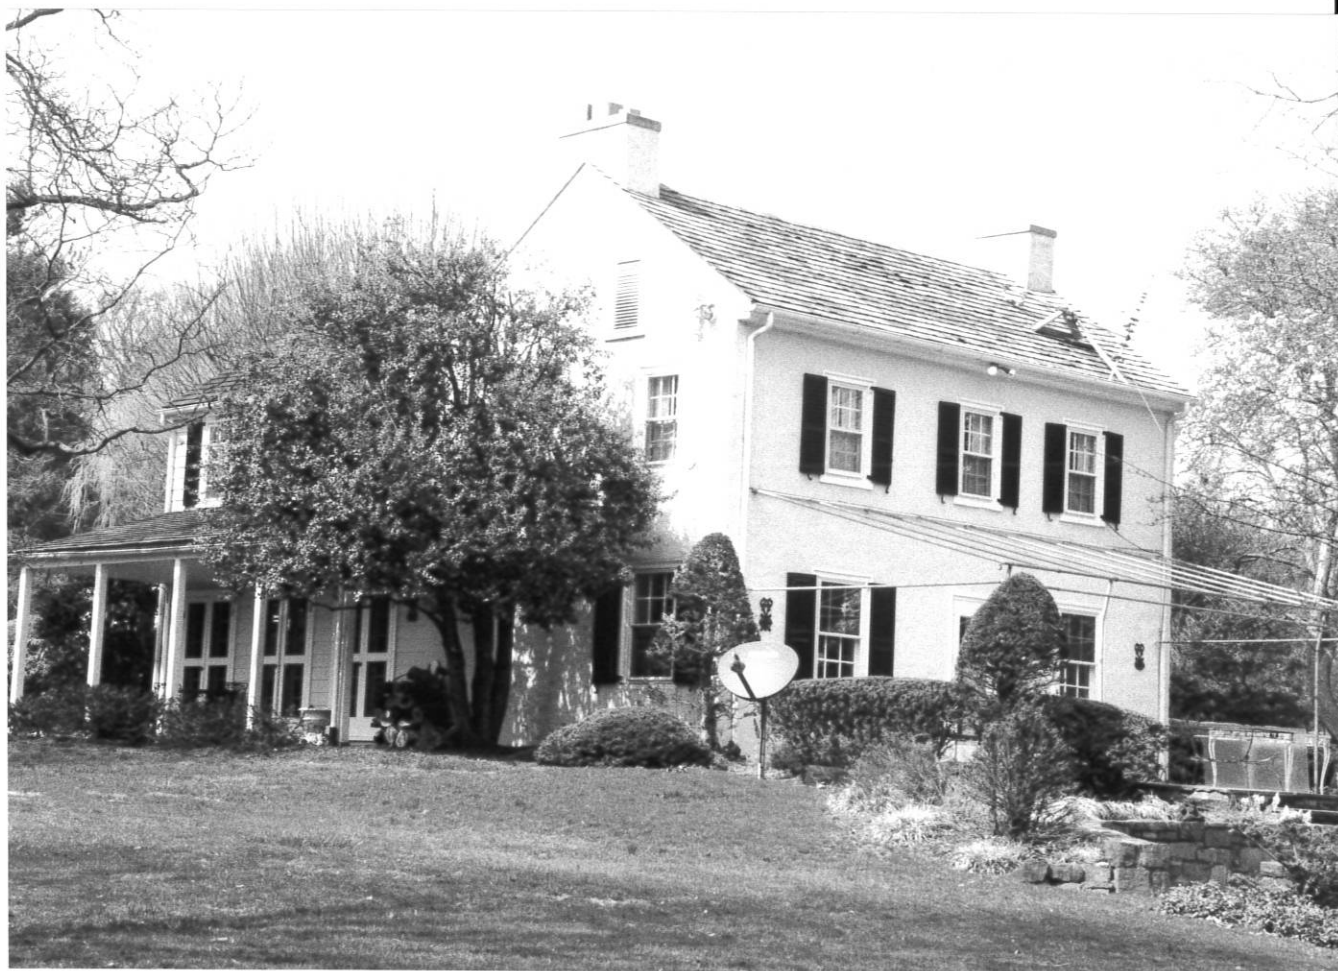
Associated Resource: (Spring House) The property has an intact stone springhouse, painted white. This building consists of a front end-gabled, wood shingled roof. To keep water out of the eastern entrance, which is below ground, the roof extend out over the gabled end wall approximately 4 feet. The eastern entrance consists of a small, doorway and window. Another door is located on the western end. Vertically slotted air vents flank the western door and under the eastern gable. The springhouse is in excellent shape.
