PENNSYLVANIA HISTORIC RESOURCE SURVEY FORM PHOTO/SITE PLAN SHEET

Address: 482 Cathcart Road

Surveyor Name/Title: Robert Wise Date: 6/16/2000
Project Name: Whitpain Township Historic Resource Survey
Organization: Robert Wise Consulting/Whitpain Township Telephone: (610) 722-5818
Street and No.: Station Square 1, Suite 104, 37 North Valley Road
City, State: Paoli, Pa Zip Code: 19301
Additional Survey Documentation: n/a
Associated Survey Codes: n/a

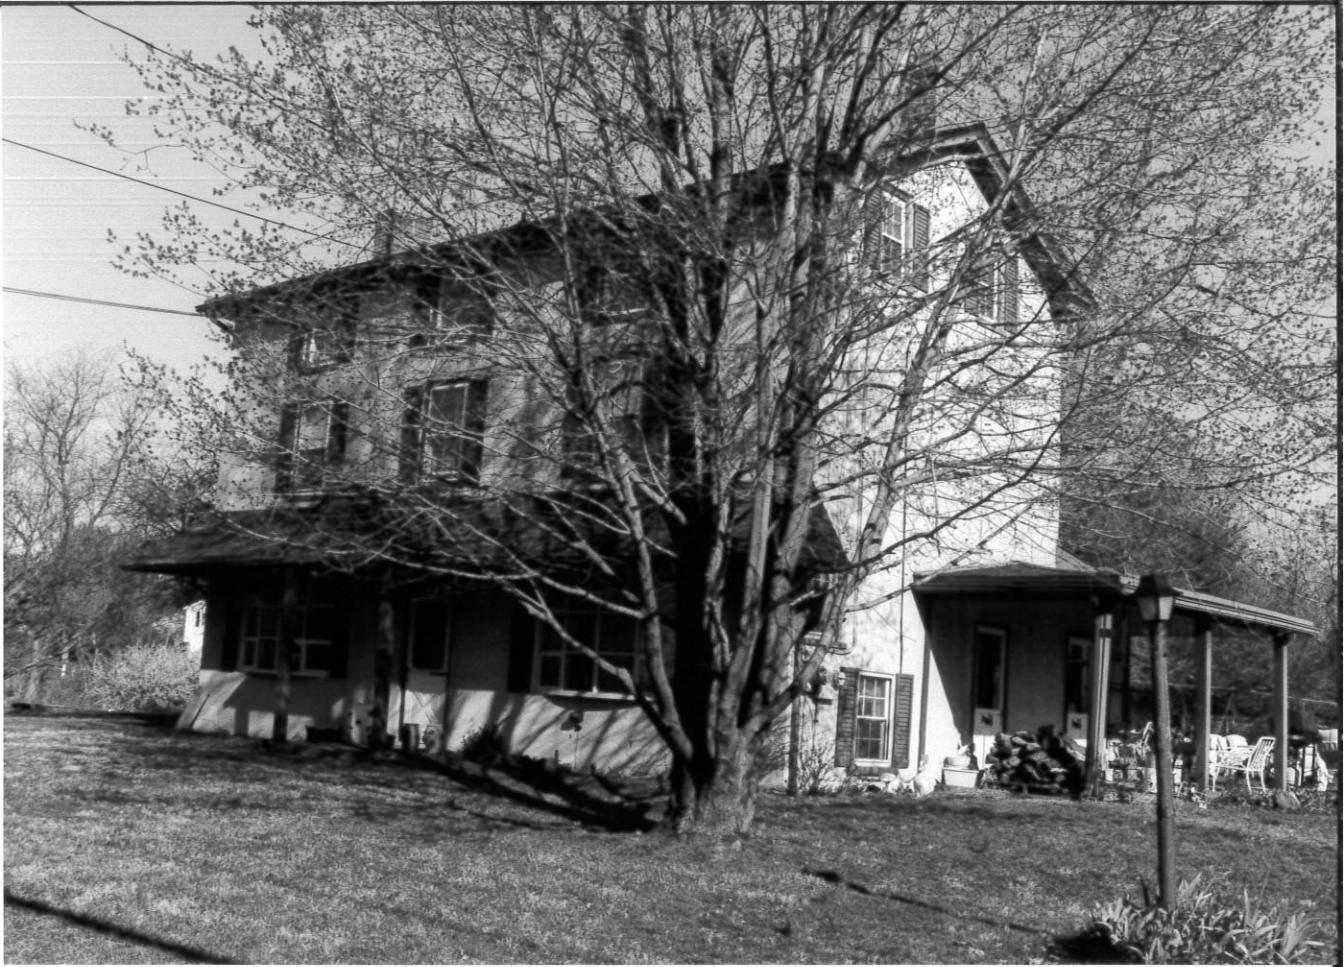
This house is an example of vernacular construction. It was once the farmstead for a large farm, now developed. It is a three story, three bay house measuring 20 x 35 feet and having interior end chimneys in the gable ends. The house was built with brick c. 1880 and covered with stucco. Each window has louvered shutters; two large 20th century bay windows appear on the first floor. A pent roof separates the first floor from the second and has a gabled entry hood supported by square columns. A one story shed addition appears on the rear of the house supported by square columns.

Classification: The many alterations on this house make it a Class II resource.

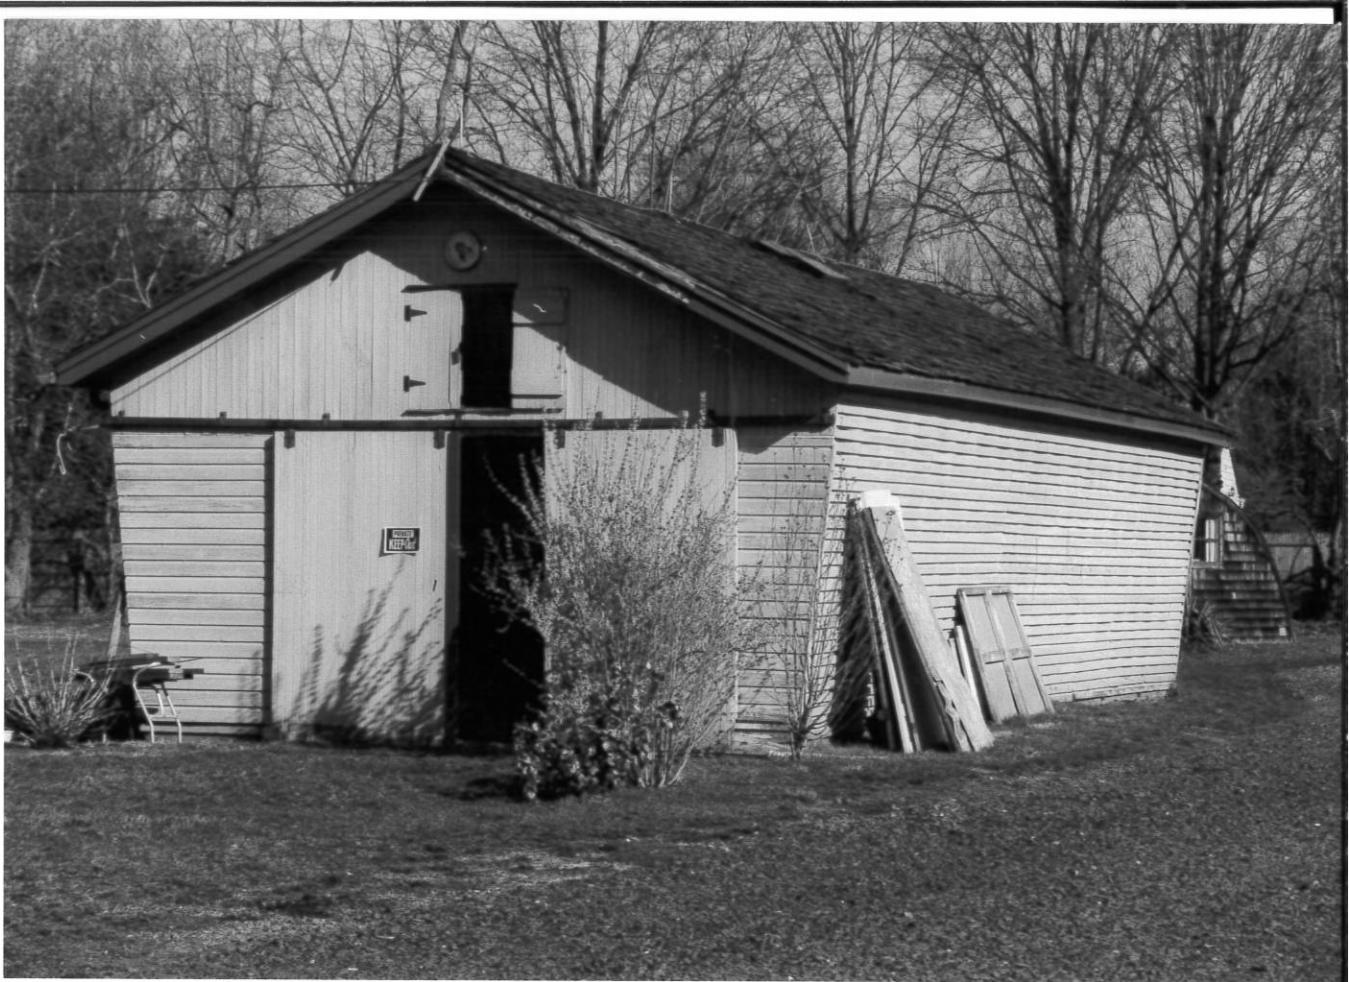
Additional Resource: (1) **Double Corn Crib** The walls of this building slope outward to give the building more volume. It is an end gabled, 1½ story frame building.
