PENNSYLVANIA HISTORIC RESOURCE SURVEY FORM PHOTO/SITE PLAN SHEET

Address: 485 Lewis Lane

Surveyor Name/Title: Robert Wise Date: 6/16/2000
Project Name: Whitpain Township Historic Resource Survey
Organization: Robert Wise Consulting/Whitpain Township Telephone: (610) 722-5818
Street and No.: Station Square 1, Suite 104, 37 North Valley Road
City, State: Paoli, Pa Zip Code: 19301
Additional Survey Documentation: n/a
Associated Survey Codes: n/a

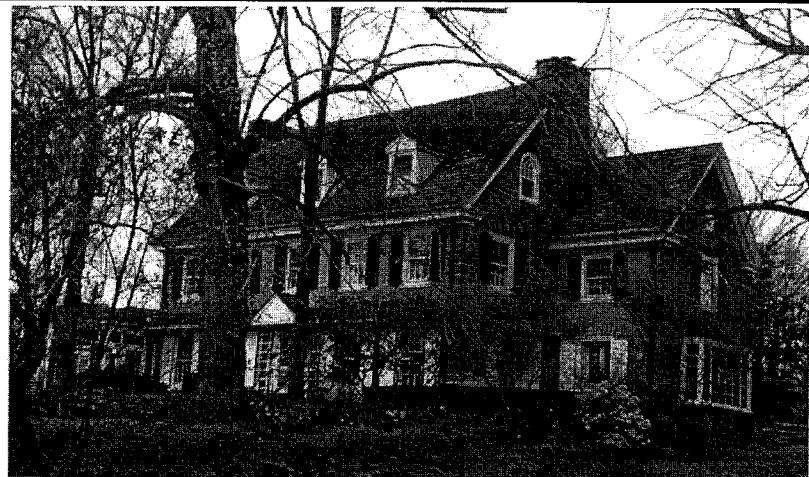
SITE PLAN**PHOTO INFORMATION**

Number	Description of View	Direction of Camera
1	House – façade	
2	House – rear	
3	Garage	
4	Stone Outbuilding	
5		
6		
Photographer Name:	Robert Wise	Date: 1999
Negative Location:	Robert Wise Consulting, Station Square 1, Suite 104, 37 N. Valley Road, Paoli PA 19301

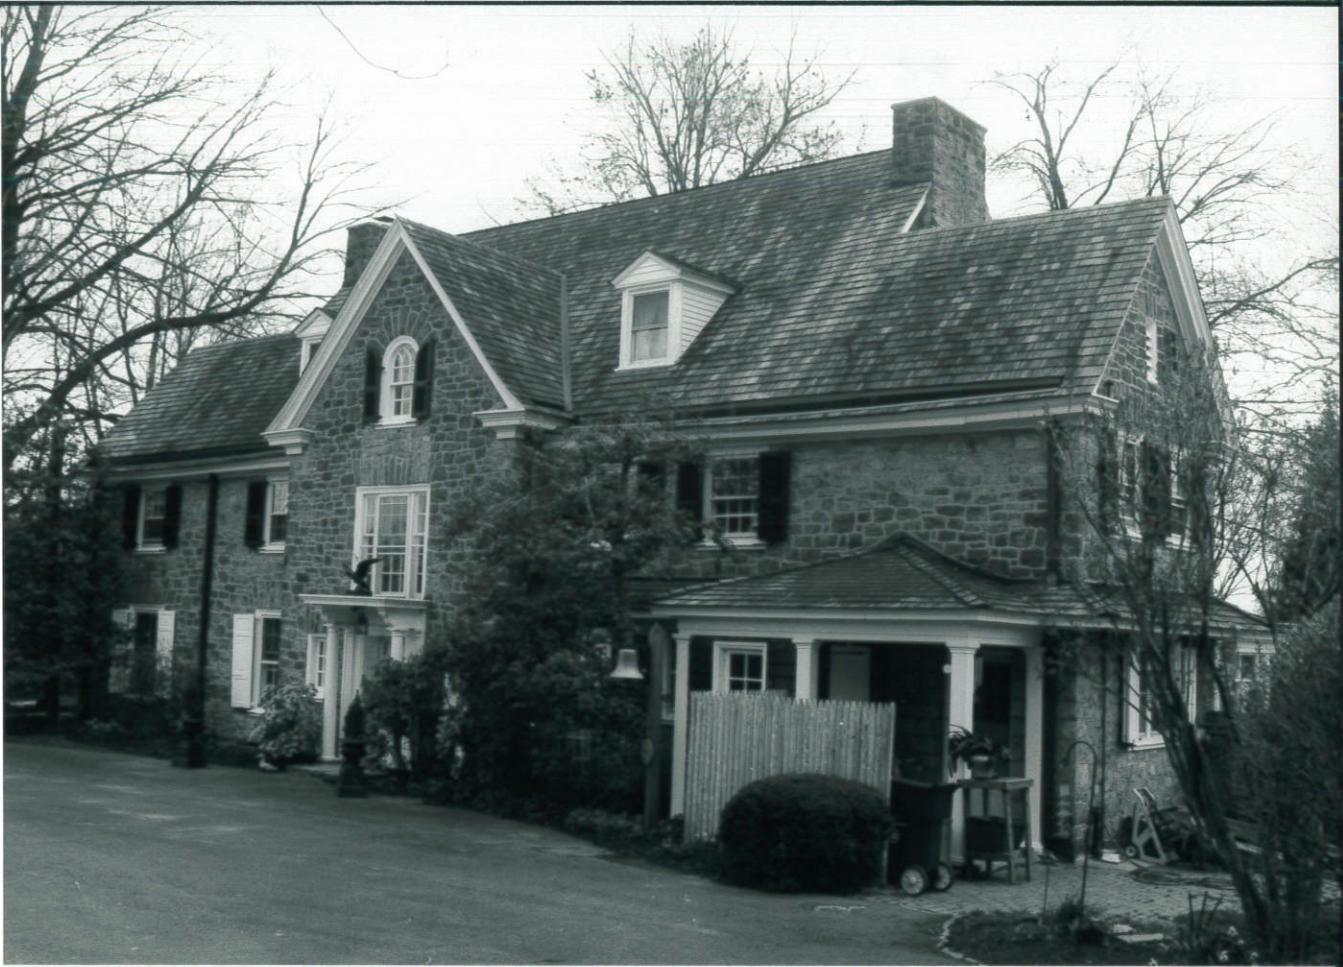
Classification: This house is in excellent condition and is a Class I resource. Its other resources, particularly the stone outbuilding, are also important.

This house is a fine example of the Colonial Revival construction. The core is a 2½ story, five bay house with exterior end chimneys which break through the gable ends of the house. There is a strong cornice framing the roof. The 30 x 60 core was constructed of semi-coursed stone c. 1920. Each of the windows has a jack arch and shutters (except some round headed windows in the gable ends which have no shutters and a rounded stone arch). A pent roof separates the first and second floors, and a small gabled entry hood breaks through the pent roof on the façade. Three gabled roof dormers adorn the façade as well. The rear of the house is quite unexpected. Two 2-story wings that seem to be additions from the front appear original on the rear. The center of the rear is marked by a projecting 2½ story gable with a round headed window on the third floor, a tripartite window on the second, and a nice entry porch on the first floor. The entry porch has two round unfluted columns supporting an entablature and a flying eagle sculpture. The dormers and windows on the rear follow the pattern of the façade. The pent roof rounds the corner on one end of the rear and becomes part of a small porch with a hipped roof resting on three square columns. This porch is partially enclosed with a privacy fence.

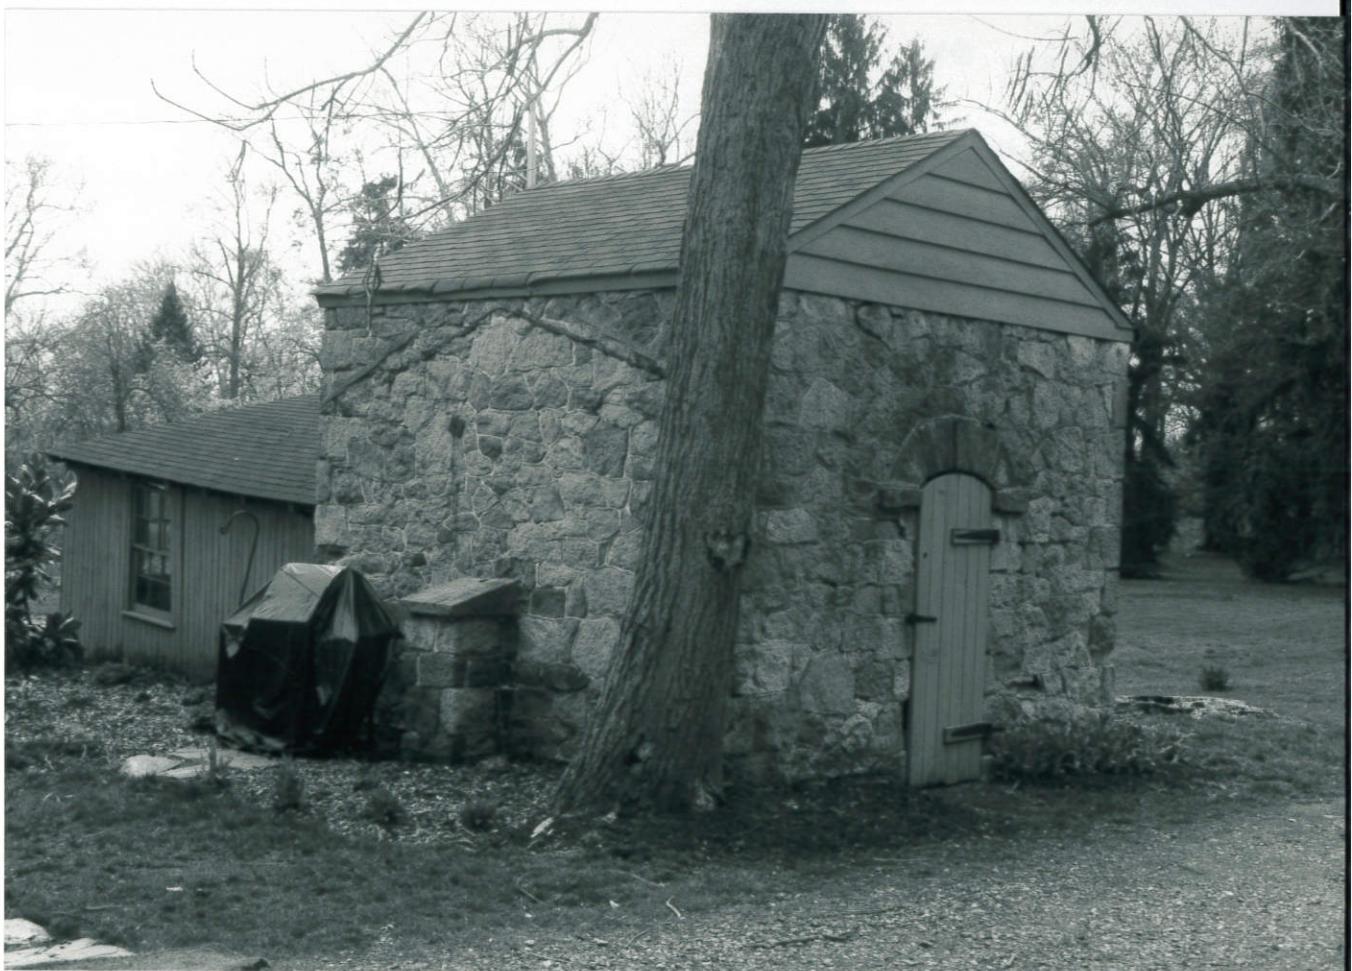
- (2) **Stone Outbuilding.** This building was constructed of uncoursed stone. It has a narrow door under a large stone arch. A scar on the side of the building leaves evidence of a former gabled addition now removed. The upper portion of the building is frame. A rear portion of the building is a one story frame addition. Key elements are the medieval arch above the arched wooded door and the small buttress where the former addition was once located (C)
