PENNSYLVANIA HISTORIC RESOURCE SURVEY FORM PHOTO/SITE PLAN SHEET

Municipality: Whitpain Township

Address: 520 Skippack Pike

Project Name: Whitpain Township Historic Resource Survey

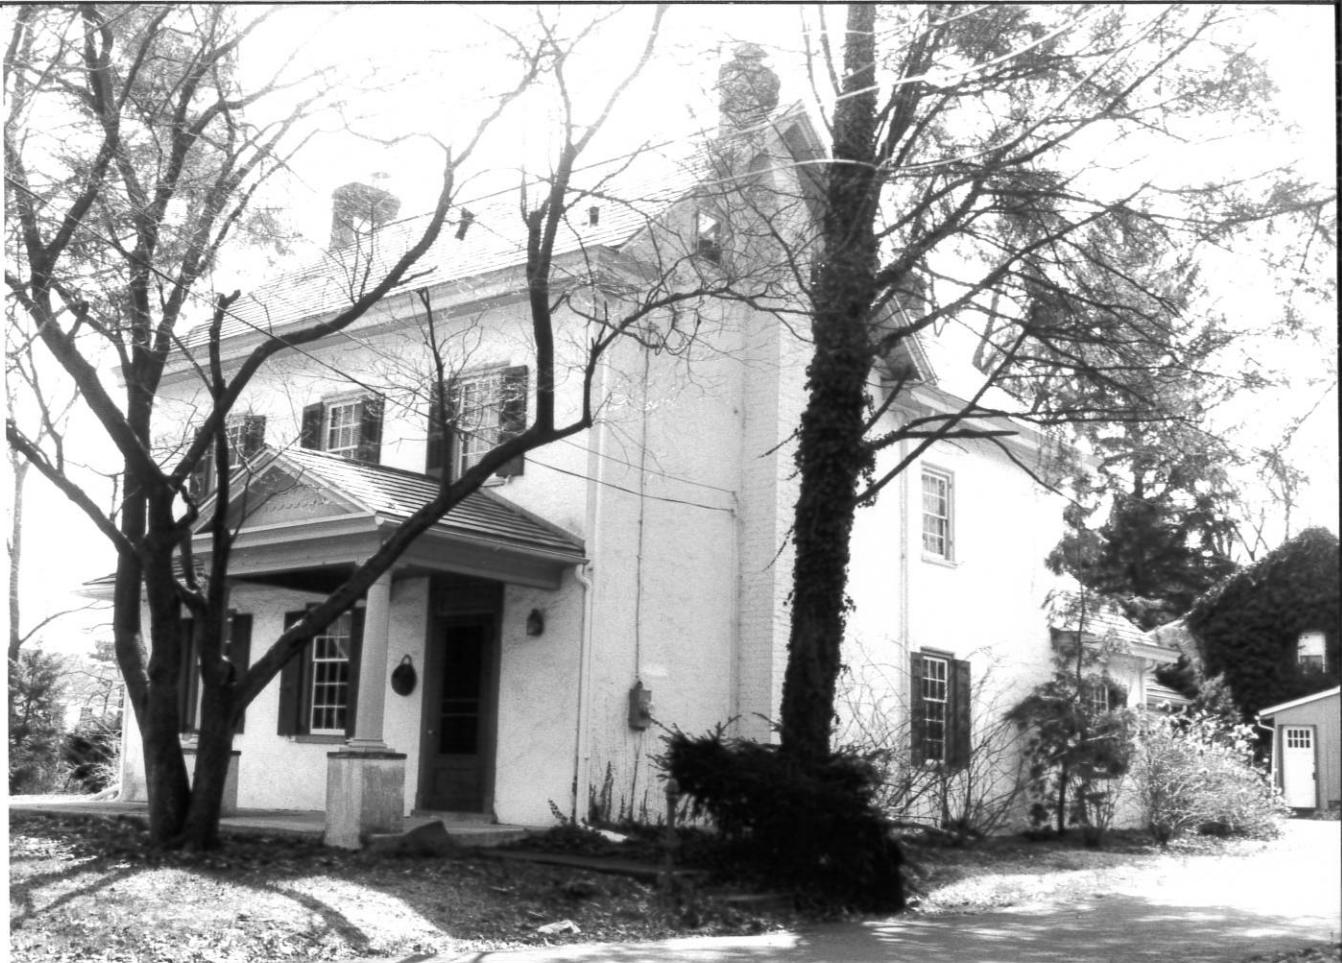
This Colonial style house, constructed c. 1769, is a 4-part additive, masonry building with a rehabilitated barn. The building was recently restored. The core of the house is two stories, stucco over stone, three bays wide, and has an end gabled, wood shingled roof. In Colonial style, there are partial roof returns. There is a flush brick chimney on the south end and an exposed brick chimney on the north end, the latter tapered under the apex of the roof. The cornice features thick but plain wood molding and box gutters. Fenestration consists of 6x9 sash windows on the first floor and 6x6 sash windows on the second floor. The main façade's five windows are flanked by shutters. The windows feature thick mullions and appear to be original. The paneled main door, located on the right of the façade, is deeply inset in the masonry walls. The main façade also features a pent roof that is punctuated on the right side by a pedimented hood over the door. The hood extends approximately 6 feet from the wall and is supported by Tuscan columns. The core measures approximately 25'x 18'.

The main addition is attached to the rear of the core. Like the core, it is 2-stories high, has stucco-over-stone walls, and a wood shingled roof. Attached to the rear of the addition is a single story extension, also stucco over stone. A newer, single story addition with vinyl siding is attached to this extension. Overall size is 55'x 25'.

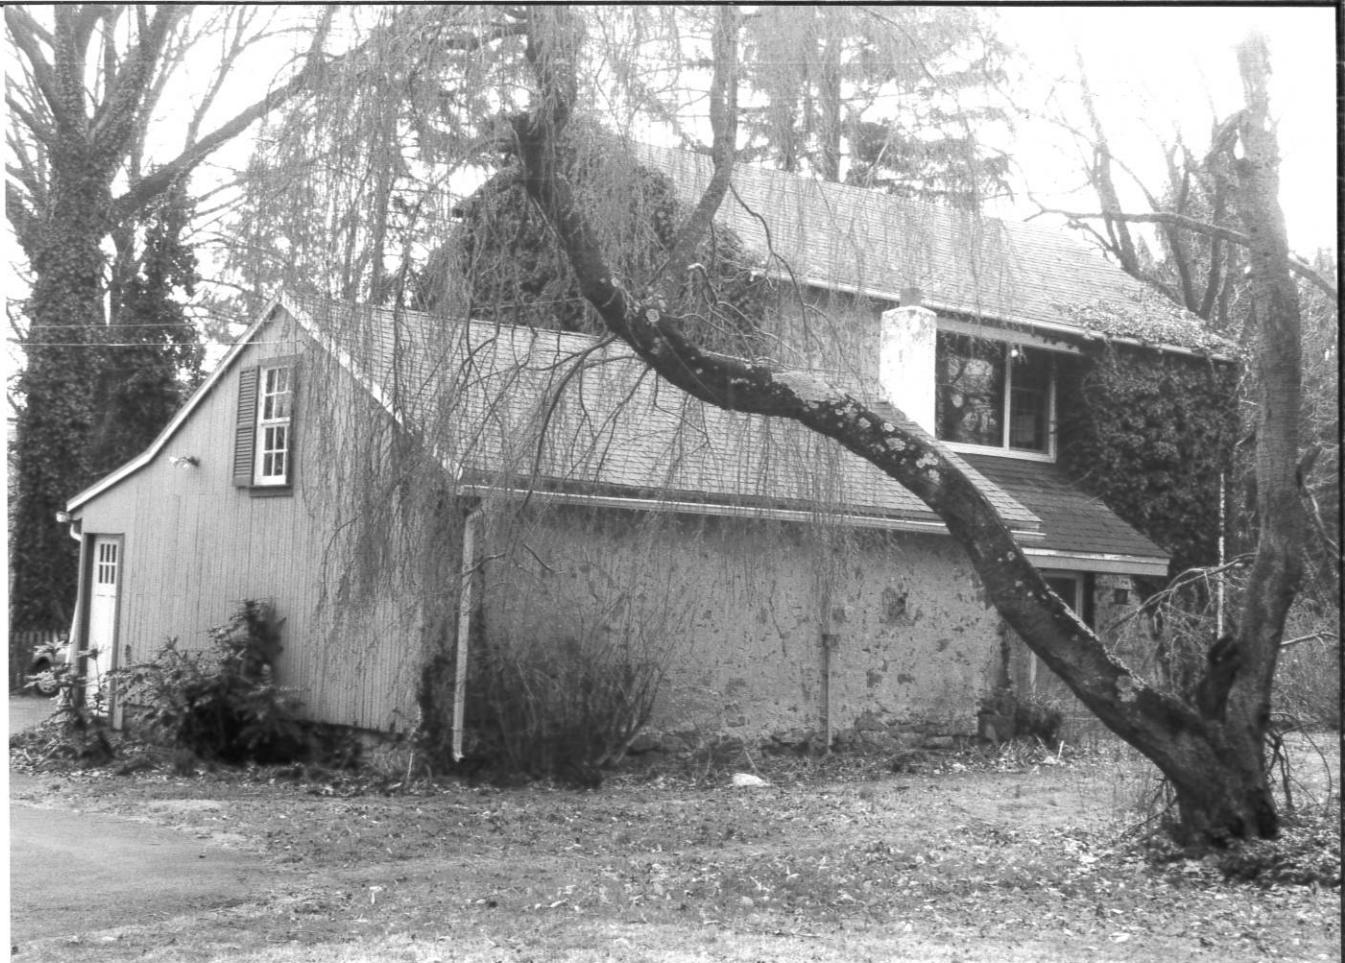
Associated Resource: (Barn) To the rear of the house is a 2-part barn. The larger section, converted to residential use, is a 2-story structure with stucco-over-stone walls and an end gabled, asphalt-shingled roof. The barn measures approximately 30'x 20'. Attached to the southeast corner of the house is a 1.5-story, stucco over stone and frame garage. It appears the building was originally used as some sort of a shed. The shed measures 22'x 20'.
