PENNSYLVANIA HISTORIC RESOURCE SURVEY FORM PHOTO/SITE PLAN SHEET

Address: 580 School Road

Surveyor Name/Title: Robert Wise Date: 6/16/2000
Project Name: Whitpain Township Historic Resource Survey
Organization: Robert Wise Consulting/Whitpain Township Telephone: (610) 722-5818
Street and No.: Station Square 1, Suite 104, 37 North Valley Road
City, State: Paoli, Pa Zip Code: 19301
Additional Survey Documentation: n/a
Associated Survey Codes: n/a

PENNSYLVANIA HISTORICAL RESOURCE SURVEY FORM
NARRATIVE SHEET 89C

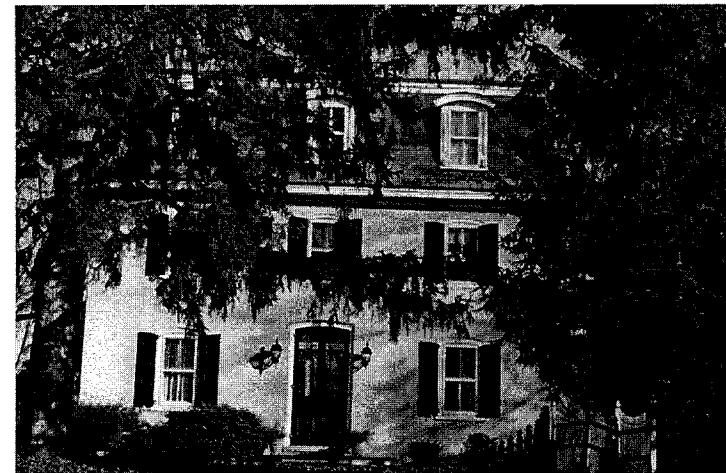
SITE PLAN**PHOTO INFORMATION**

Number	Description of View	Direction of Camera
1	House – façade	
2	House – façade	
3		
4		
5		
6		
Photographer Name:	Robert Wise	Date: 1999
Negative Location:	Robert Wise Consulting, Station Square 1, Suite 104, 37 N. Valley Road, Paoli PA 19301

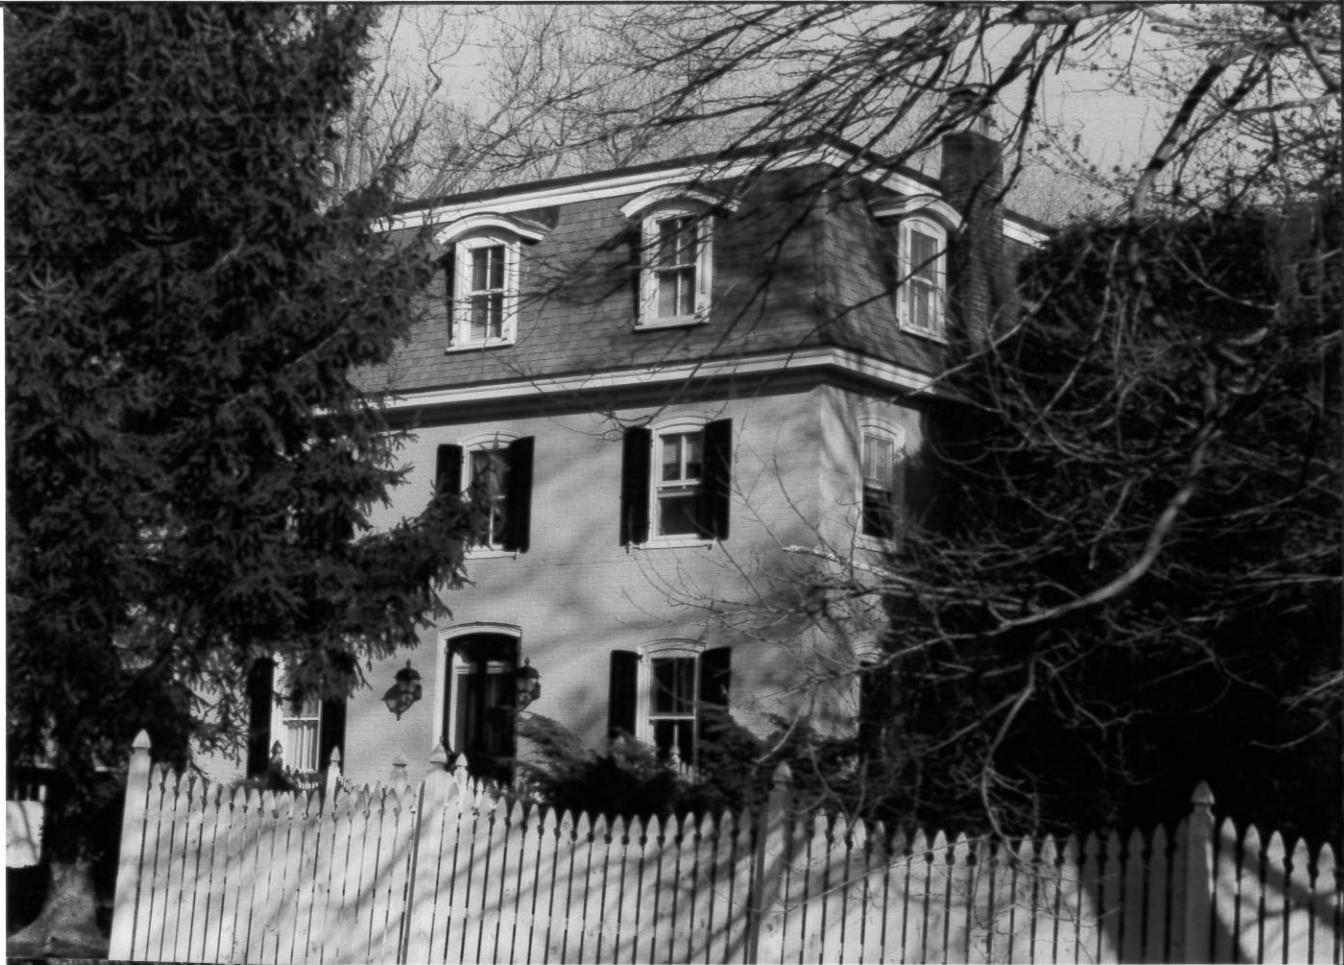
This is a fine example of a Second Empire-style house. It is a three story building with a Mansard Roof (asphalt shingles), thickly painted brick walls, and three bays wide. Three curved topped (segmented arch) dormers grace the main façade and additional dormer run along the sides. Each of the windows on the first two floors has segmental arches and shutters matching the arch. The door has French ornamentation and a curved transom. There is a one story frame addition on the back with a flat roof.

Number	Description of View	Direction of Camera
1	House – façade	
2	House – façade	
3		
4		
5		
6
