PENNSYLVANIA HISTORIC RESOURCE SURVEY FORM PHOTO/SITE PLAN SHEET

Survey Code/Tax Parcel/Other No.: 121 / 66-00-06565-00-2 Block Unit #015-065 County: Montgomery

Municipality: Whitpain Township Address: 731 Skippack Pike

Surveyor Name/Title: Robert Wise Date: 6/16/2000
Project Name: Whitpain Township Historic Resource Survey
Organization: Robert Wise Consulting/Whitpain Township Telephone: (610) 722-5818
Street and No.: Station Square 1, Suite 104, 37 North Valley Road
City, State: Paoli, Pa Zip Code: 19301
Additional Survey Documentation: n/a
Associated Survey Codes: n/a

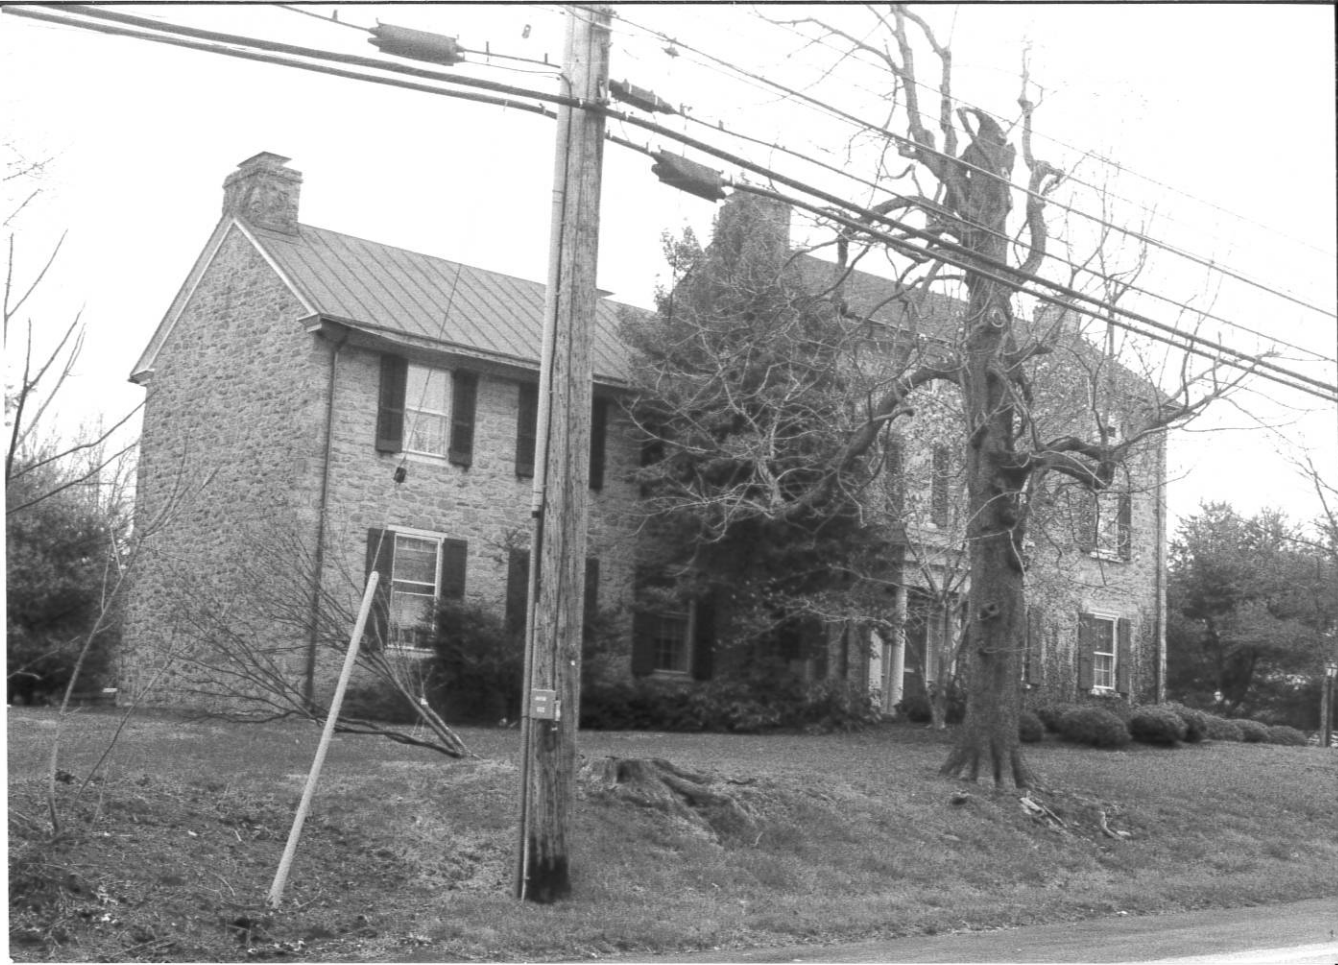
| Number | Description of View | Direction of Camera |
|---|---|---|
| 1 | House | |

This 3-part Federal style building consists of a stone walled core, a stone addition on the north end, and a frame addition on the rear of the house. With the rear frame addition, the house, which now serves as the offices for PAREC Homes, Inc., is T-shaped. The core consists of a three story, three bay wide structure with an asphalt covered, end gabled roof. The roof's eaves exhibit a partial return on the gabled ends. There are chimneys on each end: stone chimney on the north end and a smaller brick chimney on the south end, both flush with the end walls. The masonry core consists of un-coursed stone, which was probably covered with stucco when constructed. Fenestration consists three bays of 6x6 sash windows on the first and second floors and 3x3 sash frieze band windows on the third floor. Molded wooden lintels are located over the first and second floor windows. Paneled shutters flank the windows on the first floor; louvered windows are on the second floor. A single vertical row of windows serving all three floors is found on the southern end. The entrance consists of a door on the left side of the front facade. Most notable is the square portico supported by Roman Tuscan columns and featuring a three-tiered entablature and two modillion courses.

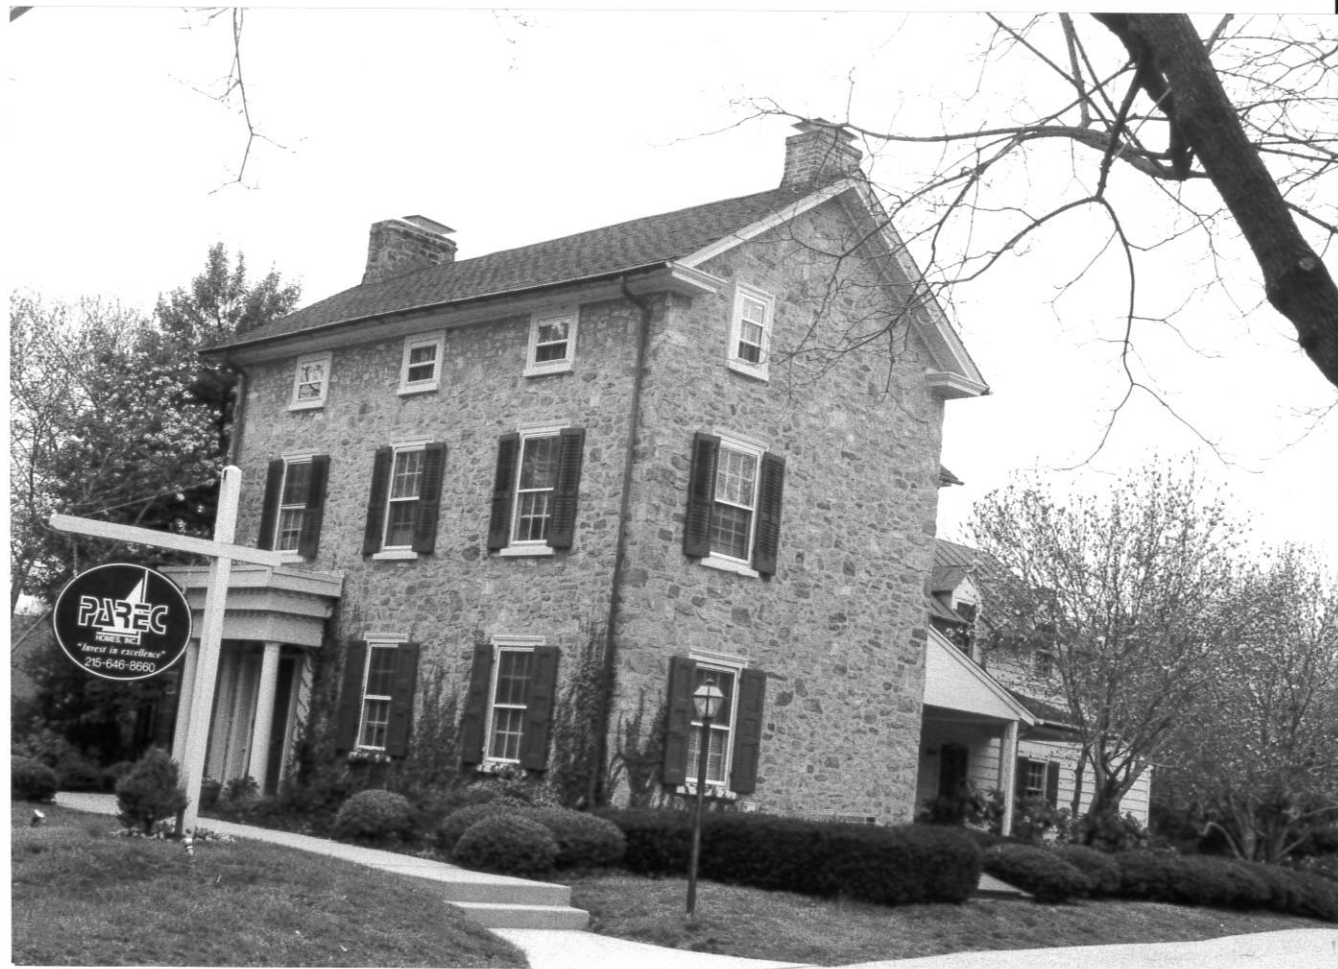
| Number | Description of View | Direction of Camera |
|---|---|---|
| 2 | Addition | |

The first addition consists of an end gabled, two-story unit with a standing seam tin roof. A slight cornice return is evident on the north end. A single, flush, banded stone chimney is located on the northern end. The fenestration and stonewalls are similar to that of the core. The addition is set back from the facade of the core.

The rear addition is a 1.5 story frame addition with a standing seam tin roof. Walls are clad in weatherboard. Notable features are the gabled wall dormers.
