PENNSYLVANIA HISTORIC RESOURCE SURVEY FORM PHOTO/SITE PLAN SHEET

Municipality: Whitpain Township

Address: 825 DeKalb Pike

Surveyor Name/Title: Robert Wise Date: 6/16/2000
Project Name: Whitpain Township Historic Resource Survey
Organization: Robert Wise Consulting/Whitpain Township Telephone: (610) 722-5818
Street and No.: Station Square 1, Suite 104, 37 North Valley Road
City, State: Paoli, Pa Zip Code: 19301
Additional Survey Documentation: n/a
Associated Survey Codes: n/a

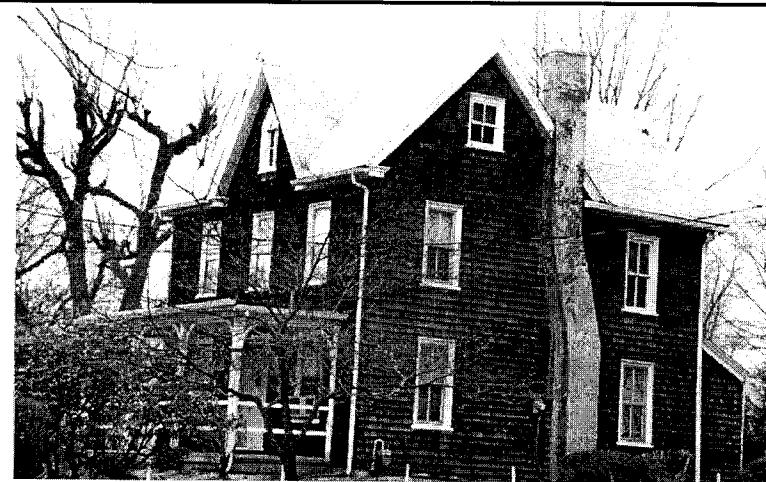
SITE PLAN**PHOTO INFORMATION**

Number	Description of View	Direction of Camera
1	House – façade	
2		
3		
4		
5		
6		
Photographer Name: Robert Wise		Date: 1999
Negative Location: Robert Wise Consulting, Station Square 1, Suite 104, 37 N. Valley Road, Paoli PA 19301

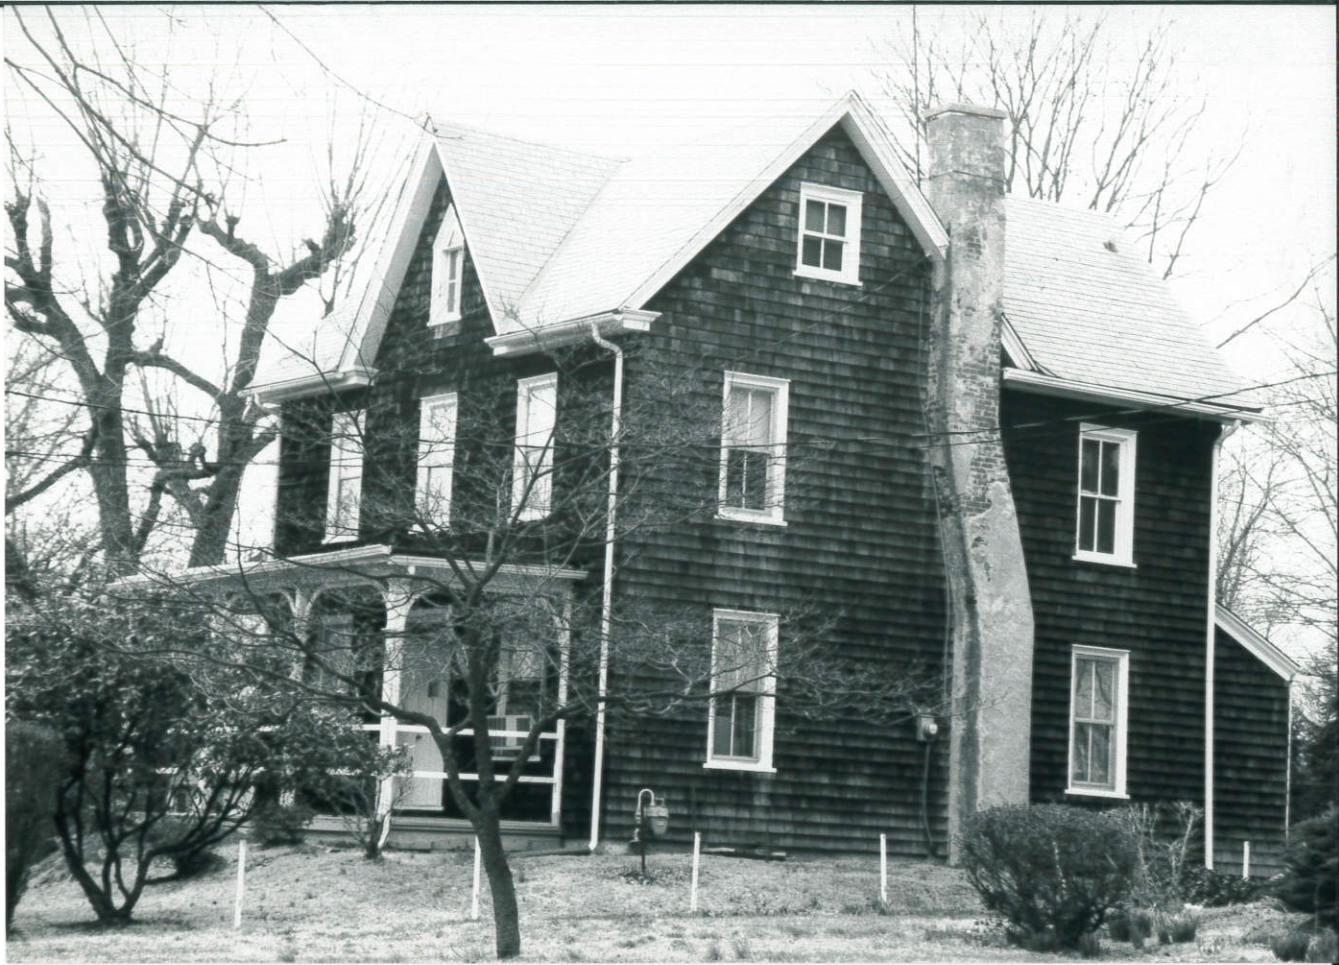
This is a 2.5-story, center gabled house designed in the Victorian Gothic mode (c. 1860). It has a cross-gabled, asphalt-shingled roof and is clad in wood shingles. The main façade is three bays wide. It is an ell-shaped core with an infill addition, a small shed-roofed addition attached to the rear and a hipped-roof front porch. Windows are 2 x 2 sash with French doors in the center. The window under the center dormer is pointed. Cornice is molded wood. There is a brick chimney on the right side of house with an awkward swale. The brick is partially covered with stucco. The building measures approximately 30'x30', including additions.

Classification: Due to alterations the house is Class II.
