PENNSYLVANIA HISTORIC RESOURCE SURVEY FORM PHOTO/SITE PLAN SHEET

Address: 990 DeKalb Pike

Surveyor Name/Title: Robert Wise Date: 6/16/2000
Project Name: Whitpain Township Historic Resource Survey
Organization: Robert Wise Consulting/Whitpain Township Telephone: (610) 722-5818
Street and No.: Station Square 1, Suite 104, 37 North Valley Road
City, State: Paoli, Pa Zip Code: 19301
Additional Survey Documentation: n/a
Associated Survey Codes: n/a

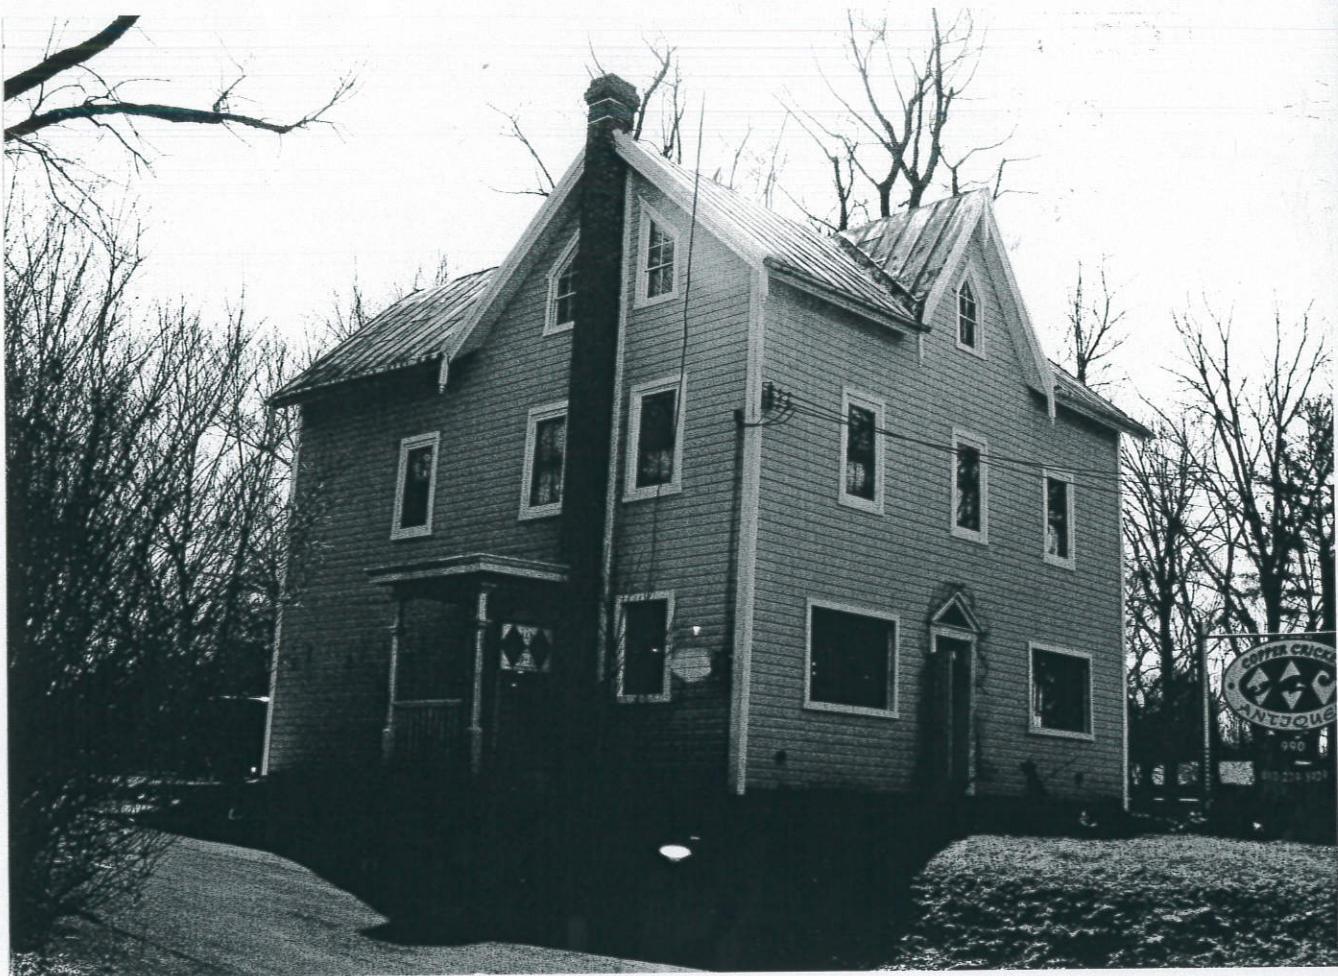
Number	Description of View	Direction of Camera
1	House – façade (left)	
2	House – façade (right)	
3		
4		
5		
6		
Photographer Name: Robert Wise		Date: 1999
Negative Location: Robert Wise Consulting, Station Square 1, Suite 104, 37 N. Valley Road, Paoli PA 19301

This altered Folk Victorian store and residence has several architectural features found in similar period houses through out the Township. These features may be influenced by the Gothic mode. For example, its roof is cross-axial due to the large wall dormer on the center of the building. A single pointed arched widow occupies the space under the dormer crest. A pair of angled windows, whose lintels parallel the roof line above, are found in each end. Downward finials hang from strategic points of the eaves.

Overall, the house is a three-part, 2.5 story, three bay, vinyl clad building with a standing seam, cross axial, end gabled roof. A chimney pot occupies the western end of the roof. Another chimney, a brick chimney presumably for the oil burner, has been added to the east end of the structure. In I-house tradition, the core was rectangular, with an early, two story addition occupying the rear of the house and forming an ell-shape. A later two-story addition, with a nearly flat roof, was added to the void of the ell.

With the exception of the attic windows, the windows are not original. Large openings have been cut into the first floor. The interior of the house has been highly altered to accommodate a retail business.

Classification: Due to heavy alterations, this building is Class II.
