PENNSYLVANIA HISTORIC RESOURCE SURVEY FORM PHOTO/SITE PLAN SHEET

Municipality: Whitpain Township

Address: 1451 Skippack Pike

Project Name: Whitpain Township Historic Resource Survey

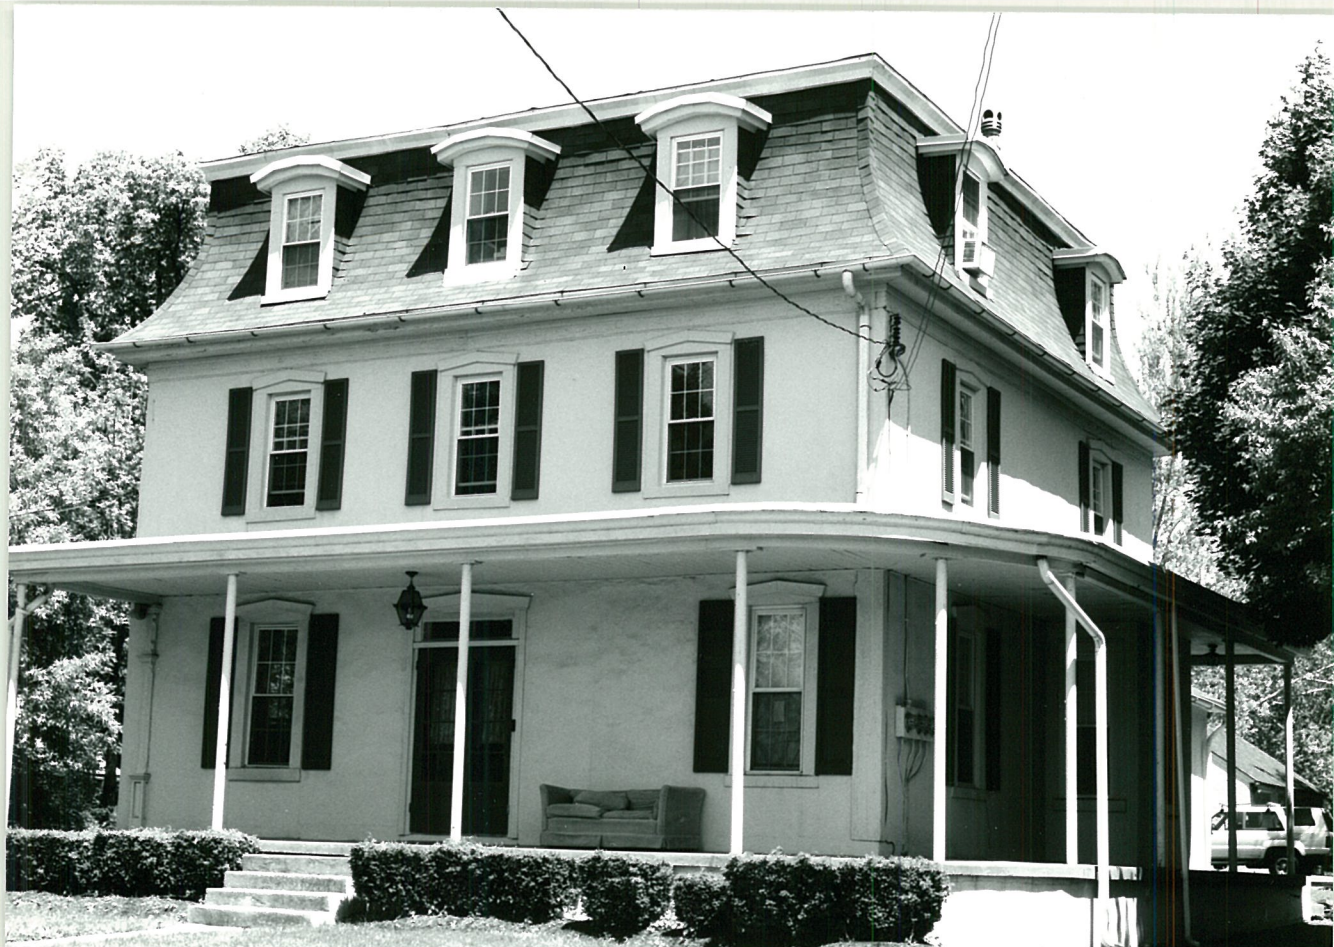
This Second Empire-style, Mansard roofed house (c. 1880) consists of a three-story core with a two-story rear addition. The house is a fine example of the Township's Second Empire influence. The core measures 30' across (three bay) and 25' deep. The addition adds another 15' to the rear of the house. The roof consists of a concave shape clad in asphalt shingles and framed with cornices on the roof and cornice line. The eaves are supported by brackets on the west end of the house, although they have been removed across the main façade and east end. Barrel topped, molded dormers are located across the front and side facades. A wrap-around porch with a curved corner is located on the front and east facades. Fenestration consists of new, 6x6 sash windows and a French door main entrance. A two-light transom is located over the door. Windows are topped with gabled lintels. Louvered shutters flank the windows on the second floor; paneled shutters flank the first floor windows. The west end has a two-story bay window arrangement. The core is stucco covered. The Rear addition has a bracketed flat roof with a similar bracketed cornice system to that of the end of the core. The windows of the addition also have a gabled lintel and the walls are clad in weatherboard.

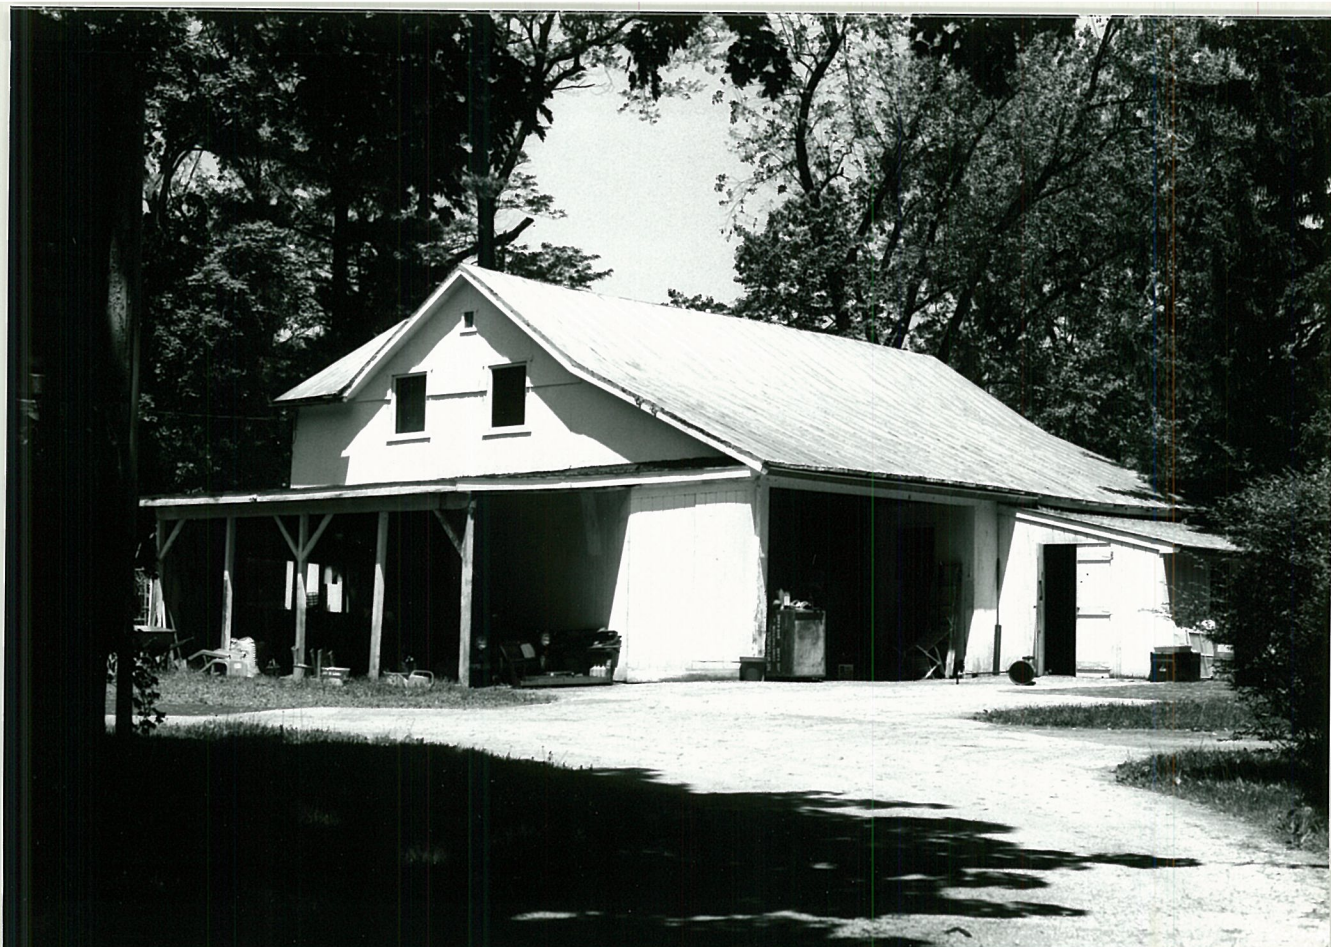
Associated Building: (Barn) To the rear of the house is a contributing barn or carriage house. It consists of a 1.5 story frame addition with a standing seam tin roof and shed roof additions.
