**PENNSYLVANIA HISTORIC RESOURCE SURVEY FORM PHOTO/SITE PLAN SHEET**

Municipality: Whitpain Township

Address: 1475 Skippack Pike

Surveyor Name/Title: Robert Wise Date: 6/16/2000  
Project Name: Whitpain Township Historic Resource Survey  
Organization: Robert Wise Consulting/Whitpain Township Telephone: (610) 722-5818  
Street and No.: Station Square 1, Suite 104, 37 North Valley Road  
City, State: Paoli, Pa Zip Code: 19301  
Additional Survey Documentation: n/a  
Associated Survey Codes: n/a

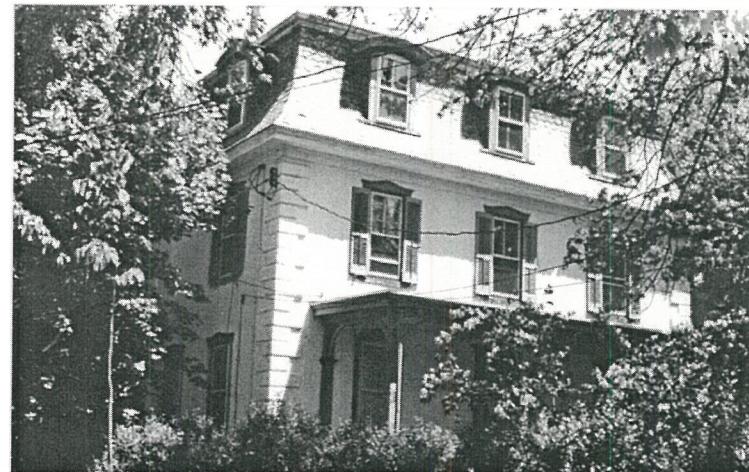
**SITE PLAN****PHOTO INFORMATION**

Number	Description of View	Direction of Camera
1	House – façade	
2	House – façade	
3		
4		
5		
6		
Photographer Name:	Robert Wise	Date: 1999
Negative Location:	Robert Wise Consulting, Station Square 1, Suite 104, 37 N. Valley Road, Paoli PA 19301

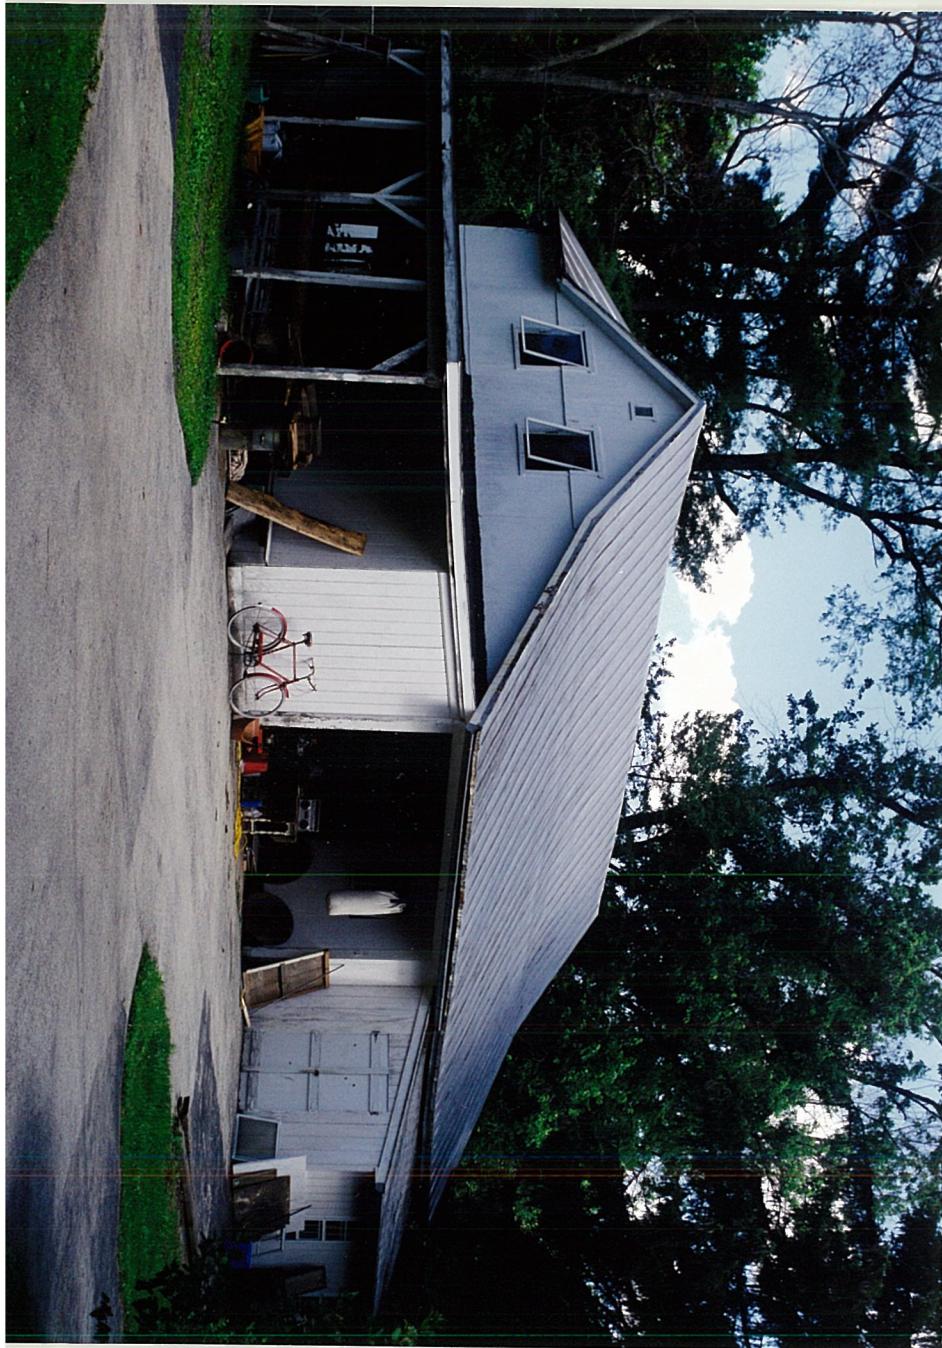
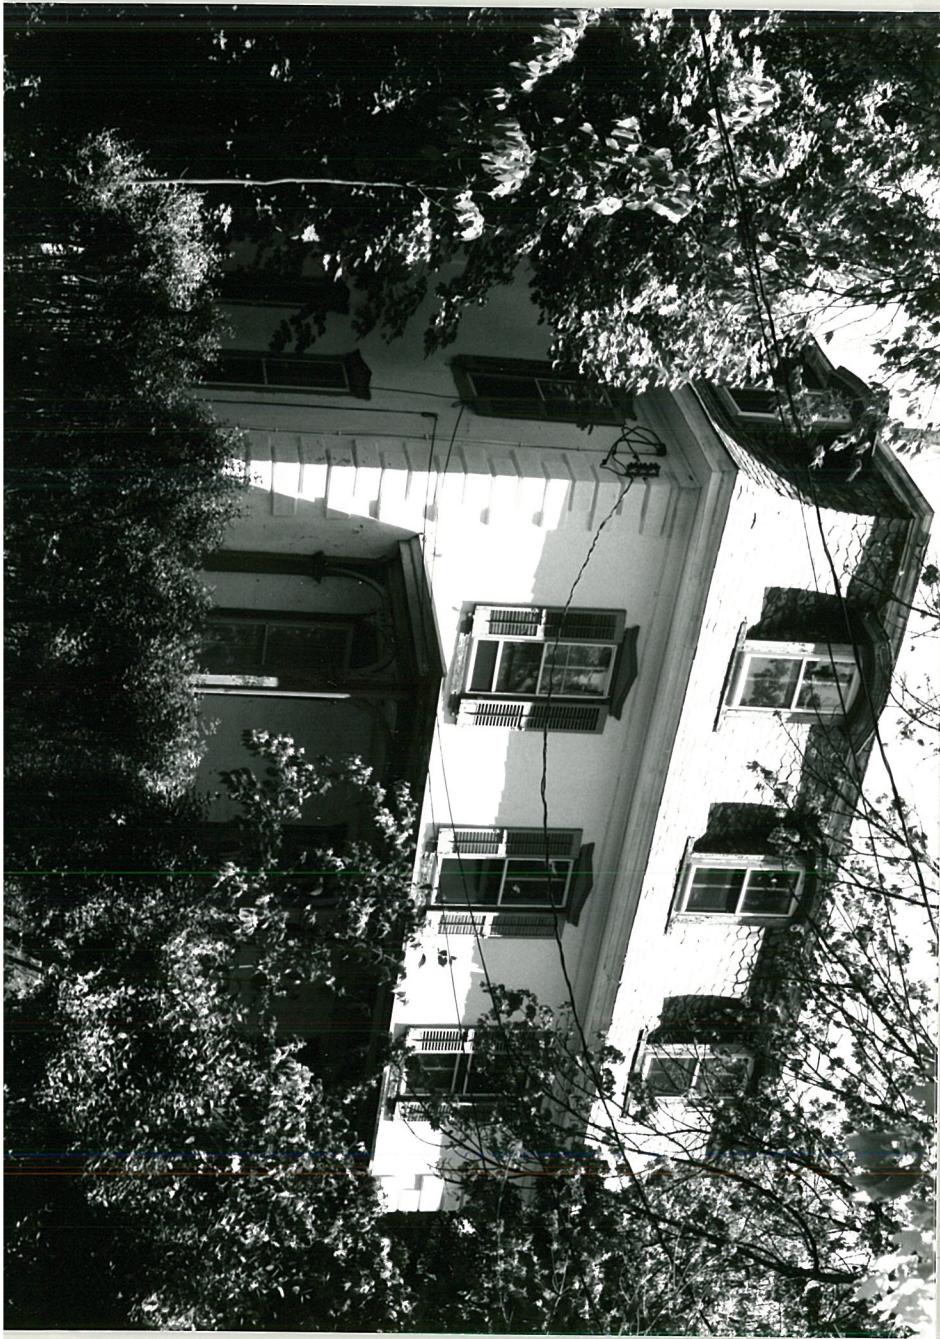
This Second Empire-style, Mansard roofed house (c. 1880 but listed as being built in 1830 on tax form) consists of a three-story core and an enclosed second-story sleeping porch. The house is a fine example of the Township's Second Empire influence and consists of several details popularized by the style. Some of these details include hexagon slate roof shingles, concave roof, curved molded dormers, exaggerated cornice above and below roof, and quoins. The house measures 30' across (three bay) and 33' deep. Barrel topped, molded dormers are located across the front and side facades. The full-length front porch is supported by decorative, scroll-sawn brackets and posts. Fenestration consists of 2x2 sash windows and a French doors as a main entrance. A transom is located over the door. Windows are topped with gabled lintels. Louvered shutters flank the windows on the second floor. In contrast to 1451 and 1463 Skippack Pike, this house has a 2-story bay window addition on the east end of the house. The house is stucco covered. The sleeping porch on the east side is enclosed with German beveled siding.

**Classification:** The house is in good shape and characteristic of the Mansard tradition in the Township. It is a Class I resource.
