PENNSYLVANIA HISTORIC RESOURCE SURVEY FORM PHOTO/SITE PLAN SHEET

Municipality: Whitpain Township

Address: 1540 Skippack Pike

Surveyor Name/Title: Robert Wise Date: 6/16/2000
Project Name: Whitpain Township Historic Resource Survey
Organization: Robert Wise Consulting/Whitpain Township Telephone: (610) 722-5818
Street and No.: Station Square 1, Suite 104, 37 North Valley Road
City, State: Paoli, Pa Zip Code: 19301
Additional Survey Documentation: n/a
Associated Survey Codes: n/a

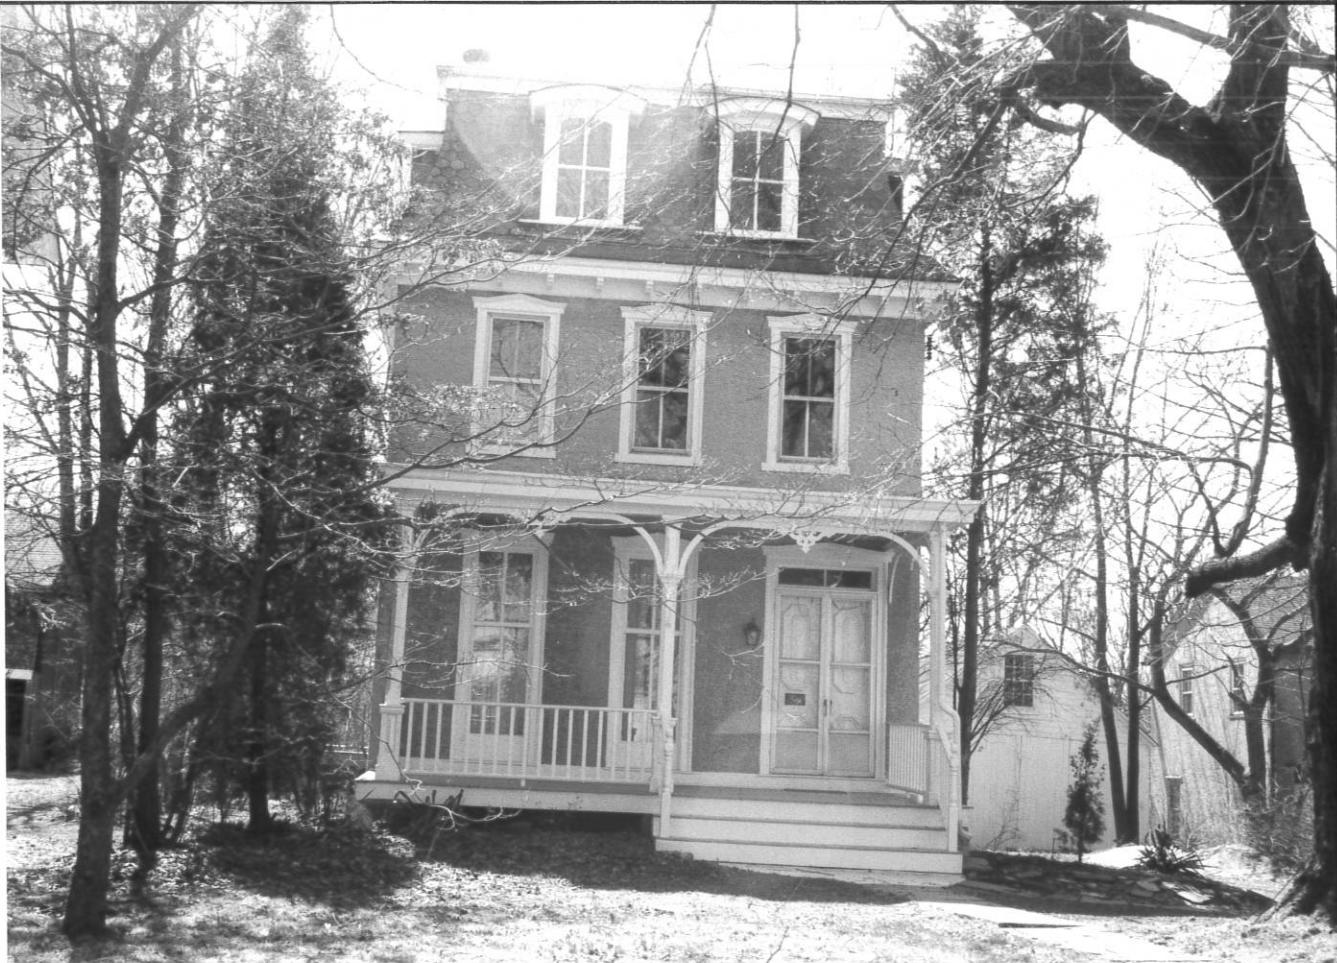
This Second Empire style house has many details characteristic of the style. The house is 2.5 stories high and features decorative woodwork, a Mansard roof, and 2-story rear addition. The property also has a frame garage. The core of the house has a highly decorative, flared Mansard roof with octagonal slate shingles, molded crest, and scroll-sawn brackets supporting the wooden eaves. Attached to the front of the house is a flat roofed entry porch/veranda with scroll-sawn spandrel. The 3-bay wide house also features plate glass, 2x2 sash windows on the second and third floors and vertical windows on the first floor. The entrance is through French doors topped with a 2-light transom. There are several curved pedimented dormers, including two on the main façade and two on the north and south sides. The other window openings have wood surrounds with pedimented lintels. The core measures 20'x 20'.

Associated Resource: (Garage) To the rear of the property is a 1.5 story frame garage. The garage, c. 1920, has a front- end gable roof and two garage doors with swinging wooden doors. A single window is located under the gable over the garage doors.

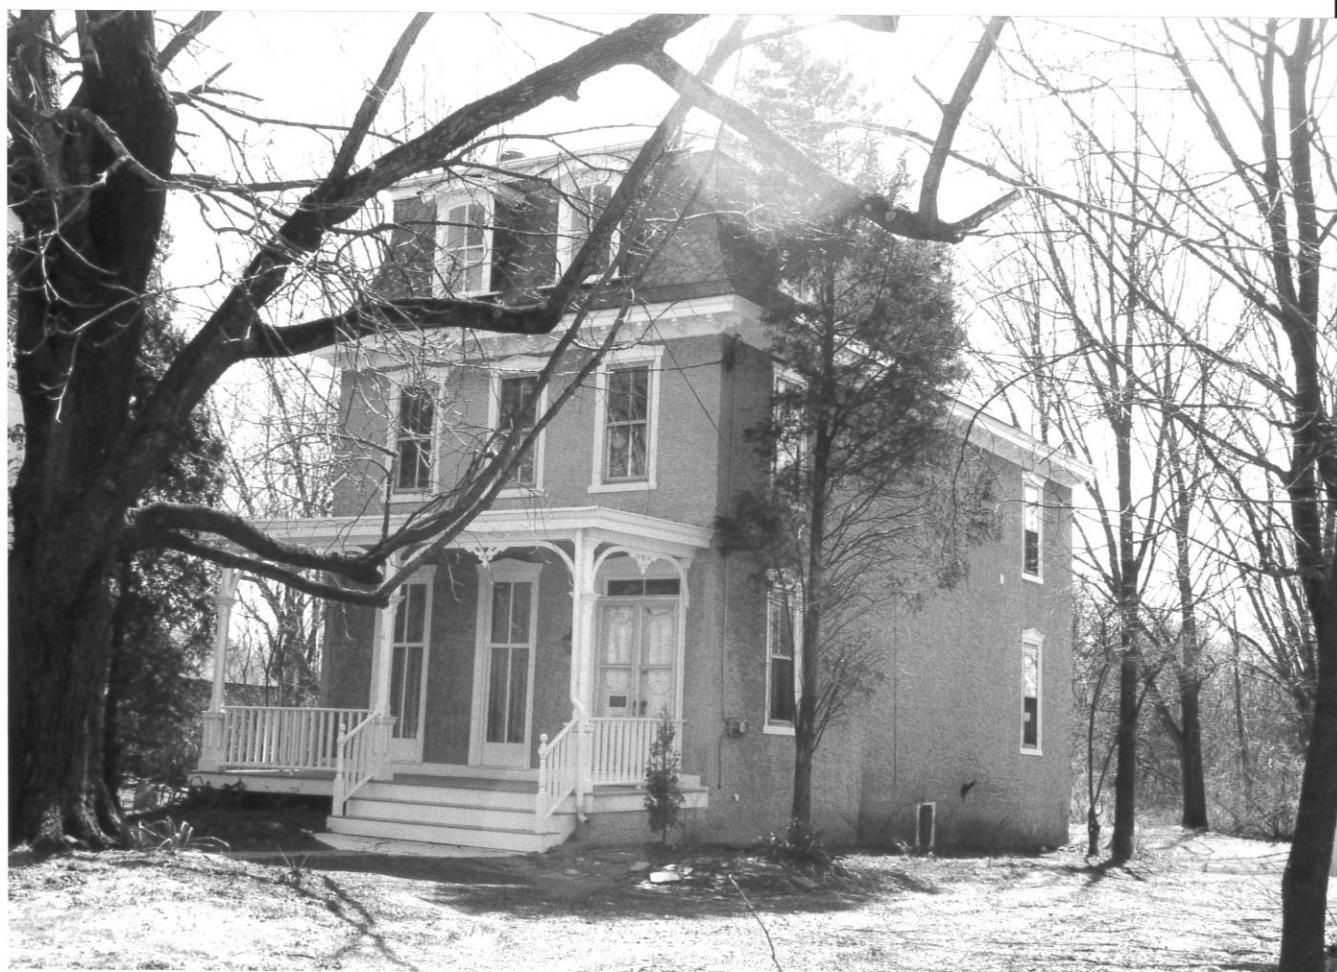
The addition is a 2-story extension to the rear of the core. Like the core it contains stucco- clad walls. The decorative eaves and brackets of the core have been extended along the roofline of the addition.
