PENNSYLVANIA HISTORIC RESOURCE SURVEY FORM PHOTO/SITE PLAN SHEET

Address: 1898 Skippack Pike

Surveyor Name/Title: Robert Wise Date: 6/16/2000
Project Name: Whitpain Township Historic Resource Survey
Organization: Robert Wise Consulting/Whitpain Township Telephone: (610) 722-5818
Street and No.: Station Square 1, Suite 104, 37 North Valley Road
City, State: Paoli, Pa Zip Code: 19301
Additional Survey Documentation: n/a
Associated Survey Codes: n/a

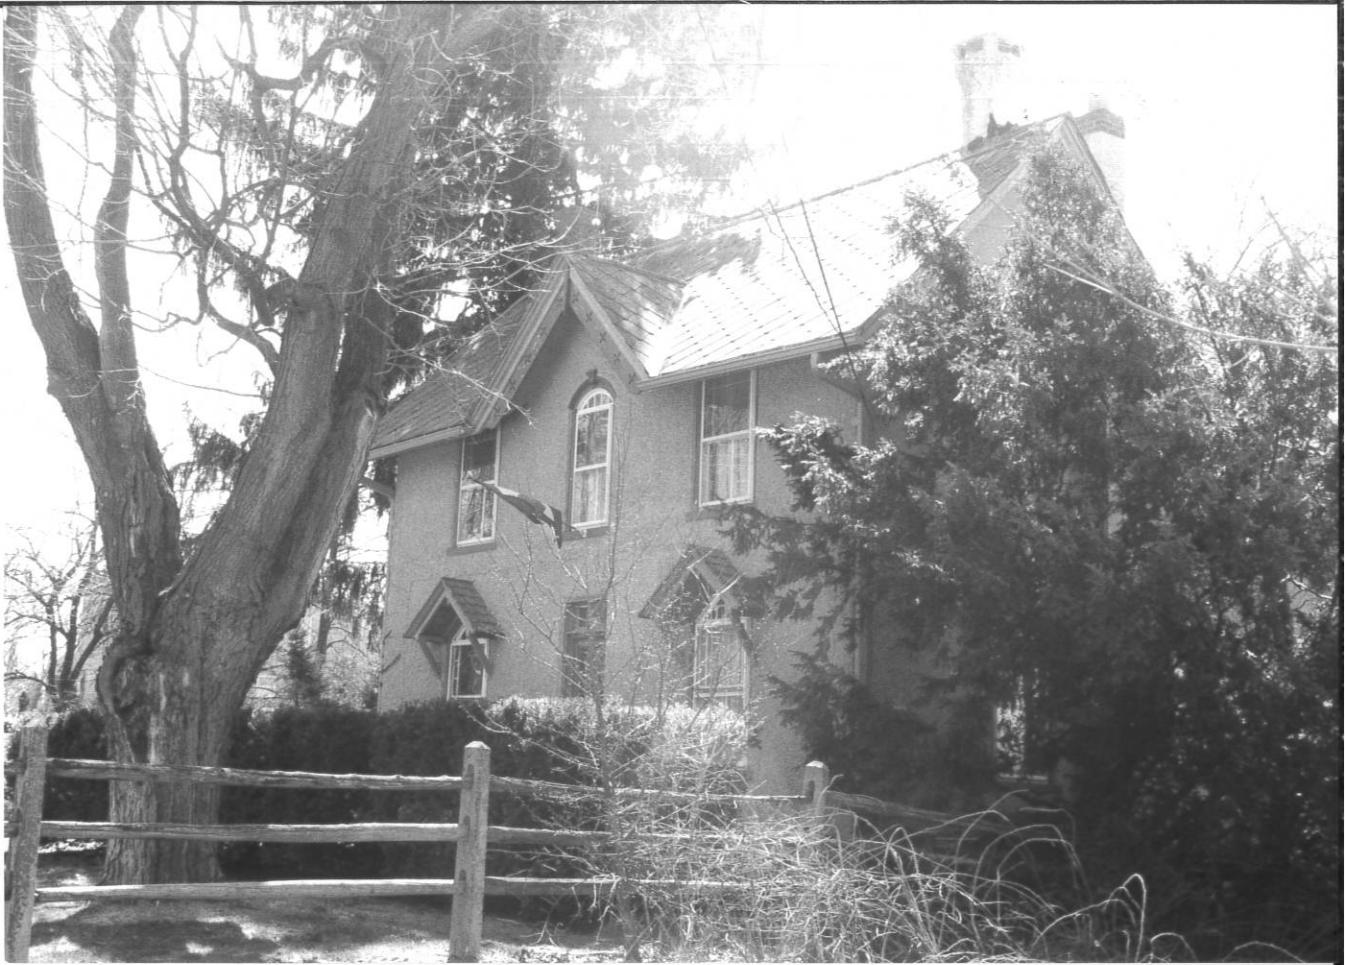
Number	Description of View
1	House – façade
2	House – façade
3	
4	
5	
6

This Gothic Revival house consists of a 3-bay wide core with rear addition and a 1-story barn in the rear of the property. The core is a 2-story, stucco-clad building with an end-gabled, asbestos shingled (diamond shape) roof. The roof is punctuated on the main facade with a small cross gable. The gable is adorned with a decorative bargeboard, in Gothic Revival fashion. Stucco-covered, flush chimneys are located on both ends of the house, with a third chimney located on the north end. Fenestration consists of pedimented topped windows with surrounding panes (in Queen Ann style) on the first floor windows. Bracketed gabled hoods, with scalloped wood shingles, are located over the first floor windows (complimenting the pedimented tops of the windows below) and the second floor windows under the gabled ends. The Queen Ann style windows (large plate glass surrounded by smaller panes) are also located on the second floor. A single Palladium window, minus the flanking units, is located under the center gable. It is capped with curved hood mood with a decorative wood keystone in the center of the arch. Access to the core is through a centered door, with transom. Markings between the first and second floor window openings indicate the presence of a pent or porch roof. The core measures 30'x 15'.

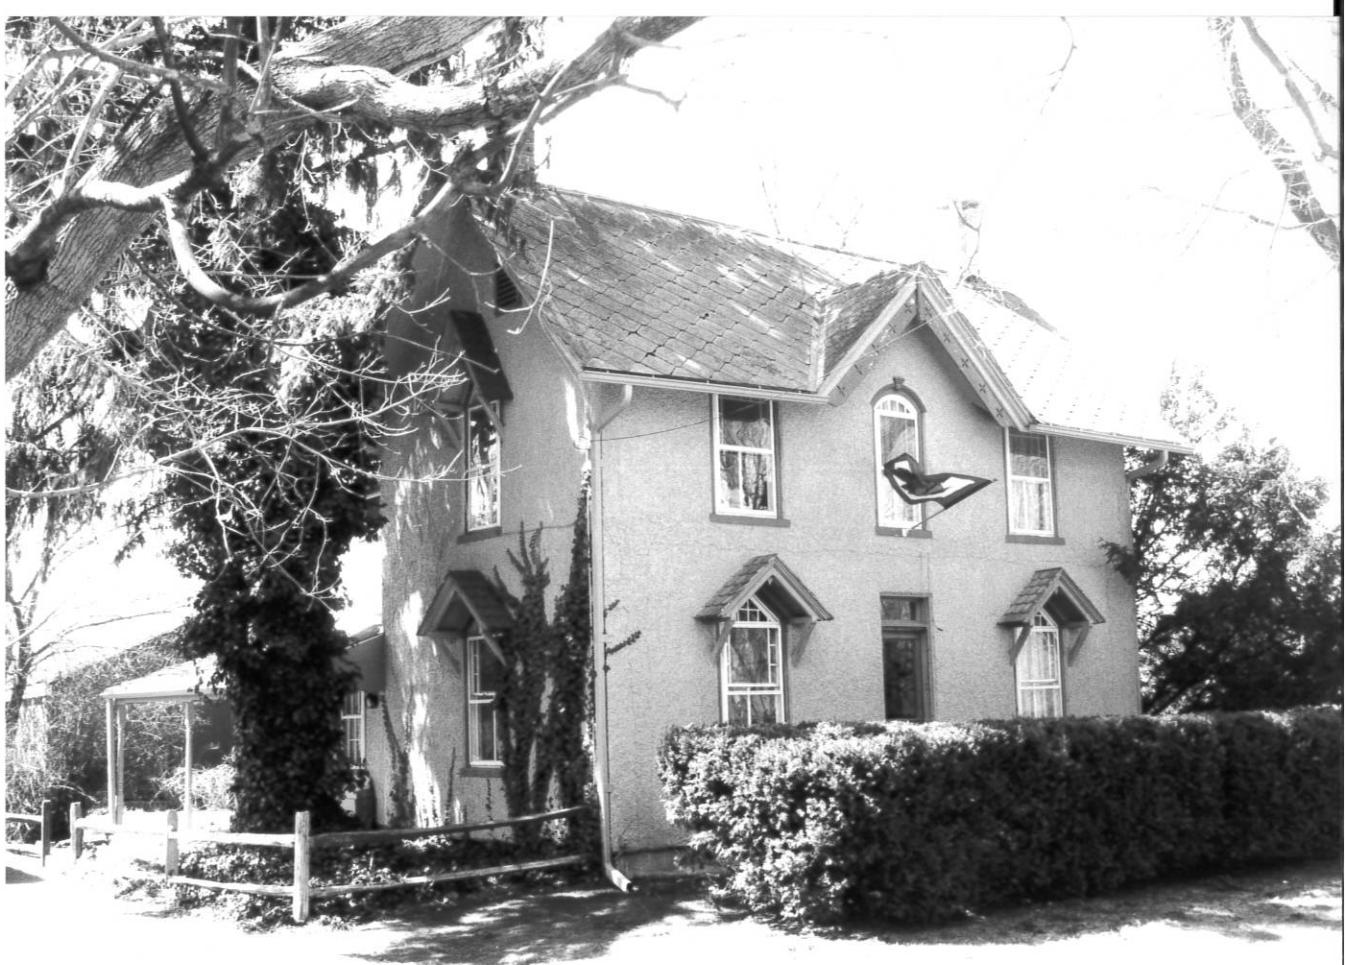
A two story, stucco-clad addition is attached to the rear of the core. It features a shed-roofed porch on the southwest corner. Overall, the house measures 30'x 40'.
