# PENNSYLVANIA HISTORIC RESOURCE SURVEY FORM - DATA SHEET

Address: 1709 Skippack Pike Historic Name:

Surveyor Name/Title: Robert Wise Date: 6/16/2000  
Project Name: Whitpain Township Historic Resource Survey  
Organization: Robert Wise Consulting/Whitpain Township Telephone: (610) 722-5818  
Street and No.: Station Square 1, Suite 104, 37 North Valley Road  
City, State: Paoli, Pa Zip Code: 19301  
Additional Survey Documentation: n/a  
Associated Survey Codes: n/a

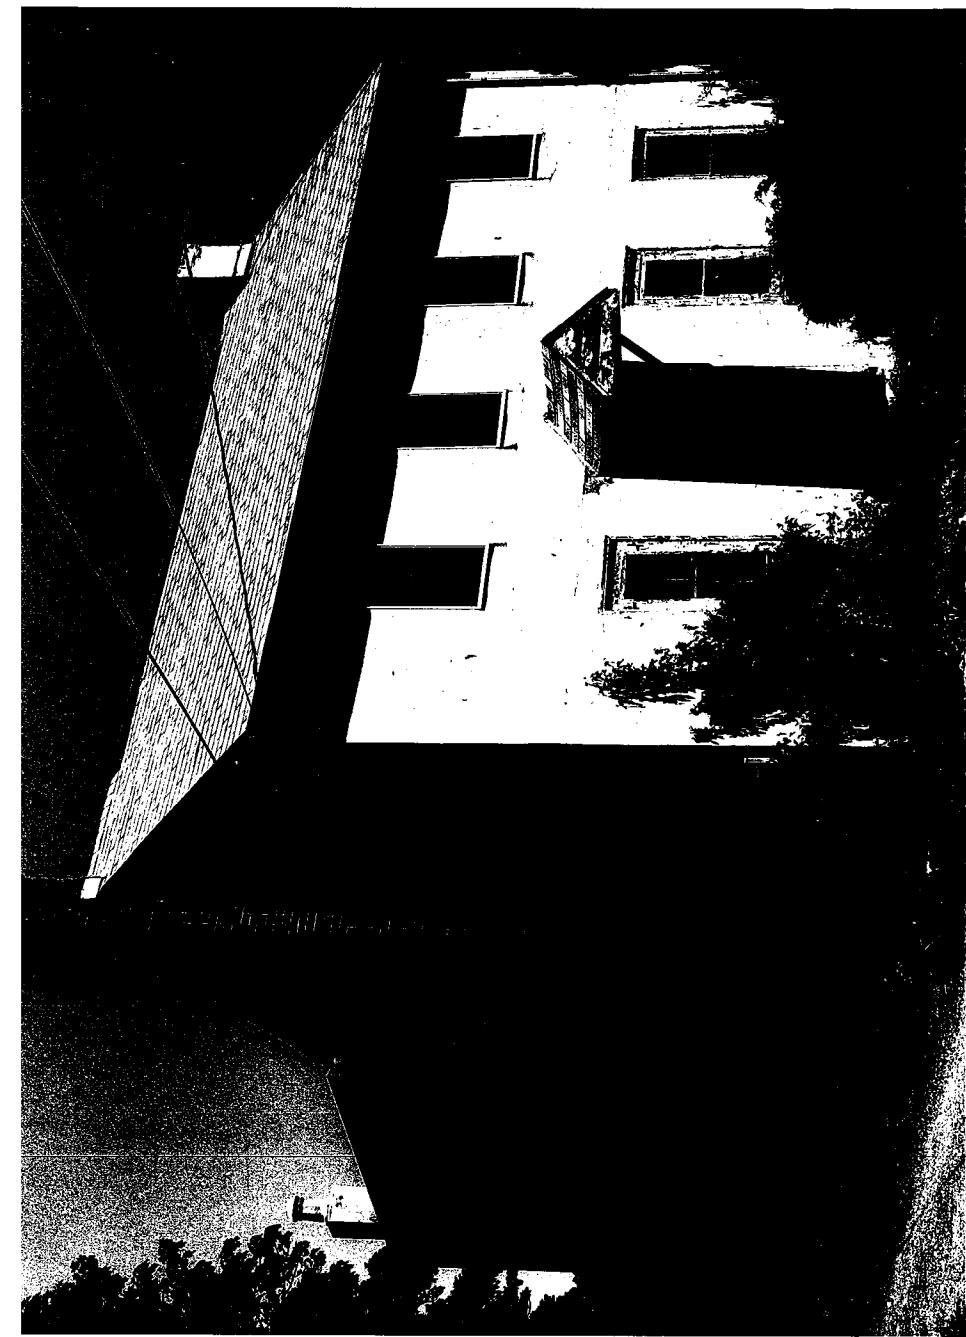
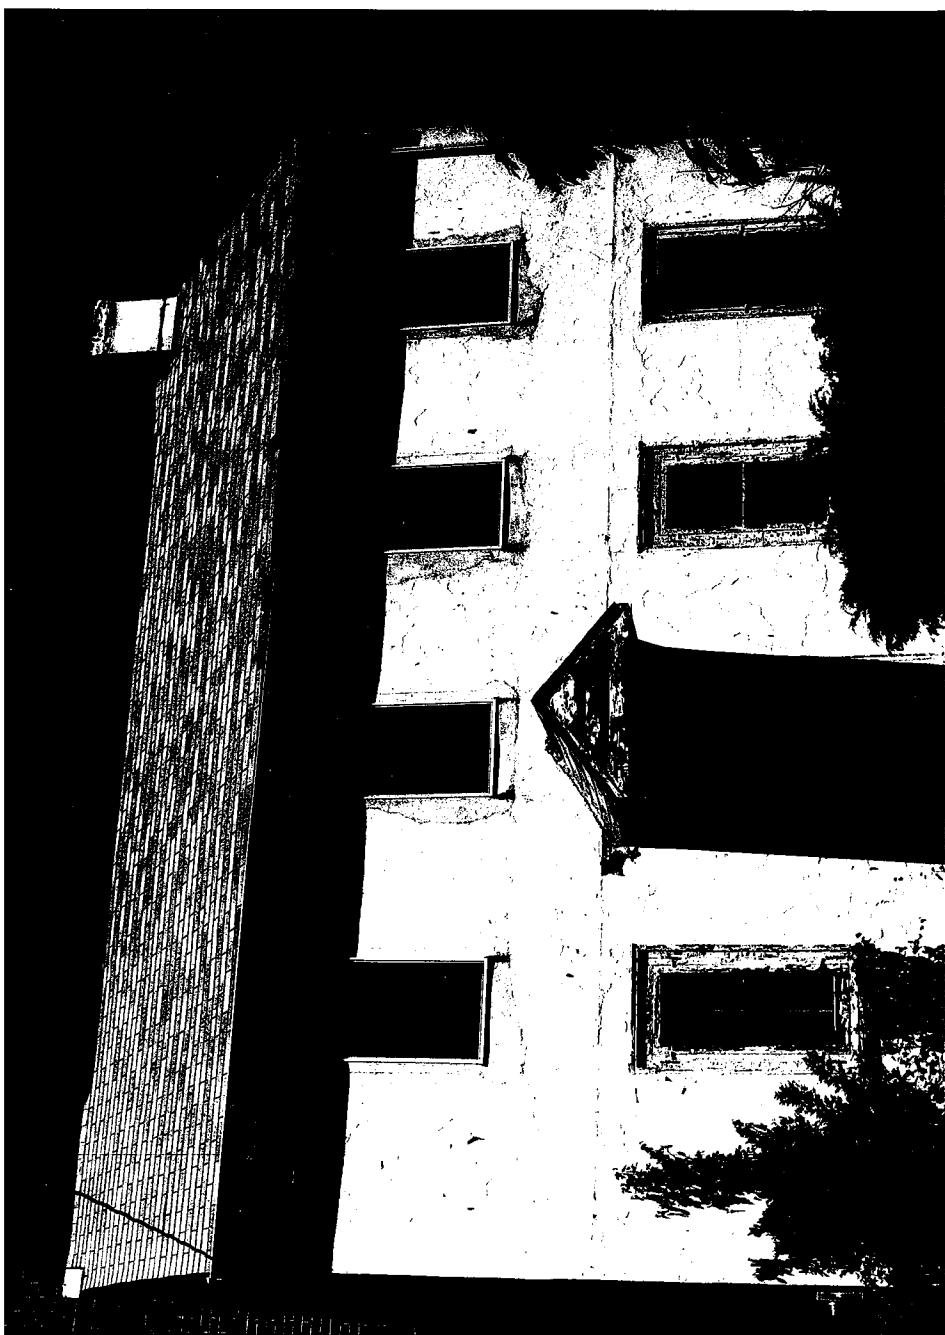
Although listed as c. 1870, more likely that is when this house's two-story frame addition was constructed onto the rear of the house. The vernacular house (with Federal style influences) was probably constructed around 1800. It consists of a 2-story, end gabled, asphalt shingle roofed house with a 4-bay wide façade. The off center entrance sits under a protruding gabled hood. Markings in the stucco walls of the house indicate a former pent roof or porch. The core measures 40' x 18' plus the addition. The core has two chimneys: one a stucco-clad, flush chimney on the east end and a newer brick chimney attached to the west end. The rear addition is a two-story frame extension with a flat roof, German siding, and a terracotta chimney pot. There is also a smaller one story shed roofed addition on the rear of the house.

**Classification:** Class II. Also, the house is abandoned and in poor condition.
